# **Slope Stability Report**

## **Proposed Residential Development**

51-55 Hawkesville Road, St. Jacobs

January 23, 2025  
Project No. 2403070

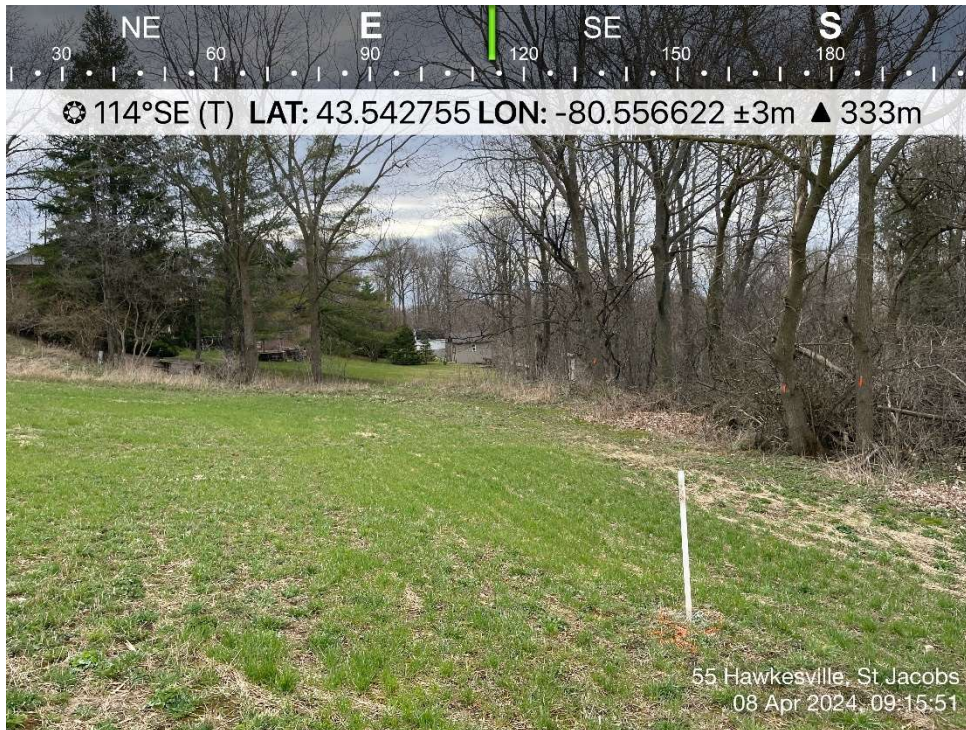
**PHOTOGRAPH 1**

View of tableland near southeast corner of site. Staked borehole 24-02 is visible in the foreground.

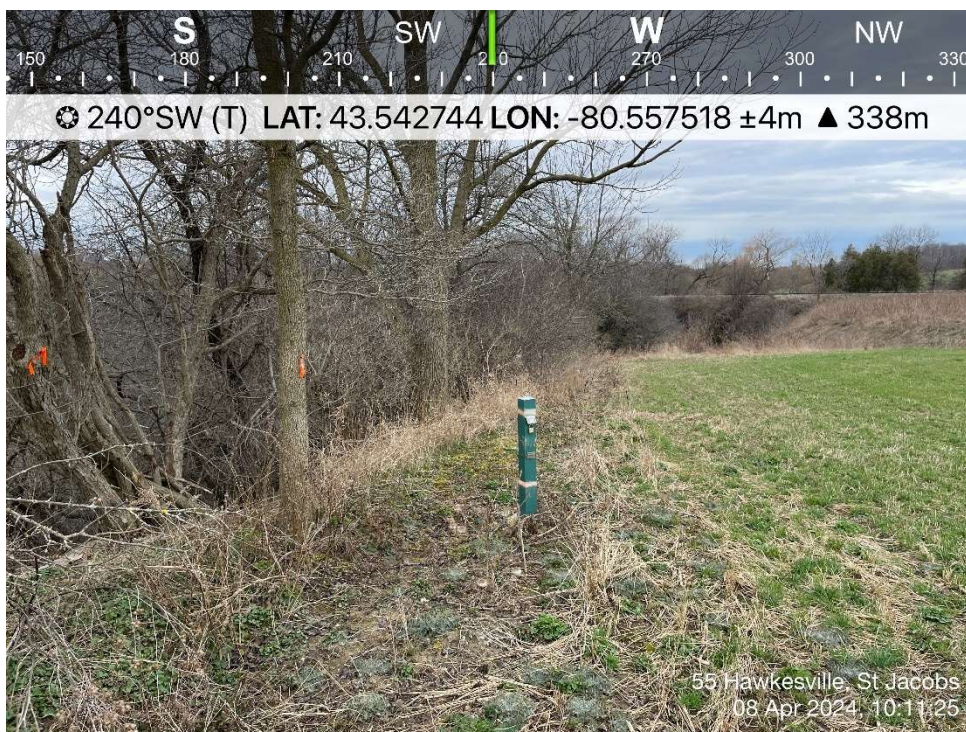
**PHOTOGRAPH 2**

View of tableland near CVD Borehole 2.

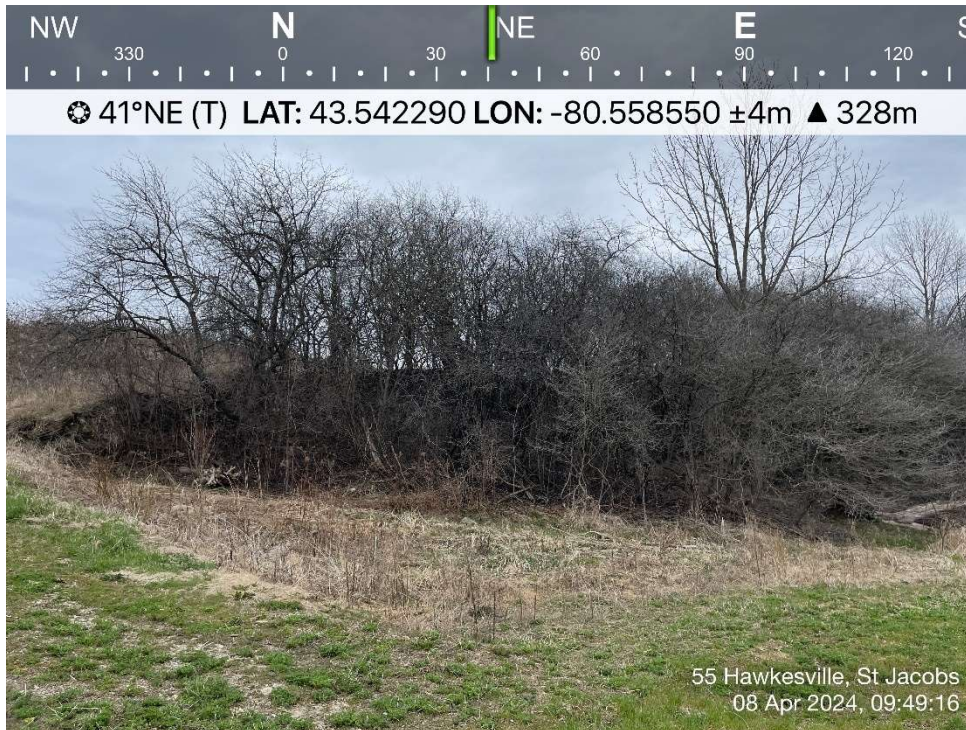
**PHOTOGRAPH 3**

View of western end of slope.  
 Photo taken looking north from  
 beyond slope toe.

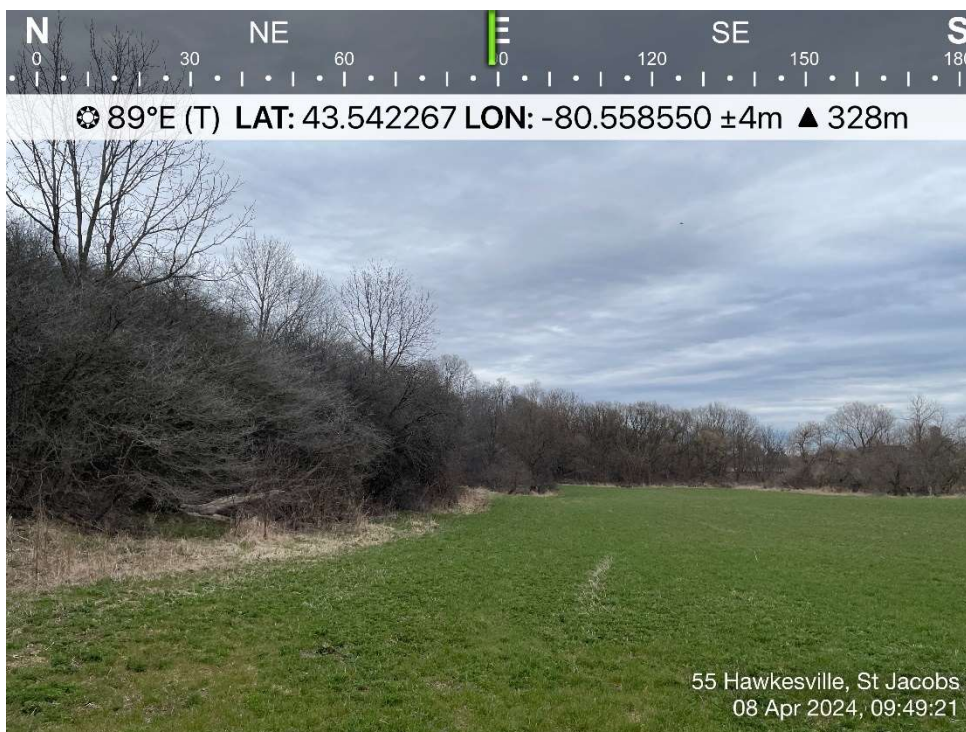
**PHOTOGRAPH 4**

View of lands in front of  
 (south) of slope. Although not  
 visible in the photo, Conestogo  
 river is present to the south  
 (right).

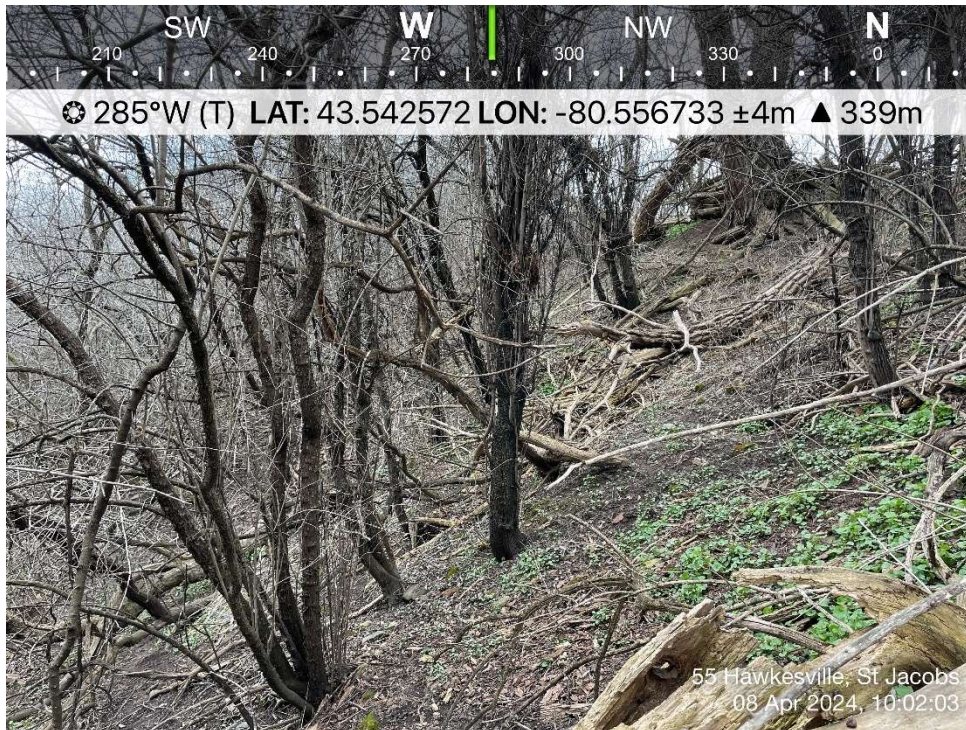
**PHOTOGRAPH 5**

The face of the slope was densely covered with small to medium sized trees. The trees were mostly vertical although some very slightly leaning. Due to the dense tree coverage, there was limited undergrowth, however there were areas of light vegetation and numerous leaves, sticks and rocks. The tree coverage was so dense in areas that it was not possible to access certain parts of the slope. No signs of concentrated runoff or seepage were observed, nor did we observe any signs of slope instability (e.g. tension cracks, toe bulging, etc.).

View of the slope face taken near southeast corner of property. Slope was densely covered with small to medium sized trees with and slope face had limit undergrowth.

- A healthy vegetative cover should be maintained on the slope, and disturbance to the slope and vegetation on the slope should not occur. Any slope areas disturbed by construction should be restored with suitable native vegetation as soon as possible.

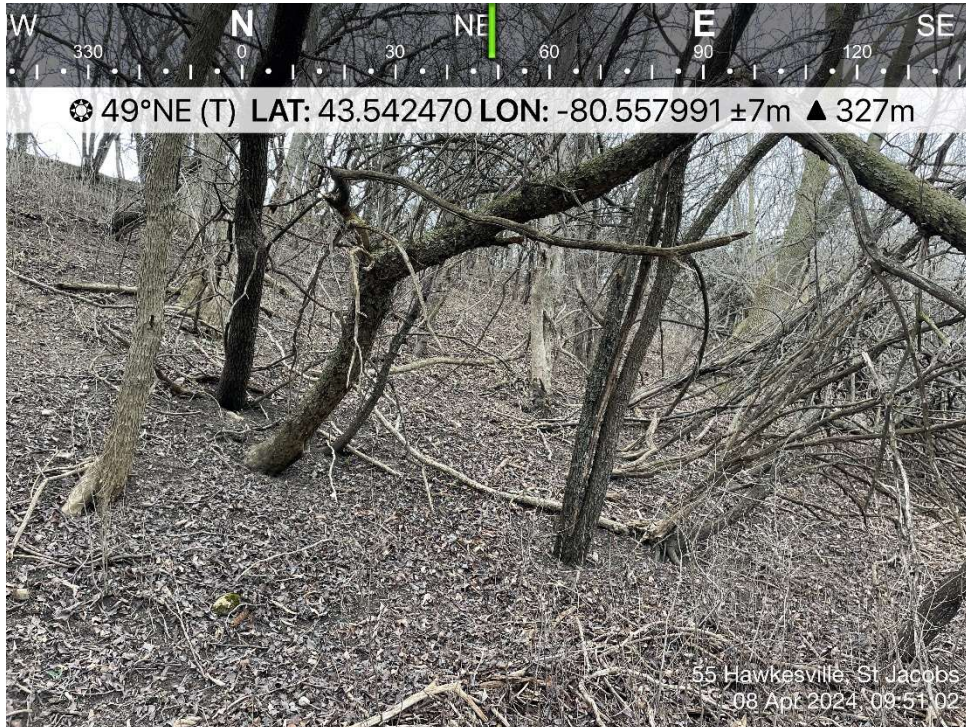
**PHOTOGRAPH 6**

View of the slope face taken from near west end of slope. Slope was densely covered with small to medium sized trees with and slope face had limit undergrowth.

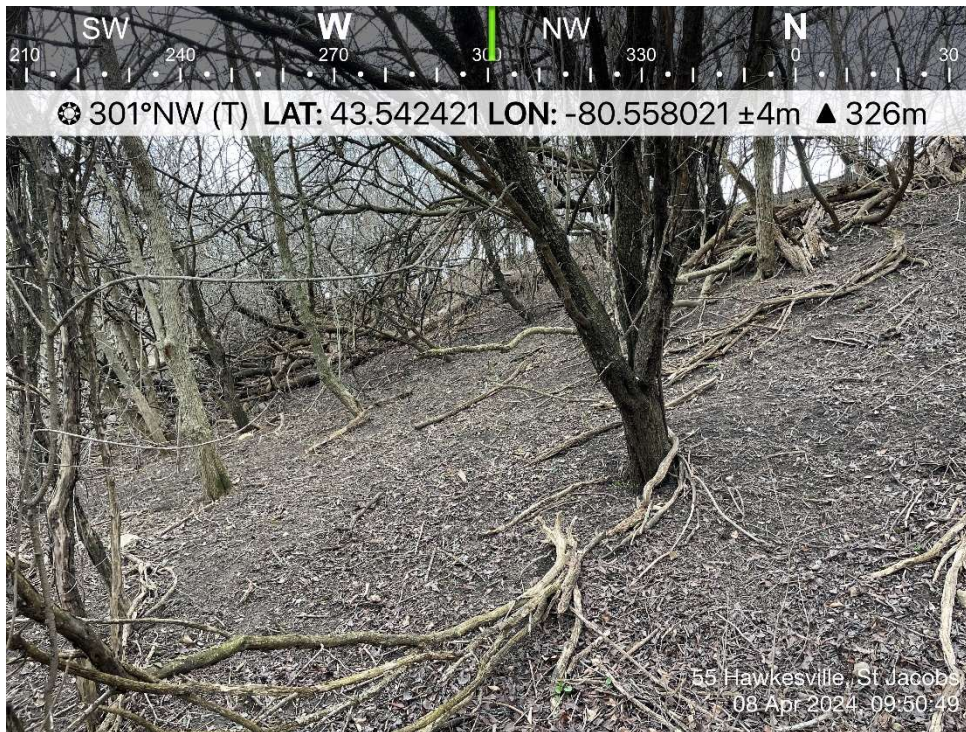
**PHOTOGRAPH 7**

View of the slope face taken from near west end of slope. Slope was densely covered with small to medium sized trees with and slope face had limit undergrowth.

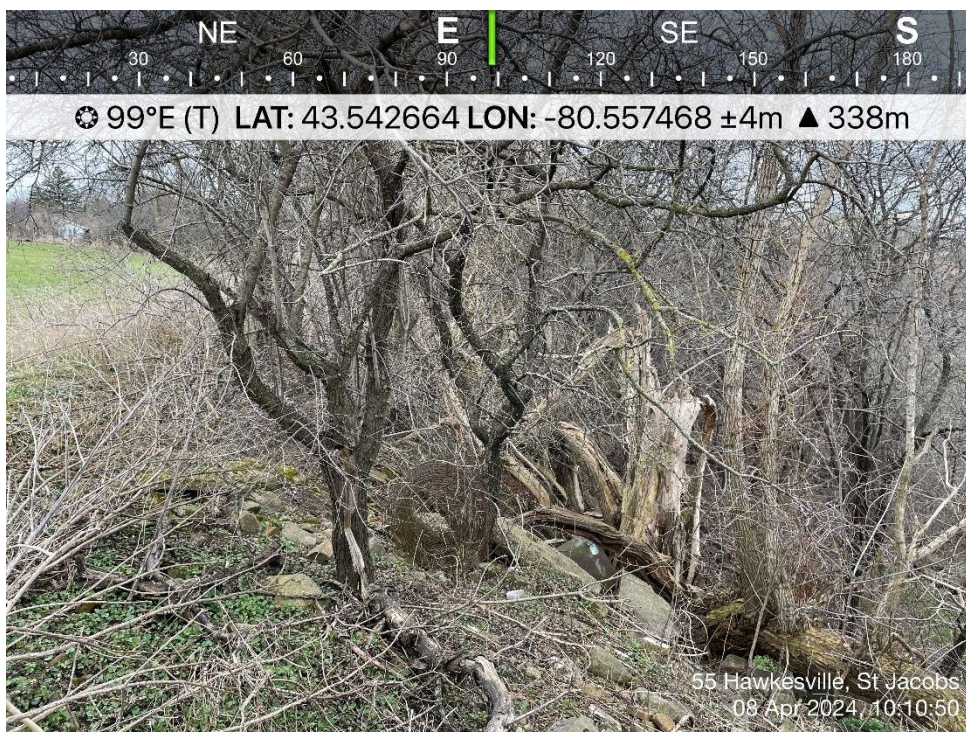
**PHOTOGRAPH 8**

The slope was approximately 8 to 13 m in height with an overall inclination of about 3.0H:1V to 2.4H:1V. At the top of the slope, the ground surface was flat to slightly sloping, and grass covered, although some areas of exposed topsoil were observed. There were also some piles of leaves and sticks present along the top of slope and fill materials (e.g. pieces of concrete, wire mesh etc.) had also been dumped near the top of the slope.

View of the slope at the top. Piles of sticks and fill materials (e.g. pieces of concrete, wire mesh etc.) were observed.

- The slope should not be steepened and fill materials (including landscape debris) should not be placed on the slope or within 3 metres of the slope crest.

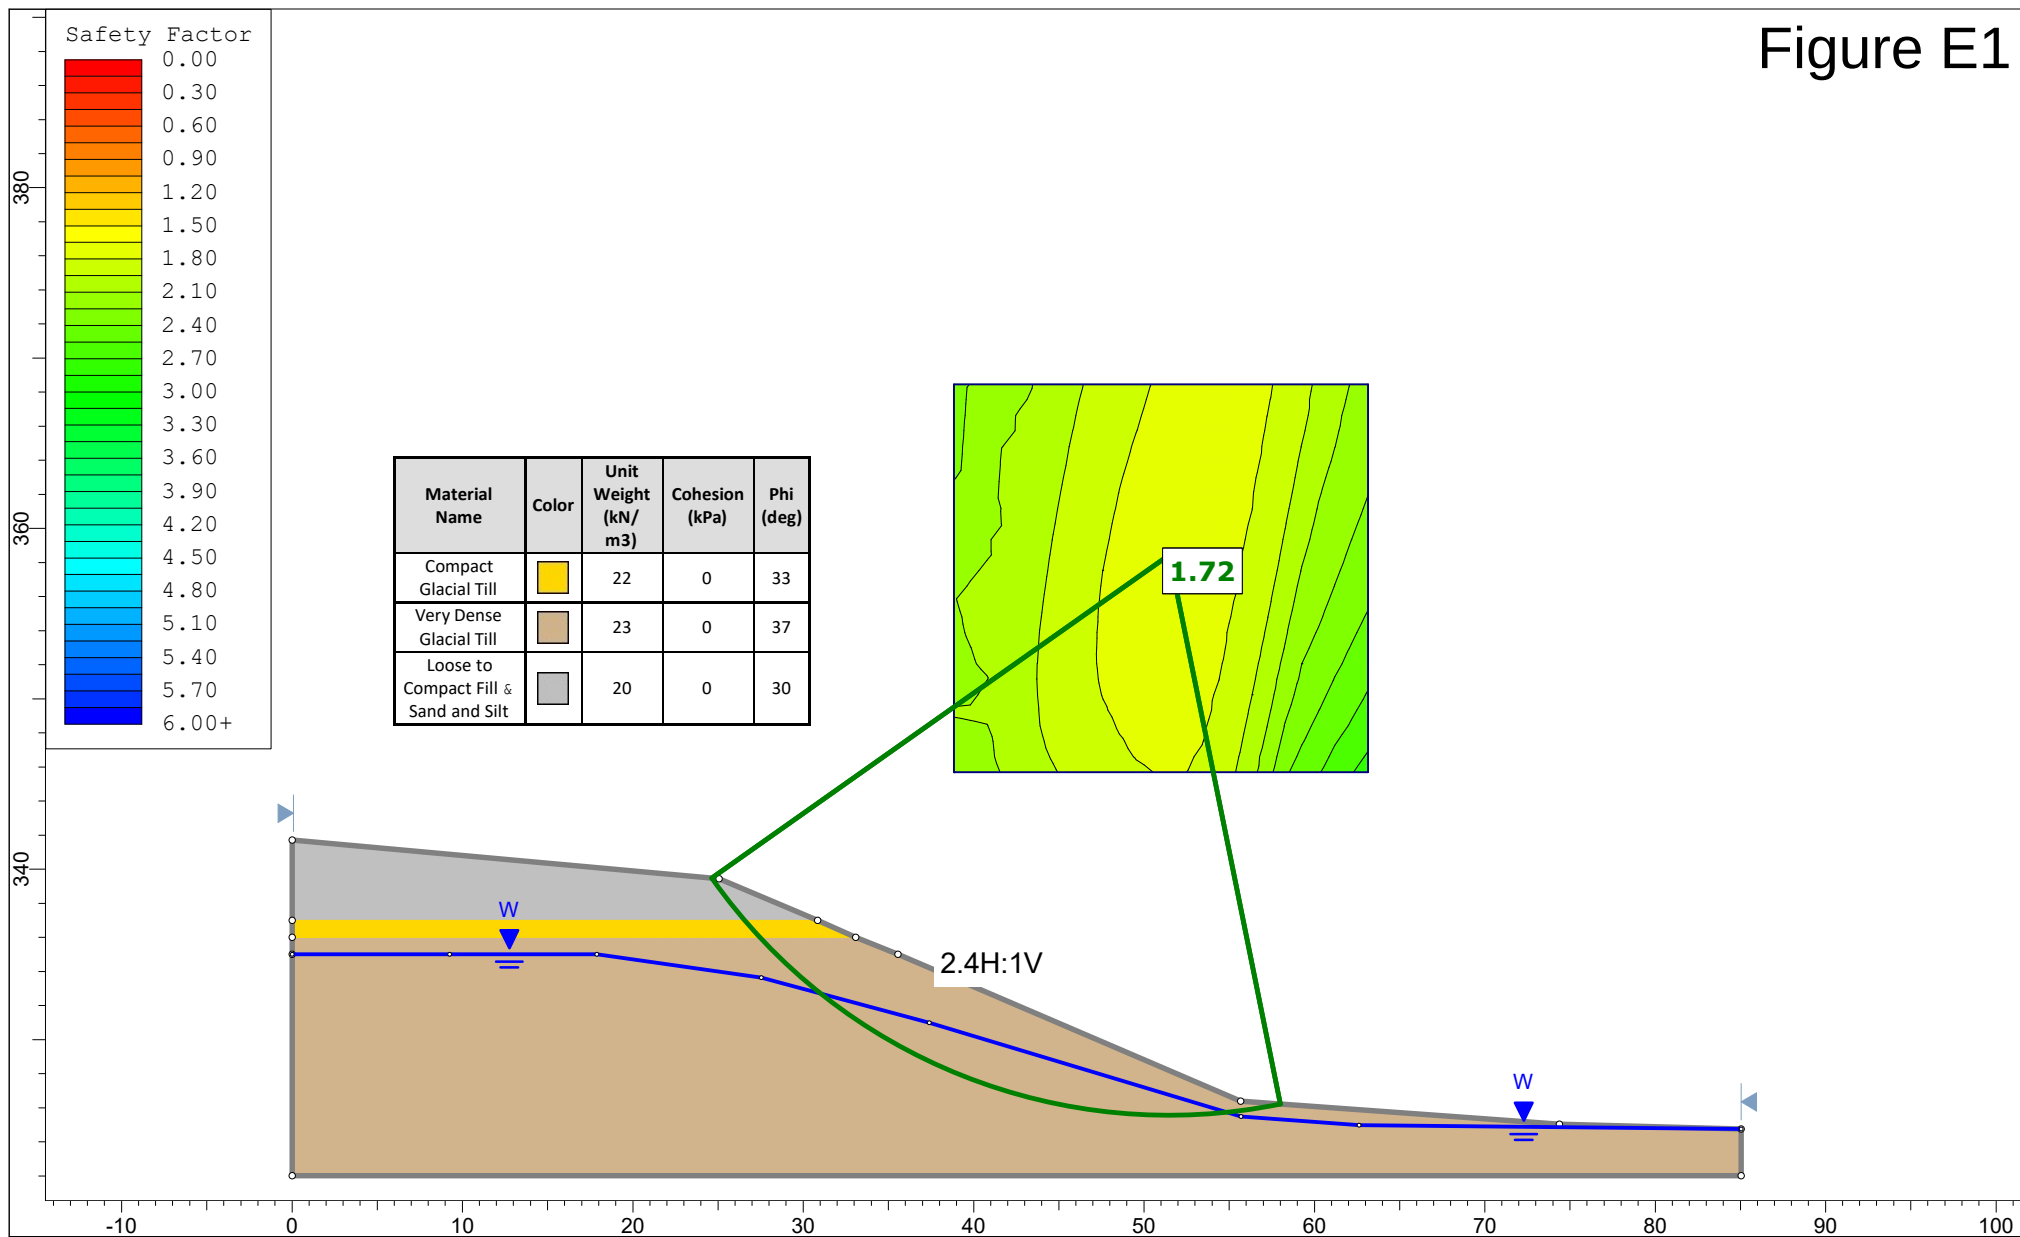
# Figure E1

| Cross-Section Location | Approximate Slope Height | Existing Slope Inclination | Existing Slope Stability Factor of Safety | Figure No. (Appendix E) |
|---|---|---|---|---|
| Section B-B | 13 m | 2.4H:1V | 1.72 | E1 |

The computed factor of safety (FOS) for the existing slope was 1.71. The FOS is considered reasonable for a slope comprised primarily of very dense glacial till and indicates that the slope is stable.

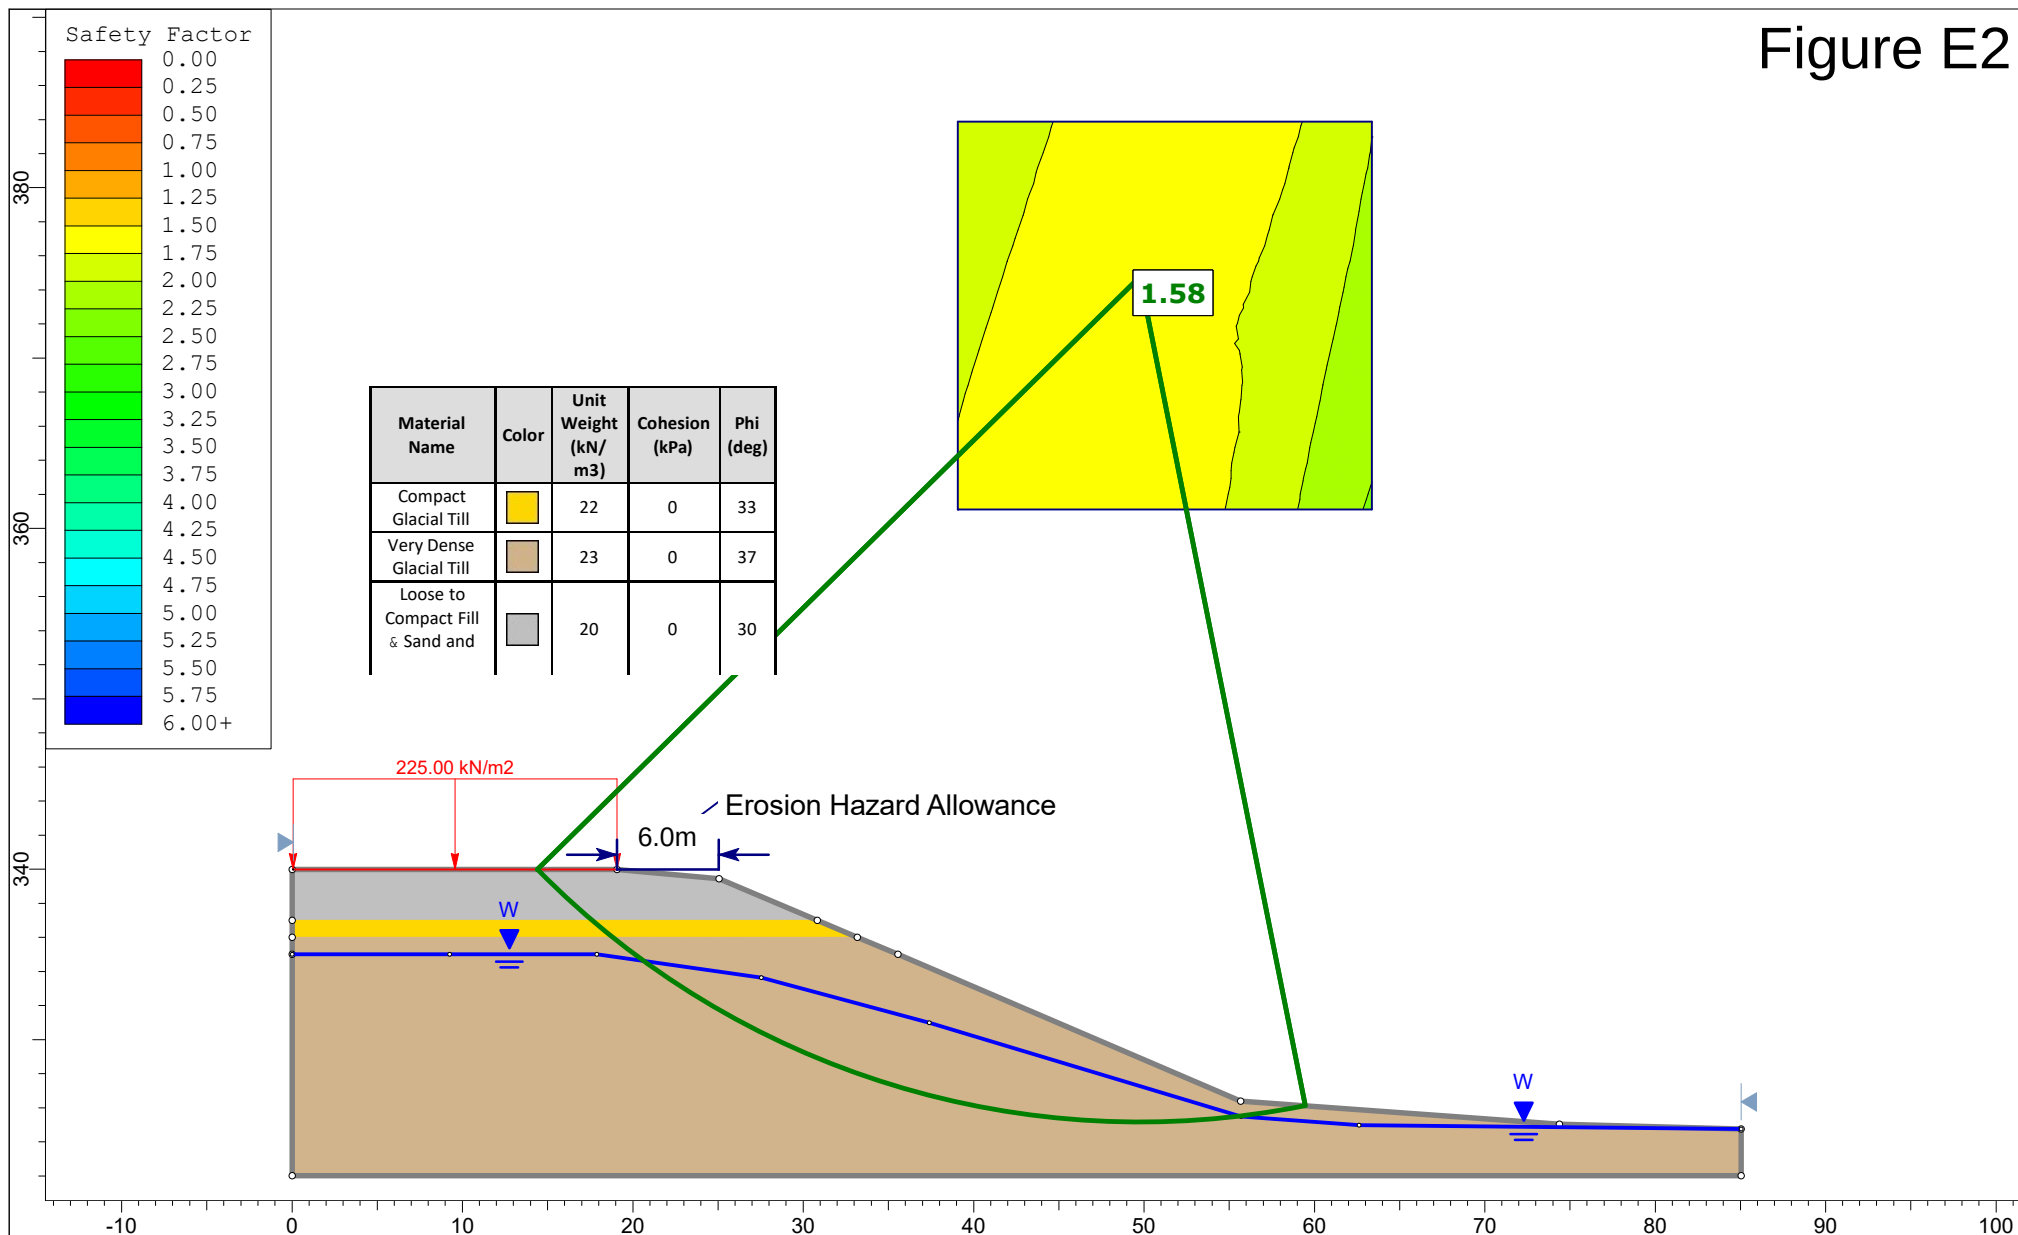
# Figure E2

The results of the analysis are included in Figure E2 for the 6 m setback condition (Appendix E). A FOS of 1.58 was computed for this condition which exceeded the minimum FOS of 1.30 to 1.50 required for active land use under the GRCA policy guideline.

| Setback from Top of Slope | Groundwater Table condition | Factor of Safety (FOS) | Meets Minimum GRCA Factor of Safety? | Figure No. (Appendix E) |
|---|---|---|---|---|
| 6 m | Normal | 1.58 | Yes | E2 |

- All new building lots should be setback a minimum distance of 6 m from the existing top of slope.
- The analysis shows that the proposed building loads have a negligible impact on slope stability and the required FOS of 1.3 to 1.5 for active land use is still met under the loading condition for both normal and elevated groundwater conditions.
- The 6 m setback allows for access to the valley for maintenance or emergency purposes.
- It is expected that overland drainage will improve using engineering controls when the site is developed during civil engineering design (by others), which would reduce the risk of concentrated runoff over the slope and surficial erosion.
- Other considerations for construction works are provided in Section 5.5 to further reduce the risk of erosion or slope instability.

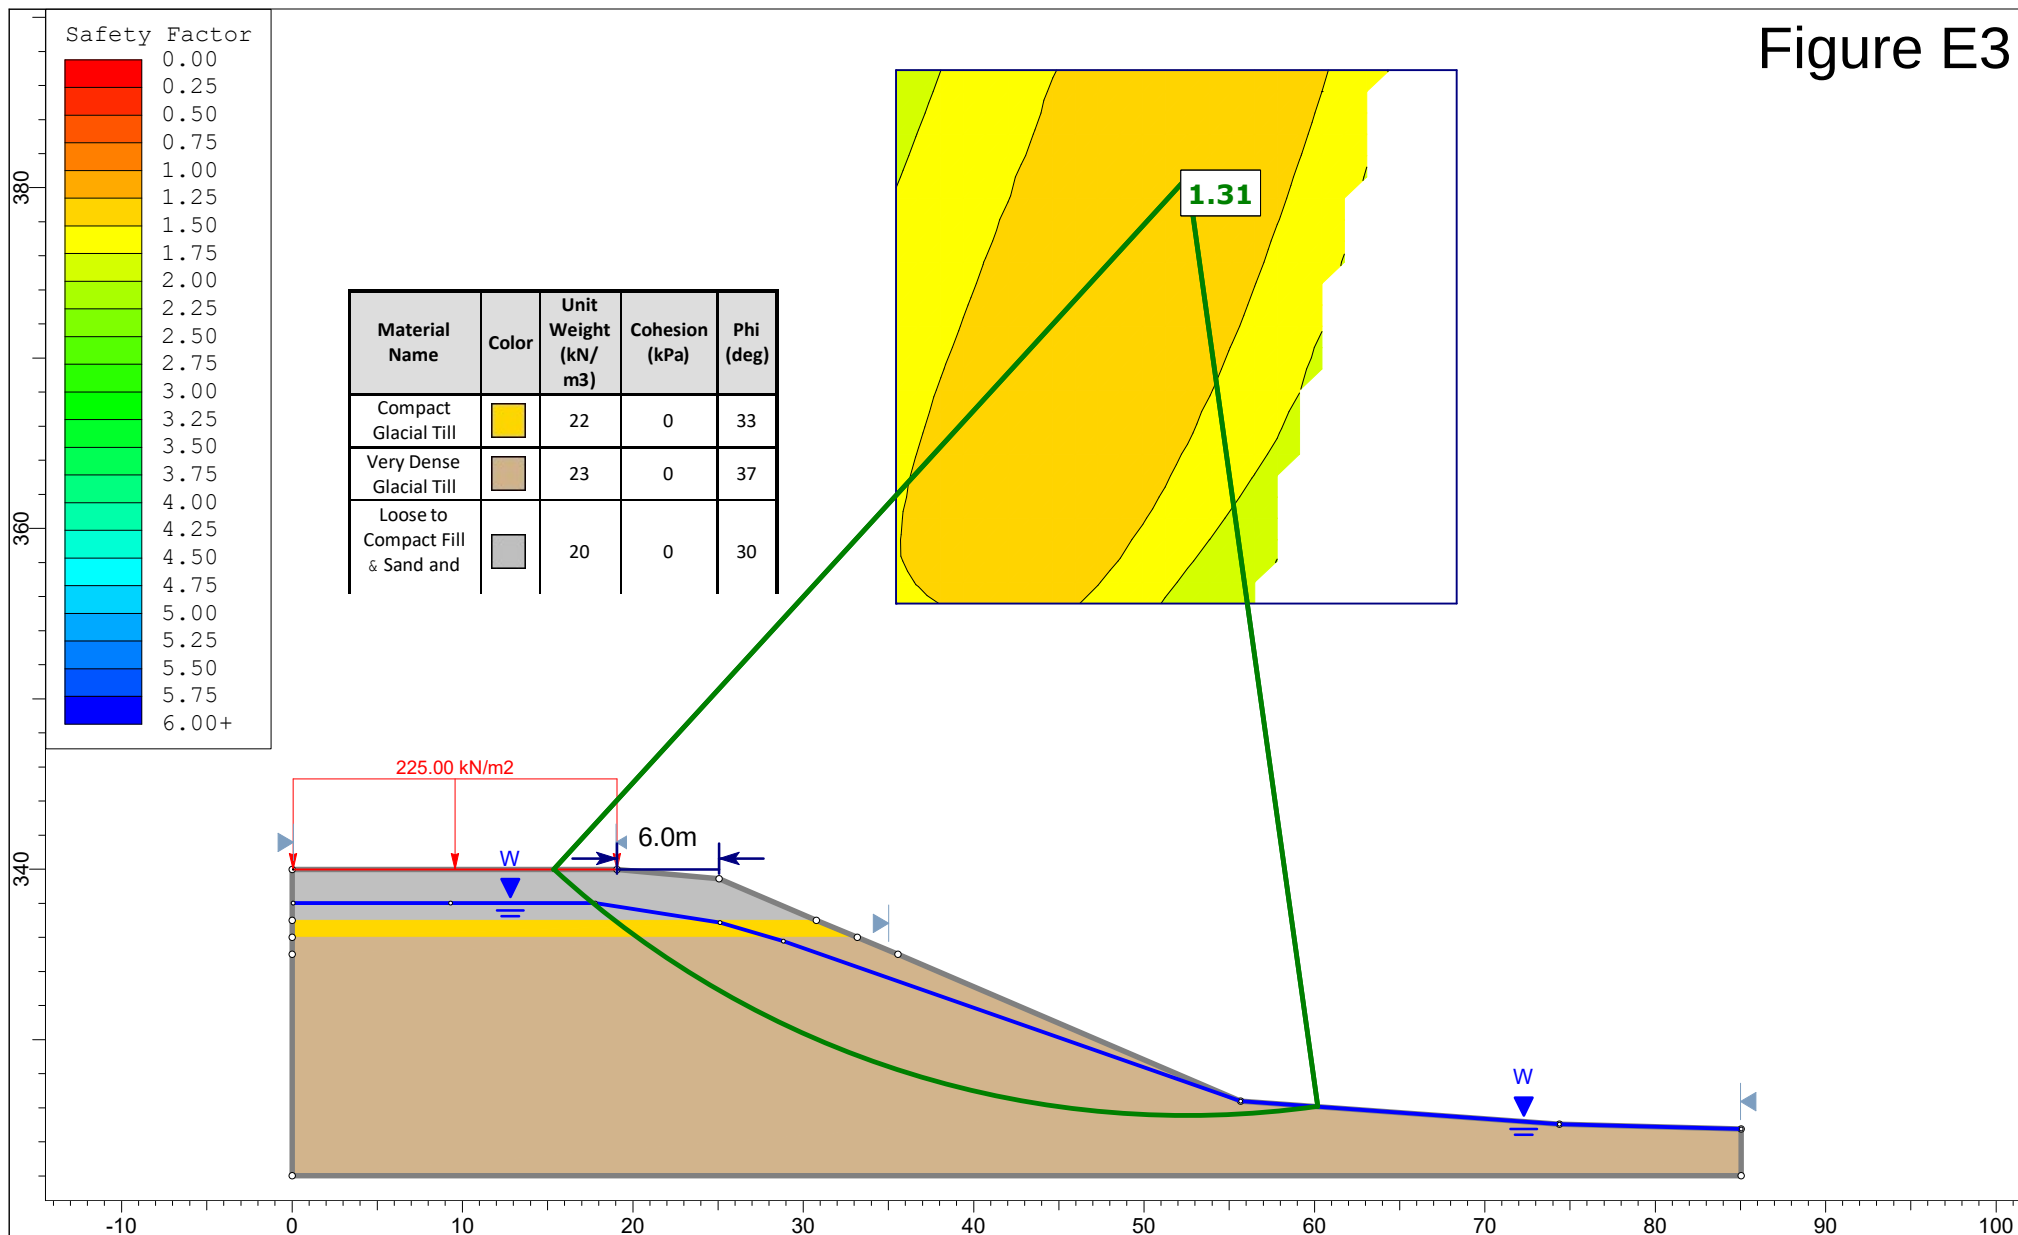
# Figure E3

| Setback from Top of Slope | Groundwater Table condition | Factor of Safety (FOS) | Meets Minimum GRCA Factor of Safety? | Figure No. (Appendix E) |
|---|---|---|---|---|
| 6 m | High | 1.31 | Yes | E3 |

To account for a potential high groundwater scenario, the groundwater table in the 6 m setback model was then increased to 2 m below existing ground surface at the top of slope (Figure E3). The computed FOS for this scenario is 1.31 which is the lower end of the FOS range for active land use but still meets the GRCA policy guideline.
