**18 – 20 Hickory Street West  
Waterloo, Ontario**

**ARBORIST REPORT**

1. Zoning Amendment – April 29, 2024

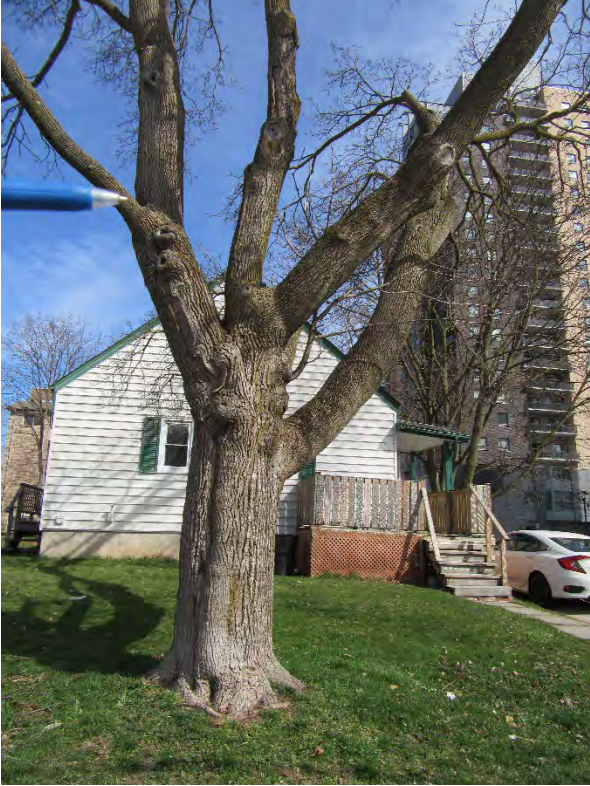
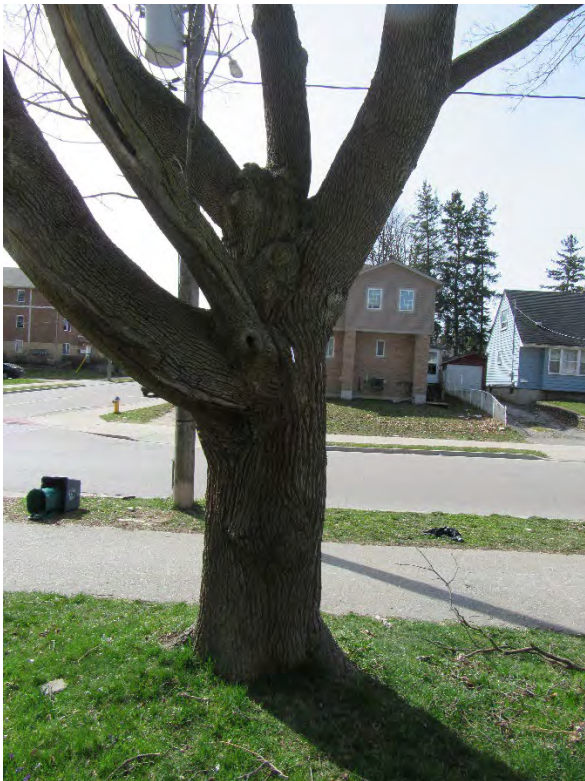
| Tree Tag # or ID | Botanical Name | Common Name | DBH (cm) | Dripline Radius (m) | City of Waterloo Minimum Tree Protection Zone Radius (m) for Retained Trees | Condition | | | | Ownership | Comments | Action | Justification for Action |
|---|---|---|---|---|---|---|---|---|---|---|---|---|---|
| 986 | <i>Acer platanoides</i> | Norway Maple | 71 | 6 | 4.8 | Poor | Poor | Poor | Poor | Project | 5 main stems in upper canopy with only one stem without rot. | REMOVE | Condition and Construction for amenity space. >50% TPZ impact from grading and construction. |

Photo 1. Trees #986, photo direction north.

Photo 2. Trees #986, photo direction south.

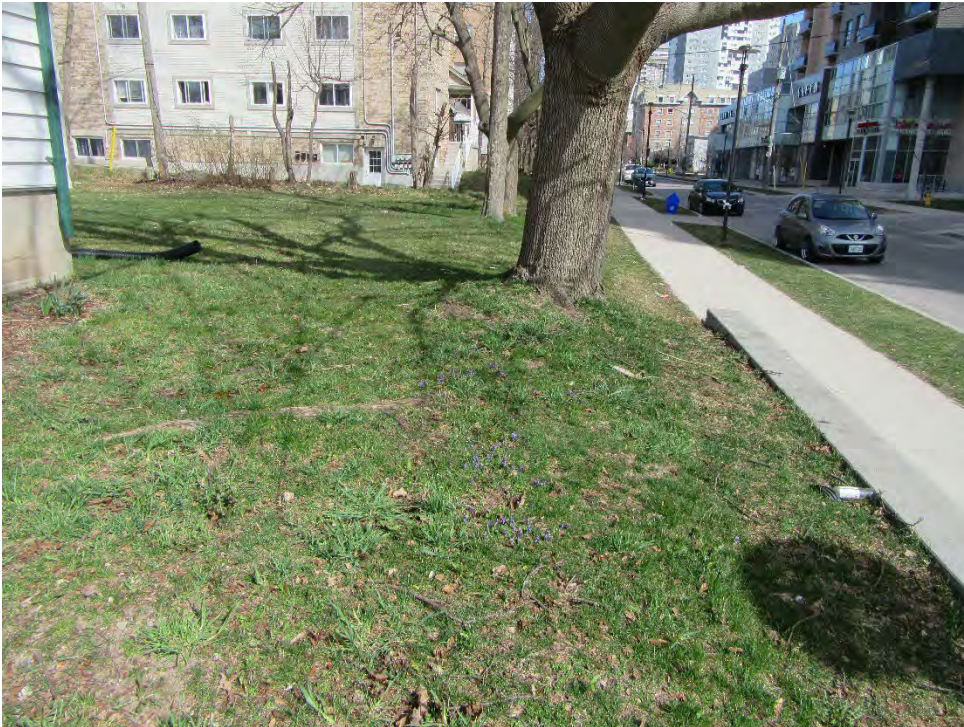
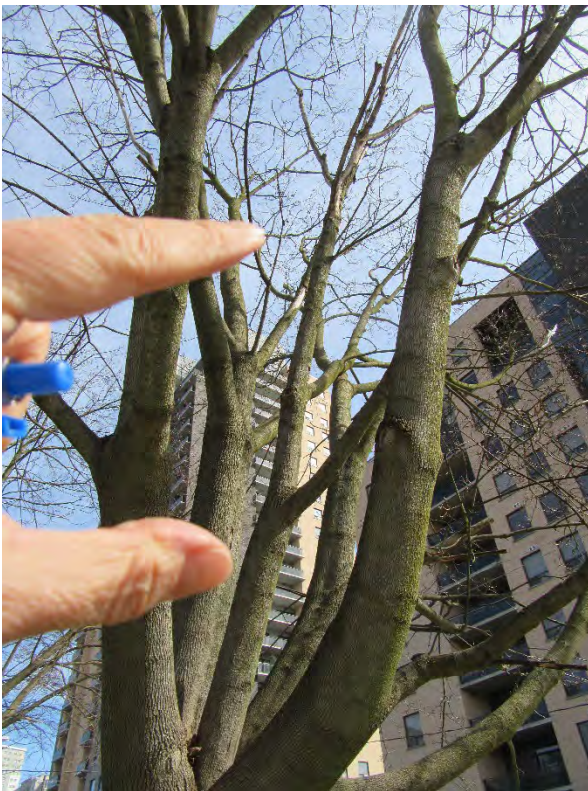
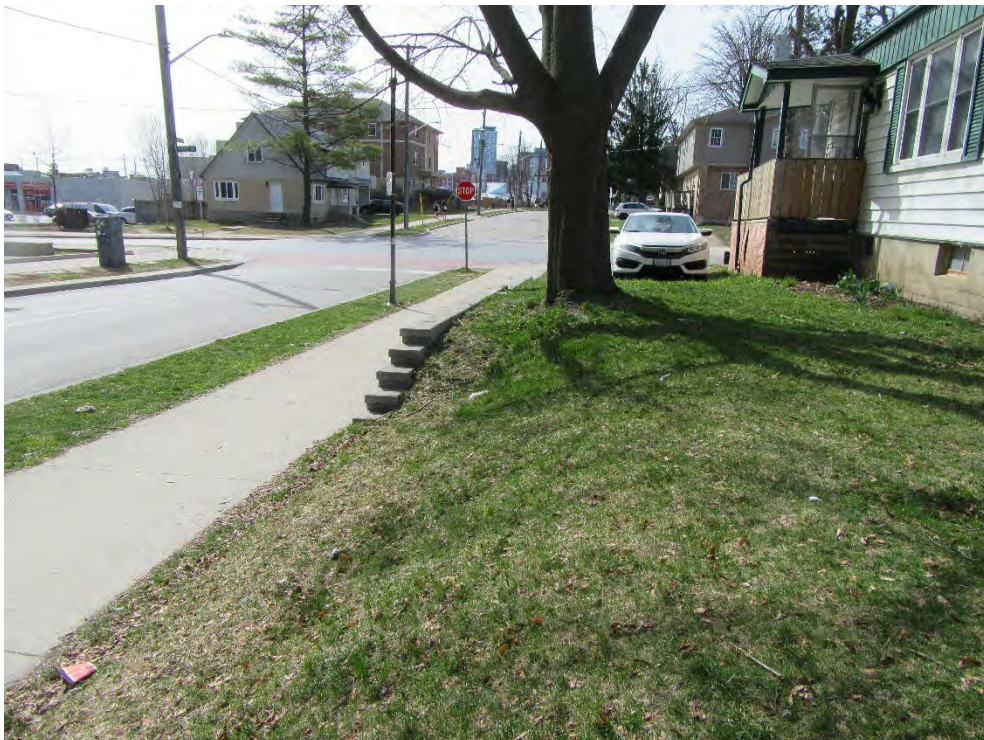
Trees growing on City property include trees #987, #994, and #995. Tree #987 is a Norway Maple observed to be in fair condition, with rot observed in stems in the canopy, and surface roots along the ground adjacent to the trunk. Tree #994 and #995 (<10cm DBH Serviceberry) were newly planted trees with stakes and ties still attached to the trees. Tree #995 was dead.

| Tree Tag # or ID | Botanical Name | Common Name | DBH (cm) | Dripline Radius (m) | City of Waterloo Minimum Tree Protection Zone Radius (m) for Retained Trees | Condition | | | | Ownership | Comments | Action | Justification for Action |
|---|---|---|---|---|---|---|---|---|---|---|---|---|---|
| 987 | <i>Acer platanoides</i> | Norway Maple | 65 | 7 | 4.2 | Good | Fair | Good | Fair | City | Surface roots; central rot in one stem. | REMOVE | Grading construction for walkway and townhouse building. >50% TPZ impact from grading and construction. |

Photo 3. Tree #987, photo direction north.

Photo 4. Trees #987, photo direction northeast.

Photo 5. Tree #987, photo direction south.

City owned trees #987 and #995 will be removed. Tree #995 is dead, and the removal of this tree will provide an open space on the boulevard for a new healthy tree to be planted. Tree #987 will be impacted by the demolition of the existing house as the tree has surface roots that extend toward the existing house. Development of the townhomes will impact approximately 40% of its rootzone, which would lead to decline in the tree due to its current condition. Also impacting surface roots, as shallow root systems are typical for Norway Maple, can create a structural unsound tree. The proposed walkway to the north of the tree would increase TPZ impact to greater than 50%. It is requested that this tree be removed, and replaced with a native species which would be tolerant to the proposed conditions. If the City does not provide approval for tree removal, that would require eliminating the walkway for Townhouse 5, with a redesign of the Project to ensure that there is no decrease in grade that would impact the surface roots.

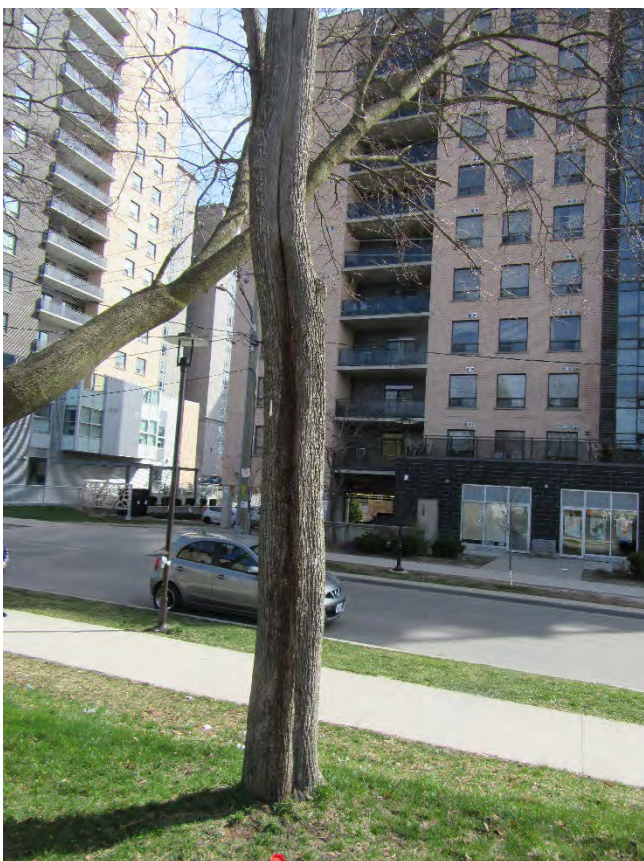
| Tree Tag # or ID | Botanical Name | Common Name | DBH (cm) | Dripline Radius (m) | City of Waterloo Minimum Tree Protection Zone Radius (m) for Retained Trees | Condition | | | | Ownership | Comments | Action | Justification for Action |
|---|---|---|---|---|---|---|---|---|---|---|---|---|---|
| 988 | <i>Acer platanoides</i> | Norway Maple | 37 | 4 | 2.4 | Fair | Good | Good | Fair | Project | Leaking stem on one side from crack. | REMOVE | Grading construction for walkway and townhouse building. >50% TPZ impact from grading and construction. |

Photo 6. Tree #988 photo direction east.

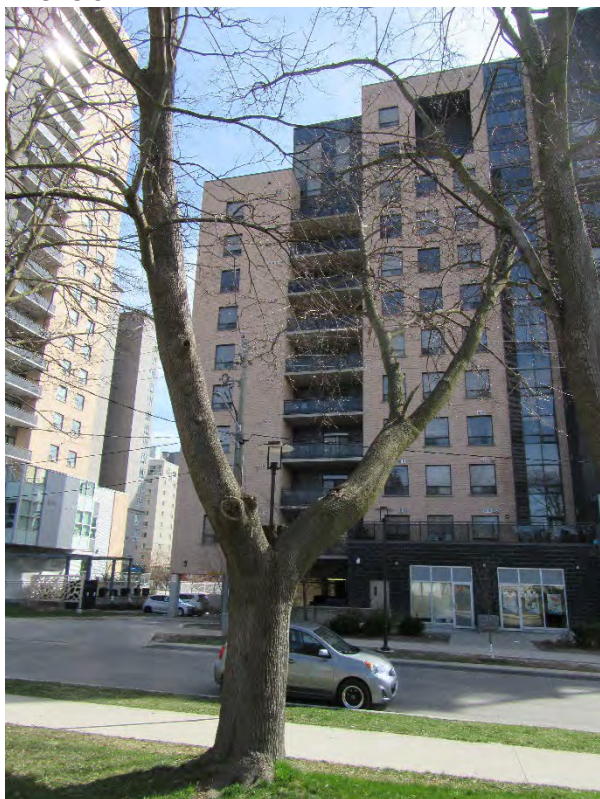
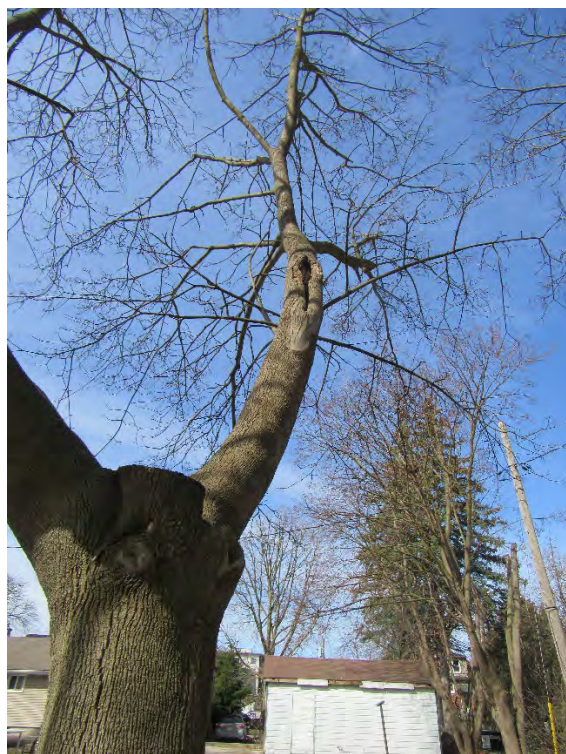
| Tree Tag # or ID | Botanical Name | Common Name | DBH (cm) | Dripline Radius (m) | City of Waterloo Minimum Tree Protection Zone Radius (m) for Retained Trees | Condition | | | | Ownership | Comments | Action | Justification for Action |
|---|---|---|---|---|---|---|---|---|---|---|---|---|---|
| 989 | <i>Acer platanoides</i> | Norway Maple | 55 | 6 | 3.6 | Poor | Poor | Fair | Poor | Project | One stem in centre of crotch has been removed previously; remaining stems in a wide 'V'; wound and rot in stem over sidewalk; surface roots observed; large rot with wound in other stem. | REMOVE | Condition and Construction. >50% TPZ impact from grading and construction. |

Photo 7. Tree #989, photo direction east.

Photo 8. Tree #989, photo direction north.

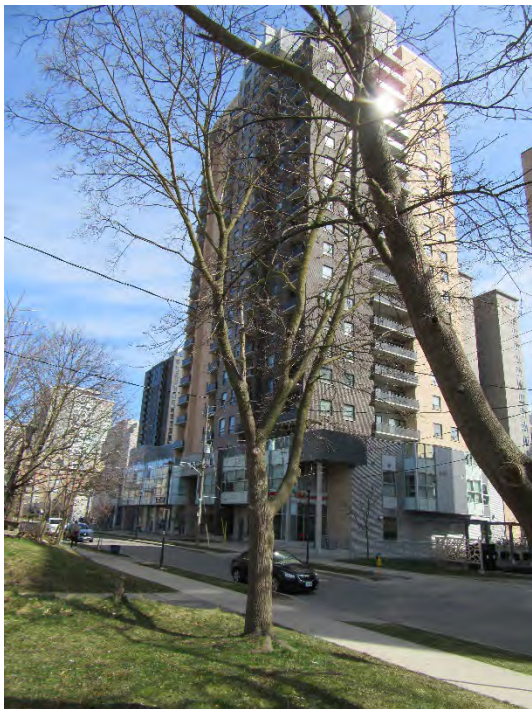
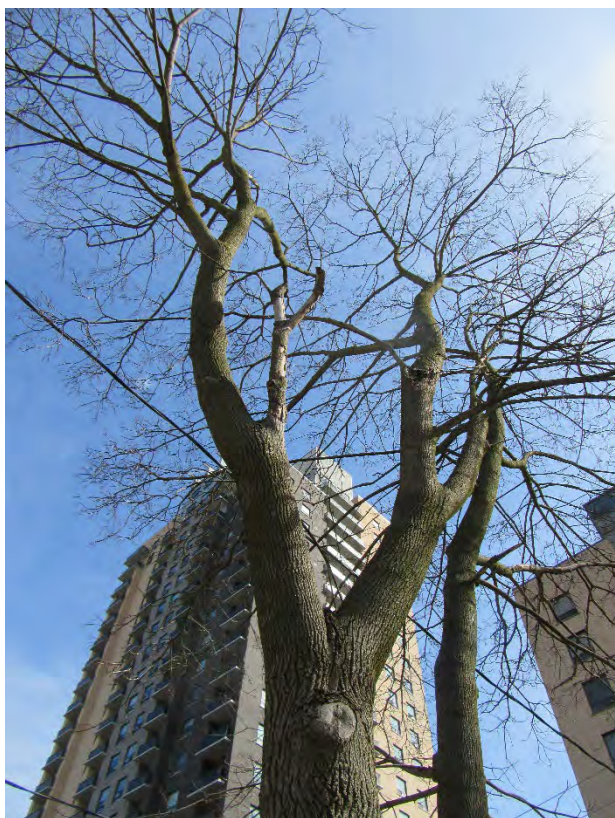
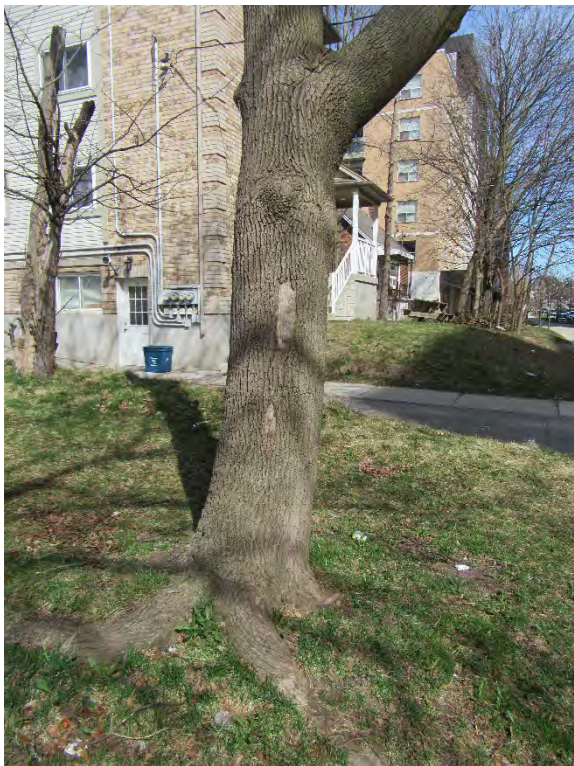
| Tree Tag # or ID | Botanical Name | Common Name | DBH (cm) | Dripline Radius (m) | City of Waterloo Minimum Tree Protection Zone Radius (m) for Retained Trees | Condition | | | | Ownership | Comments | Action | Justification for Action |
|---|---|---|---|---|---|---|---|---|---|---|---|---|---|
| 990 | <i>Acer platanoides</i> | Norway Maple | 41 | 4 | 3 | Fair | Poor | Fair | Poor | Boundary - City | Rot in upper stem and deadwood in canopy. | REMOVE | Condition and Construction. >50% TPZ impact from grading and construction. |

Photo 9. Tree #990, photo direction northeast.

Photo 10. Tree #990, photo direction north.

Photo 11. Tree #990', photo direction north.

Boundary trees recommended to be removed include #990, shared with the City, and #991, shared with 309 Spruce Street. Tree #990 was assessed to be in poor condition. The existing condition of the tree and the proposed grading for the Project, and construction of two walkways within the TPZ has resulted in the recommendation for removal. It is requested that the City provide approval for tree removal. It is recommended that tree replacement include a native species with tolerance to proposed conditions. Tree #991 is in poor condition and will be impacted by grading and construction of the proposed walkway which extends along the north property boundary. Removal would require written permission from the adjacent property owner of 309 Spruce Street. It is also recommended that permission be requested to remove tree 'A', which has been recommended to be retained as it does not have to be removed for construction, however removal is desired for aesthetics and future planting.

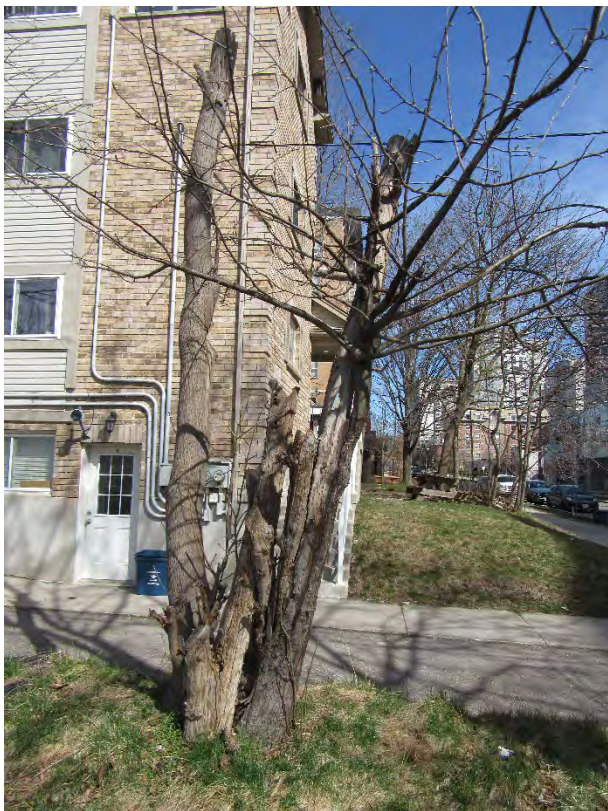
| Tree Tag # or ID | Botanical Name | Common Name | DBH (cm) | Dripline Radius (m) | City of Waterloo Minimum Tree Protection Zone Radius (m) for Retained Trees | Condition | | | | Ownership | Comments | Action | Justification for Action |
|---|---|---|---|---|---|---|---|---|---|---|---|---|---|
| 991 | <i>Pyrus sp.</i> | Pear sp. | 16 | 2 | 2.4 | Poor | Poor | Poor | Poor | Boundary - Private | A stem growing from a dead stem; and growing directly adjacent to two tree stubs. | REMOVE | Condition and Construction. >50% TPZ impact from grading and construction. |

Photo 12. Tree #991, photo direction south.

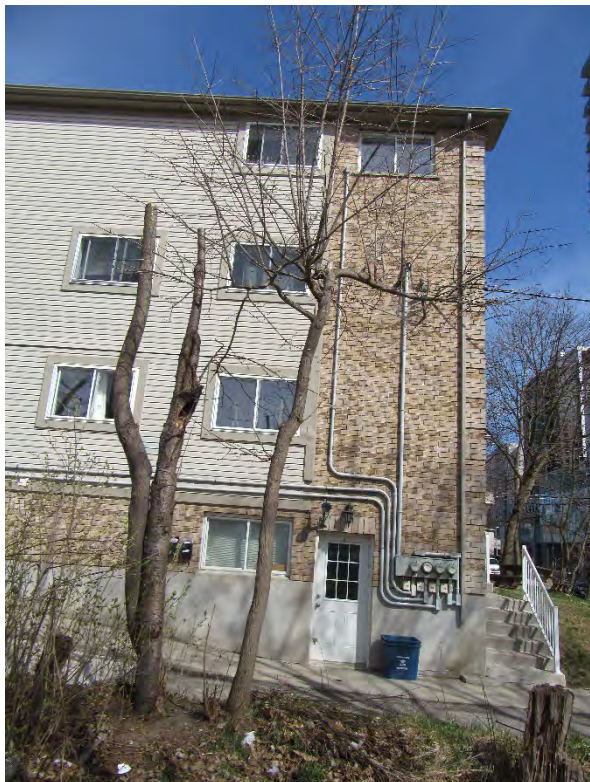
| Tree Tag # or ID | Botanical Name | Common Name | DBH (cm) | Dripline Radius (m) | City of Waterloo Minimum Tree Protection Zone Radius (m) for Retained Trees | Condition | | | | Ownership | Comments | Action | Justification for Action |
|---|---|---|---|---|---|---|---|---|---|---|---|---|---|
| A | <i>Acer platanoides</i> | Norway Maple | 12 | 2 | 2.4 | Fair | Poor | Fair | Poor | Private - Neighbour | Top main stem broke with rot; suckering branches. Recommend remove if permission is possible, for asthetic purposes, also tree will not grow into a healthy form. | Retain | TPZ impact approx. 40%, tree will continue to be in poor condition, the grading shouldn't compromise structural integrity. |

Photo 13. Tree 'A', photo direction north.

Of the fourteen trees inventoried there were five trees identified to be retained: 'A' through 'D', and #994. However, it is recommended the Client discuss the removal of tree 'A' with the adjacent property owner. This tree is in poor condition, and it would be aesthetically pleasing, and a benefit to the properties if this tree was removed along with the dead stems located adjacent. It is recommended to explore the option of planting small trees or shrubs along this area.

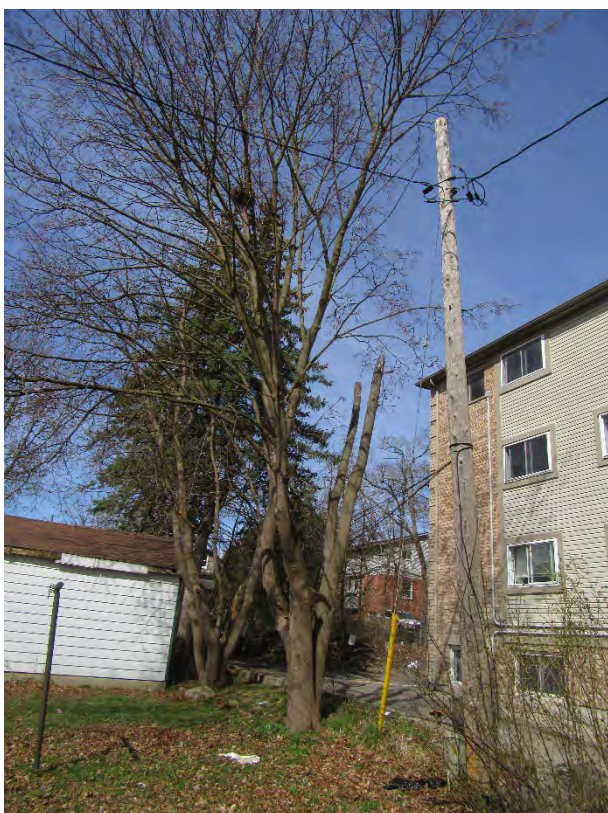
| Tree Tag # or ID | Botanical Name | Common Name | DBH (cm) | Dripline Radius (m) | City of Waterloo Minimum Tree Protection Zone Radius (m) for Retained Trees | Condition | | | | Ownership | Comments | Action | Justification for Action |
|---|---|---|---|---|---|---|---|---|---|---|---|---|---|
| 992 | <i>Acer platanoides</i> | Norway Maple | 46,30 | 5 | 3 | Poor | Poor | Fair | Poor | Project | One stem is a stub; wound on onestem with rot on upper stem. | REMOVE | Condition and Construction. >50% TPZ impact from grading and construction. |

Photo 14. Tree #992, photo direction northwest.

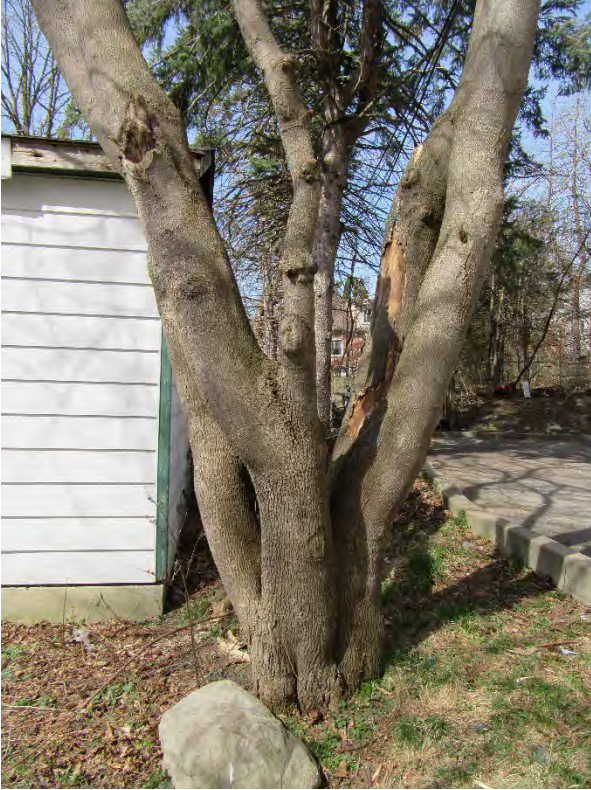
| Tree Tag # or ID | Botanical Name | Common Name | DBH (cm) | Dripline Radius (m) | City of Waterloo Minimum Tree Protection Zone Radius (m) for Retained Trees | Condition | | | | Ownership | Comments | Action | Justification for Action |
|---|---|---|---|---|---|---|---|---|---|---|---|---|---|
| 993 | <i>Acer platanoides</i> | Norway Maple | 10,(3)20,24 | 5 | 2.4 | Poor | Poor | Fair | Poor | Project | Rot and wounds on trunk. | REMOVE | Condition and Construction.>50% TPZ impact from grading and construction. |

Photo 15. Tree #993, photo direction west.

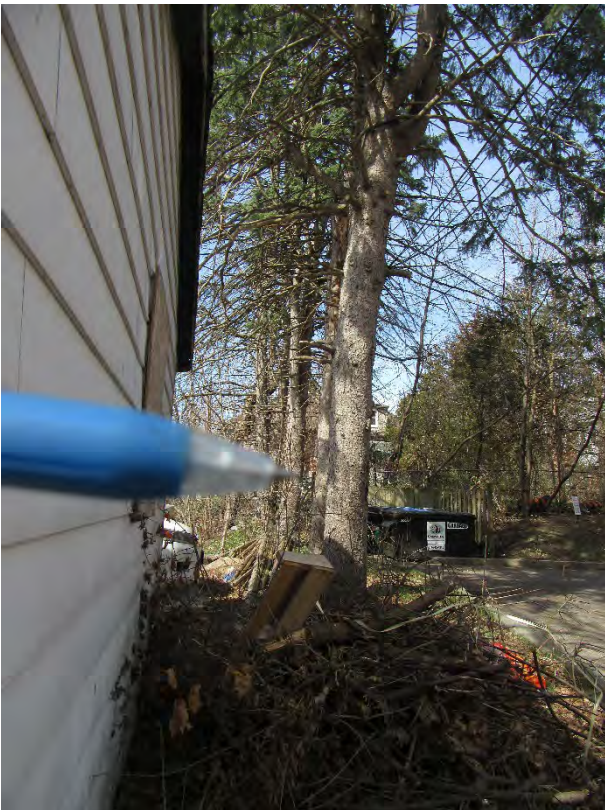
| Tree Tag # or ID | Botanical Name | Common Name | DBH (cm) | Dripline Radius (m) | City of Waterloo Minimum Tree Protection Zone Radius (m) for Retained Trees | Condition | | | | Ownership | Comments | Action | Justification for Action |
|---|---|---|---|---|---|---|---|---|---|---|---|---|---|
| B | <i>Picea pungens</i> | Colorado Spruce | 40-45 | 5 | 3 | Good | Good | Good | Good | Private - Neighbour | | Retain | Approx. 25% TPZ encroachment from grading. Tolerant to root loss. Review during construction during adjacent grading. |

Photo 16. Tree 'B', photo direction west.

Tree 'B' is a Colorado Spruce, approximately 45cm DBH in good condition. This tree is growing adjacent to the Property line and shouldn't be impacted by grading as this area will have an increase in grade. The area where there is an increase in grade should not impact the roots, however demolishing the existing shed may impact roots that could have been growing along the concrete base of the shed. As such, it is recommended that an Arborist review root impact during excavation adjacent to tree 'B'.

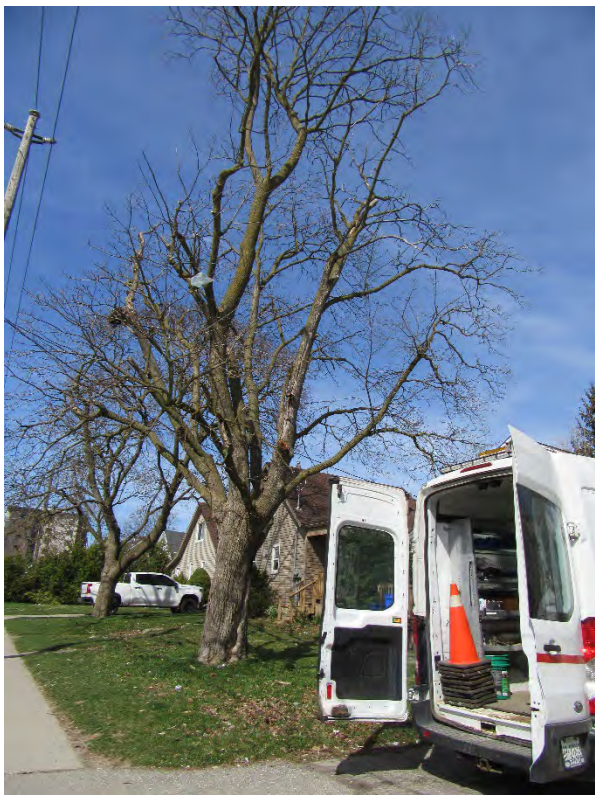
| Tree Tag # or ID | Botanical Name | Common Name | DBH (cm) | Dripline Radius (m) | City of Waterloo Minimum Tree Protection Zone Radius (m) for Retained Trees | Condition | | | | Ownership | Comments | Action | Justification for Action |
|---|---|---|---|---|---|---|---|---|---|---|---|---|---|
| D | <i>Acer platanoides</i> | Norway Maple | 50-50 | 4 | 3.6 | Poor | Poor | Poor | Poor | Private - Neighbour | | Retain | |

Photo 17. Tree 'D', photo direction west.

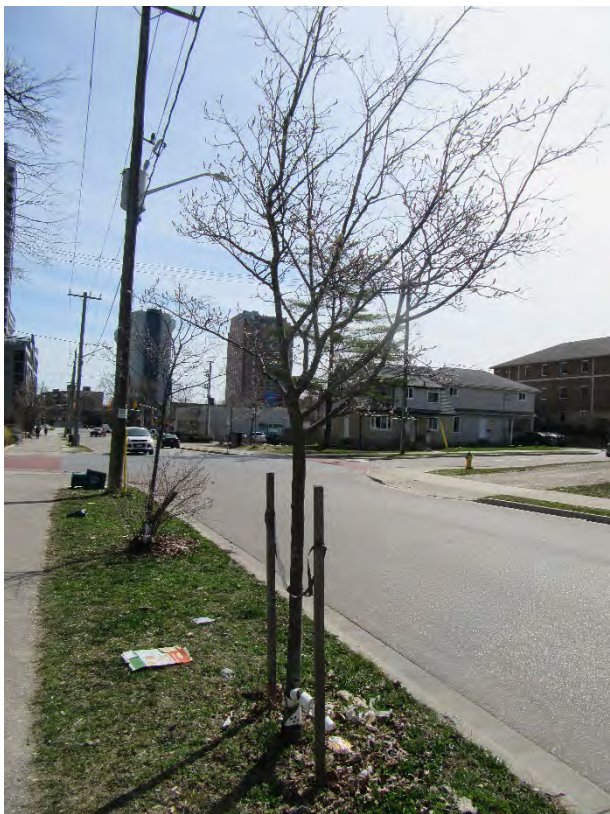
| Tree Tag # or ID | Botanical Name | Common Name | DBH (cm) | Dripline Radius (m) | City of Waterloo Minimum Tree Protection Zone Radius (m) for Retained Trees | Condition | | | | Ownership | Comments | Action | Justification for Action |
|---|---|---|---|---|---|---|---|---|---|---|---|---|---|
| 994 | <i>Amelanchier sp.</i> | Serviceberry | <10 | 1 | 1.8 | Fair | Fair | Fair | Fair | City | Tree still staked and tied. Tree appears stressed. | Retain | |
| 995 | <i>Amelanchier sp.</i> | Serviceberry | <10 | 1 | 1.8 | | | | DEAD | City | Tree still staked and tied. No live buds observed. | REMOVE | Assume City favour removal and replacement. |

Photo 18. Tree #994 and #995, photo direction east.
