## Fluvial Geomorphological Assessment Memorandum

**Date:** March 9, 2023  
**Project #:** 60683946  
**Project Name:** Greenhouse Road Reconstruction and Extension  
**From:** Rhonneke Van Riezen, M.Sc., P.Geo.  
Kathy Robitaille-Feick, M.Sc., P.Geo.  
Francisco Amaya, B.Sc., G.I.T.

# Greenhouse Road Reconstruction and Extension Project Memorandum

**Subject:** Fluvial Geomorphological Assessment

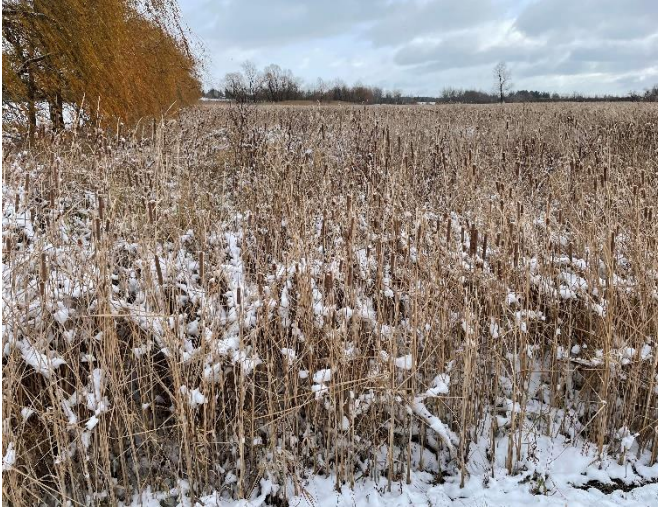
**Photograph 1. ↑**

Cattail-dominated eastern extent of feature. Looking east from roadway.

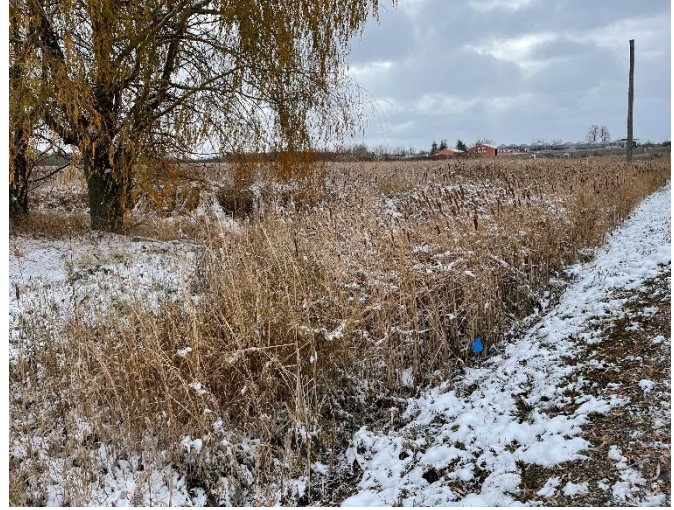
**Photograph 2. ↑**

N-S trending roadside drainage ditch that the feature flows into. Looking to the southeast.

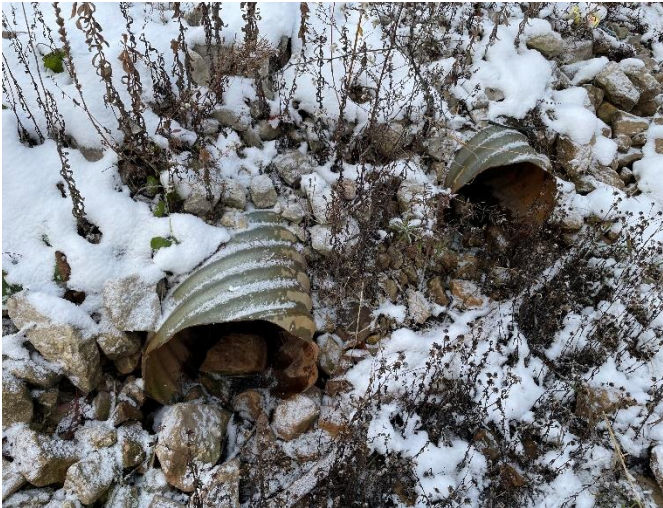
**Photograph 3. ↑**

Twin culverts (Set # 1) each measuring approximately 0.40 m wide. Culverts cross east-west under Greenhouse Road.

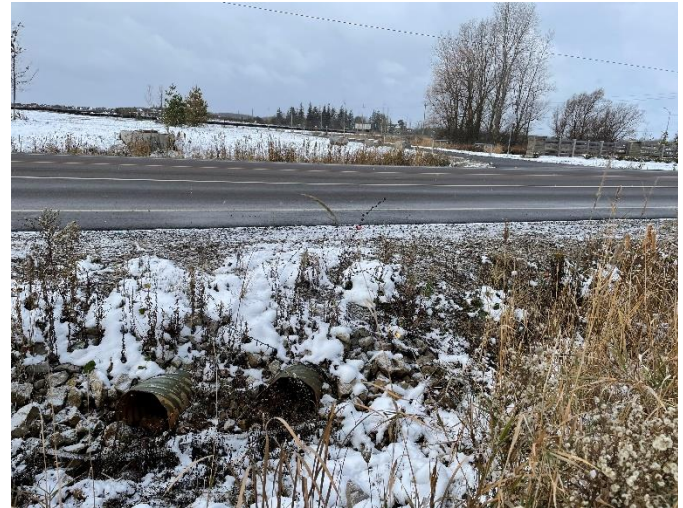
**Photograph 4. ↑**

Twin culverts (Set # 1) measuring approximately 0.40 m wide crossing east-west under Greenhouse Road. Looking to the West.

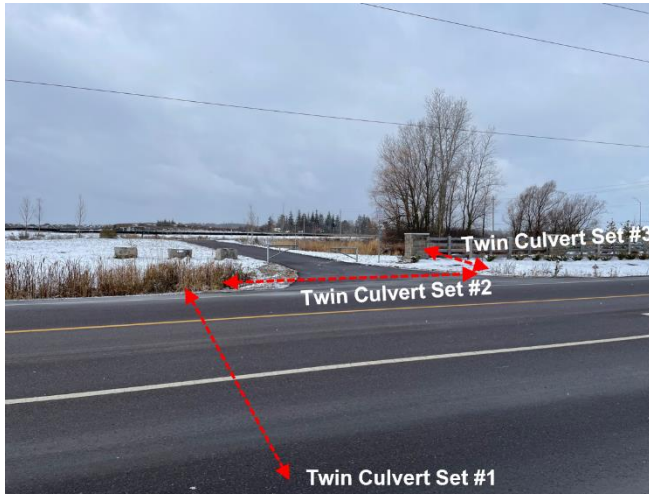
**Photograph 5.** ↑

Image with mark-up showing the location of the three sets of twin culverts. Looking to the west across Greenhouse Road.

- From a fluvial geomorphic perspective, it is key that sediment be able to move downstream. For crossing HC-East-Trib1, the perched nature of the culverts, the 90 degree turns, and the twin nature of the crossings are not recommended due to impacts to fluvial processes. These issues may pose a barrier to sediment travelling downstream and increase erosion at the locations where the culverts discharge perpendicular to the roadside ditch banks

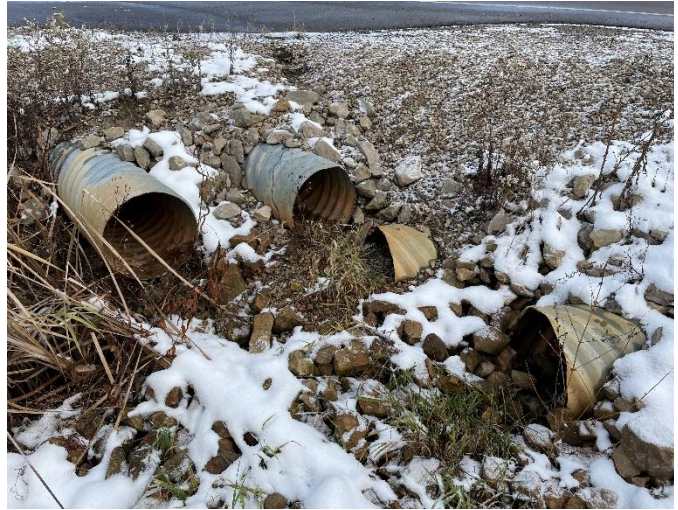
**Photograph 6.** ↑

Outlet of Twin Culvert Set #1 (right) and inlet of Twin Culvert Set #2 (left). To the far left of the figure there is a man-made drain covered in a metal grate.

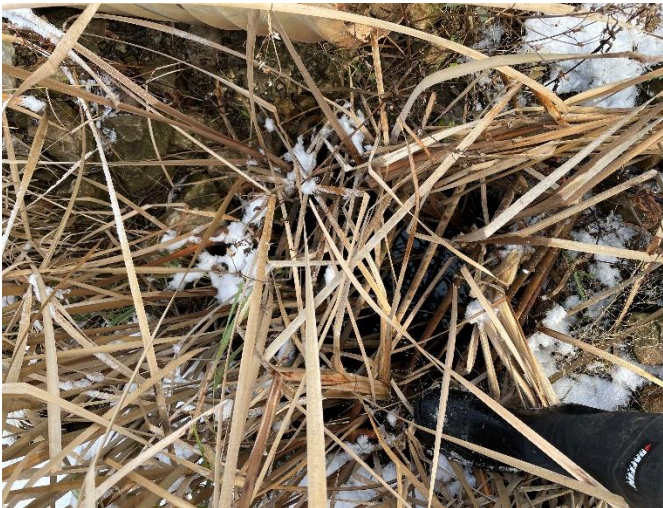
**Photograph 7.** ↑

Man made drain located beside the inlet of Twin Culvert Set #2. Drain is covered by wire and is overgrown with tall grasses. There is water in the drain approximately 1-2 m from metal grating.

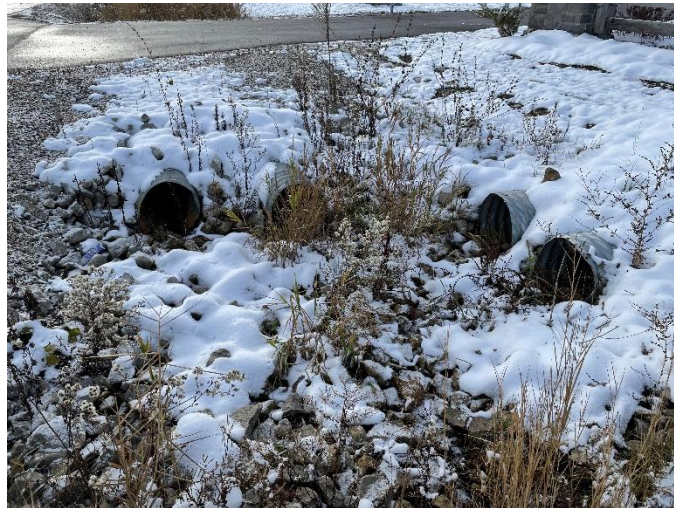
**Photograph 8.** ↑

Outlet of Twin Culvert Set #2 (left) and inlet of Twin Culvert Set #3 (right). Looking to the south. Each twin culvert for Set #2 measures 0.40 m wide, while each twin culvert for Set #3 measures 0.45 m wide.

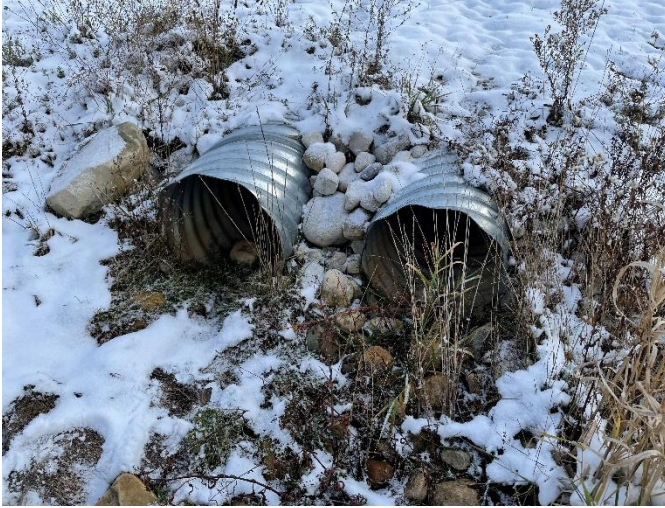
**Photograph 9. ↑**

Outlet of Twin Culvert Set #3. Each culvert is 0.45 m wide.

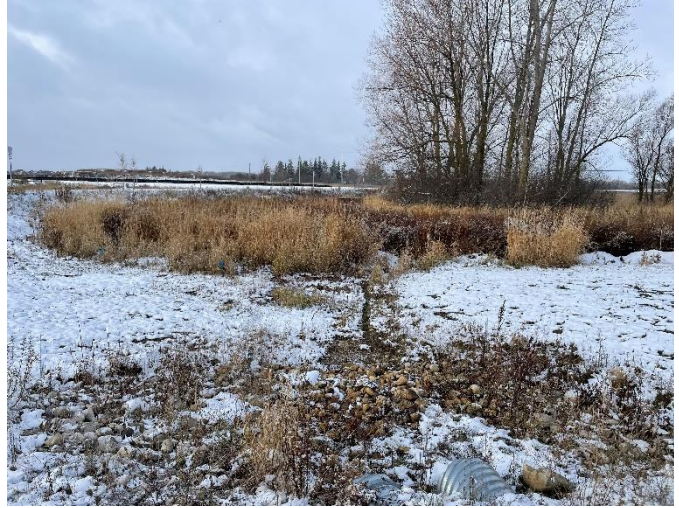
**Photograph 10. ↑**

Outlet of Twin Culvert Set #3 looking to the west.

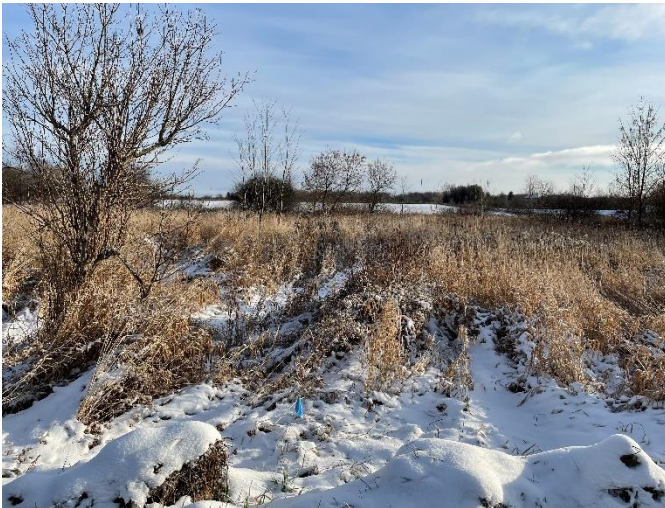
**Photograph 11. ↑**

Ephemeral feature as viewed from access trail looking to the northeast.

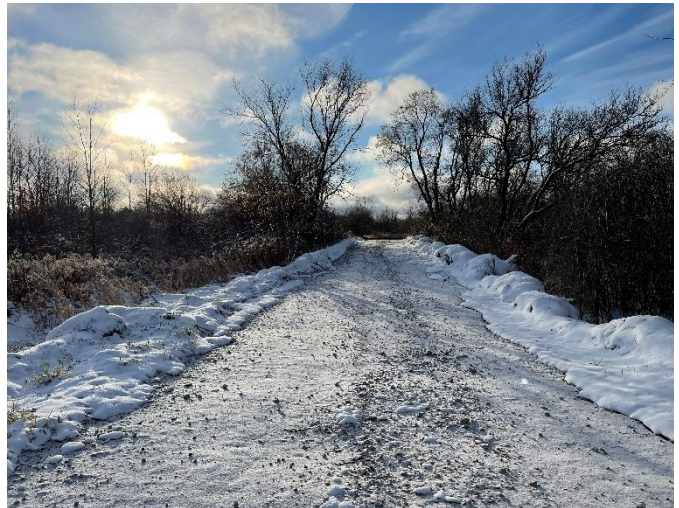
**Photograph 12. ↑**

No crossing under the trail (proposed Greenhouse Road extension location) was identified on the day of the assessment. It appears that recently placed soil on both sides of the trail, which may have covered a culvert, if one was present, was observed at the time of the field assessment. According to the reviewed background material, the feature flows southeast into Reach WGAD-1, however no discernable flow path or channel could be identified.

Gravel access trail. No culvert could be located crossing the access road. Soils have been dumped on both sides of the access trail. Looking to the southwest

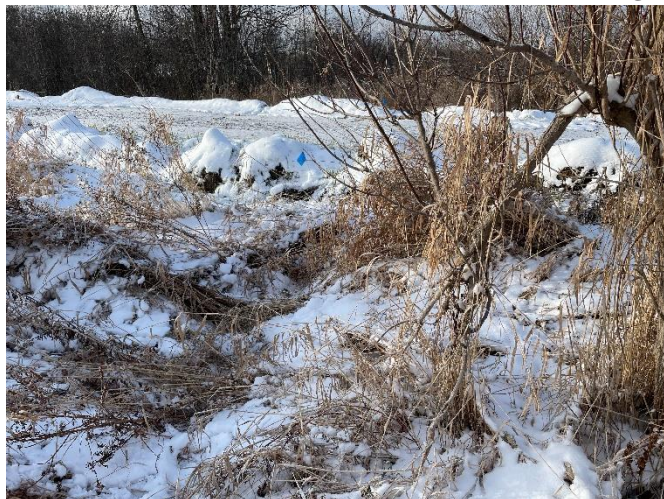
**Photograph 13. ↑**

Looking from the ephemeral feature to the access trail (looking southwest). There was freshly dumped soil on both sides of the gravel access trail which may have buried a culvert if there was one previously.

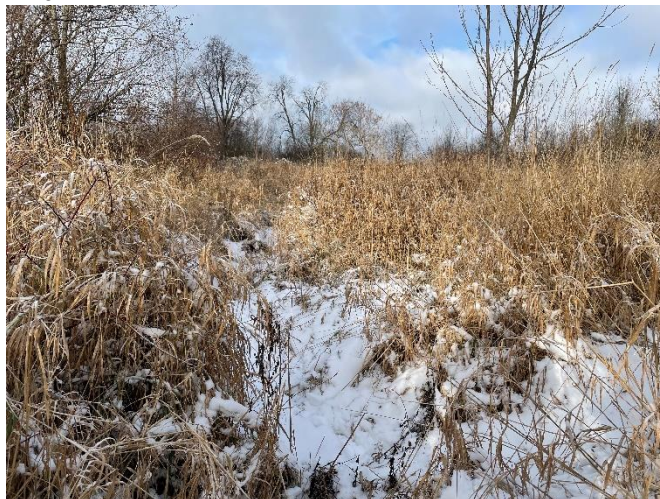
**Photograph 14. ↑**

Feature weaves through the grassy scrubland field before joining feature WGAC-1. There is no visible defined connection between the two features.

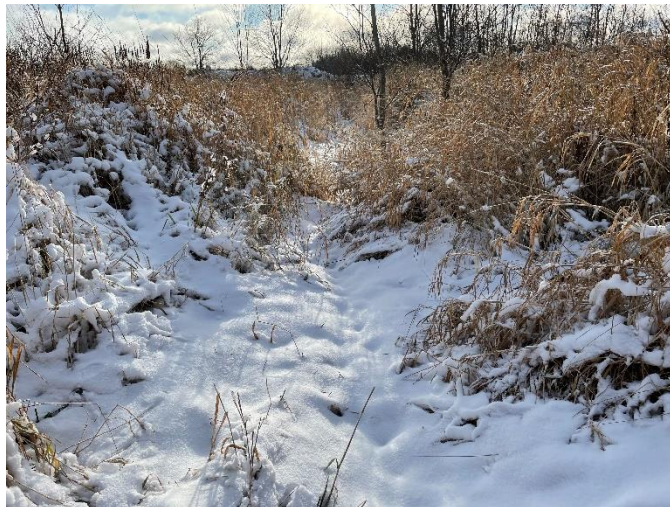
**Photograph 15. ↑**

WGAC-1 occupies a topographic low in the grassy field. Looking to the south. Approximately 100 m upstream of the rail crossing.

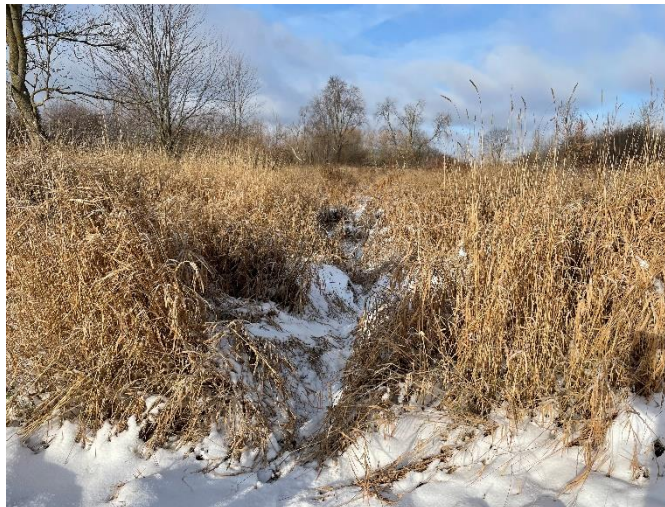
**Photograph 16. ↑**

WGAC-1 occupies a topographic low in the grassy field. Looking to the south. Approximately 20 m upstream of the rail crossing.

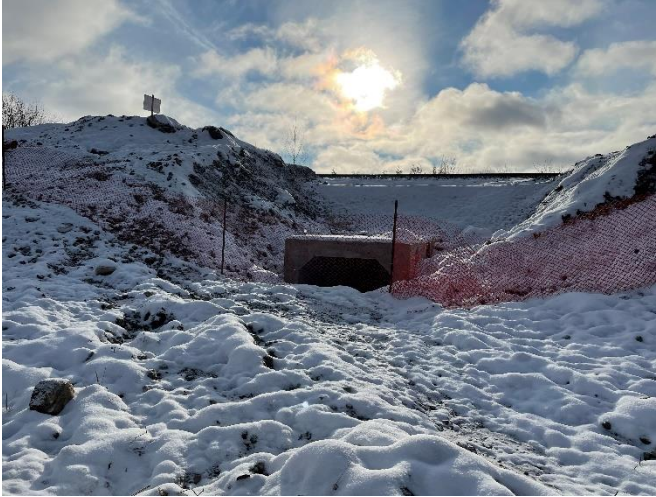
**Photograph 17. ↑**

The feature flows to the south under the CNR – Metrolinx Rail Corridor through a closed bottom culvert measuring approximately 2.4 m wide and 1.2 m high. The culvert appeared to have been recently built and no clear connection had been made yet between the feature and the culvert (i.e., no definable flow path).

New culvert that crosses under the train tracks (photo taken north of train tracks). Culvert measures 2.4 m wide and 1.2 m high. Looking to the southeast

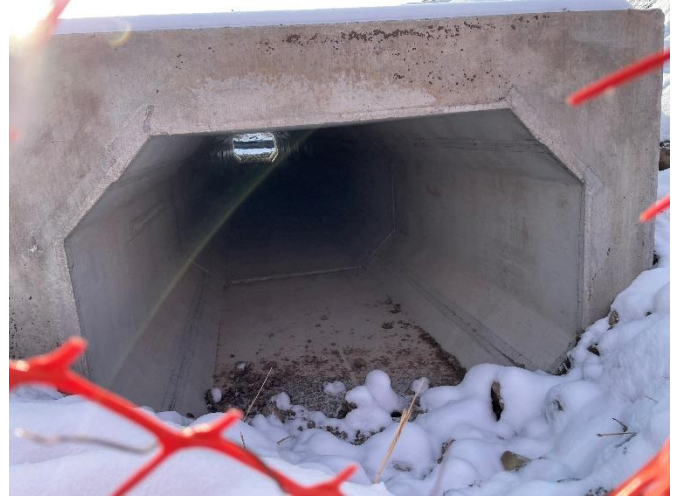
**Photograph 18. ↑**

New culvert that crosses under the train tracks (photo taken north of train tracks). Culvert measures 2.4 m wide and 1.2 m high. Looking to the southeast
