**West Side Employment Lands,  
Waterloo ON**

FINAL - Phase I Environmental Site  
Assessment

August 17, 2018

Stantec Consulting Ltd.  
100-300 Hagey Boulevard  
Waterloo ON N2L 0A4

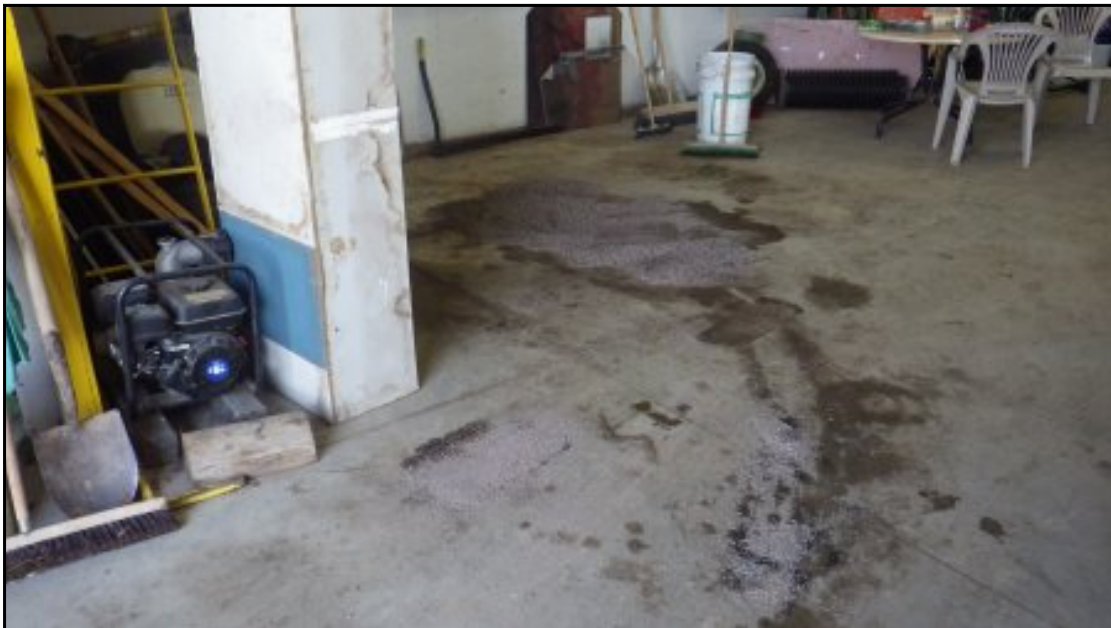
0.5 L to 20 L containers of motor oil, transmission fluid, engine oil, hydraulic fluid, anti-freeze, paints, varnishes, lubricants, degreasers and insect repellent were observed on the concrete floors, shelves and in cabinets in the Maintenance Building at 100 Wilmot Line. No staining was observed on the concrete floors in the area of the stored products.

**Staining observed within the Maintenance Building at 100 Wilmot Line.**

Stantec recommends a Phase II ESA be completed at the Site in order to evaluate the soil and/or groundwater quality in the vicinity of the above-mentioned environmental concerns.

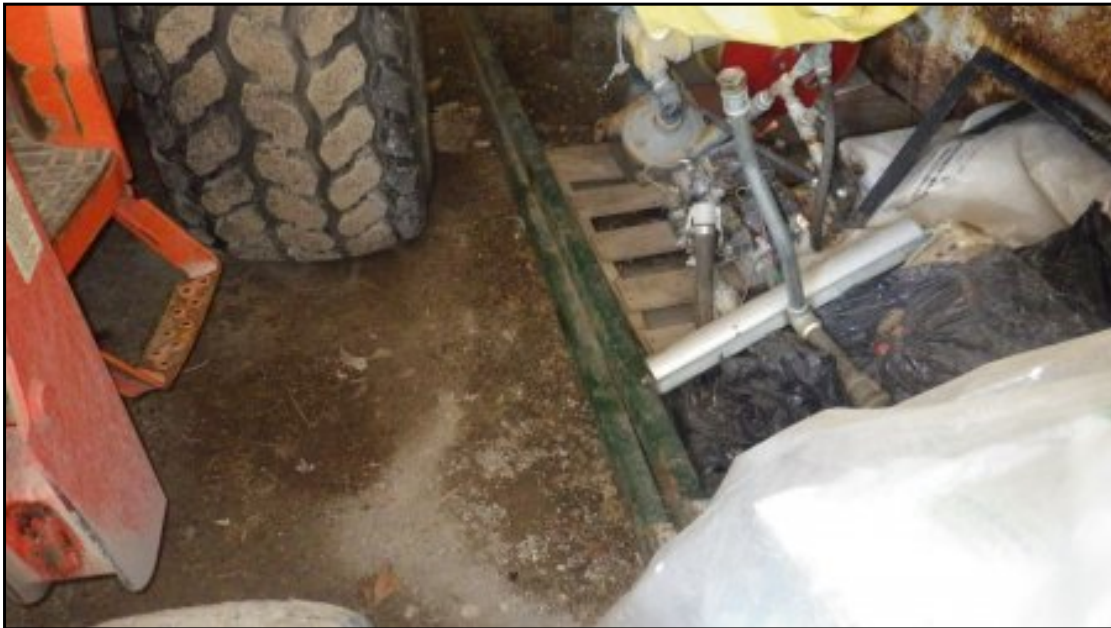
Containers labeled as engine oil in 20 L to 200 L containers were observed on the floor of the Maintenance Shed at 100 Wilmot Line. The site contacts were not aware of the age or the contents of the containers but assumed the containers contained used engine or motor oil. Staining was observed on the metal floor in the area of the stored products.

Based on the observed staining related to the assumed used motor or engine oil in the Maintenance Shed, the staining was considered to represent a potential environmental concern to the Site.

**Staining observed within the Maintenance Shed at 100 Wilmot Line.**

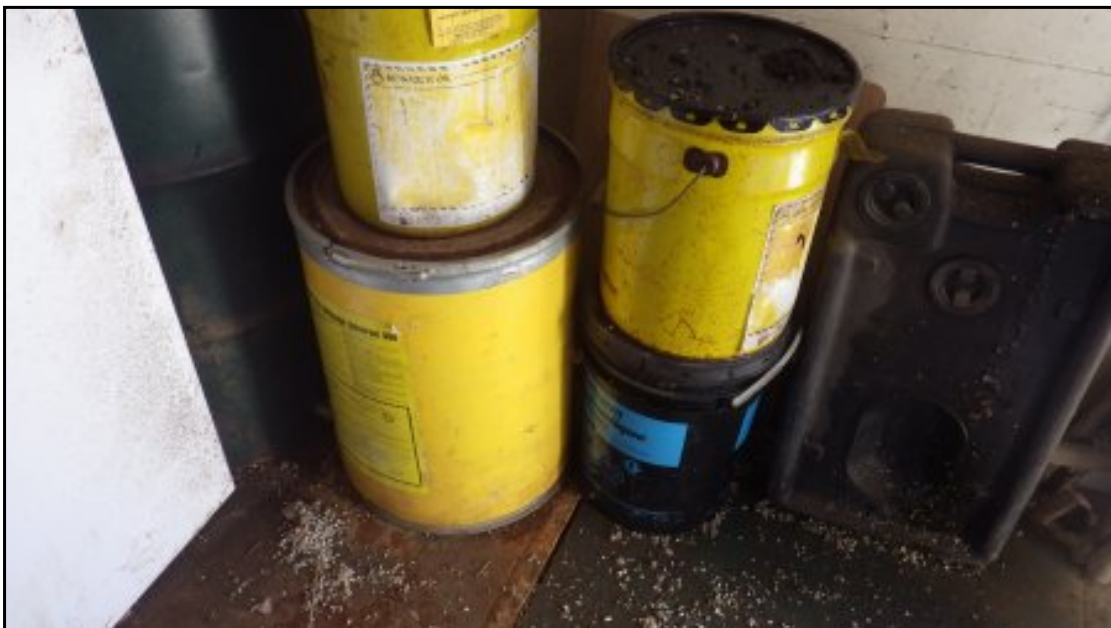
- Based on the large quantities of containers ranging from 0.5 L to 200 L, observed storage practices and staining related to the assumed used motor or engine oil, the presence of these materials at the Site were considered to represent a potential environmental concern to the Site.

**Storage of assumed used motor or engine oil within the Maintenance Shed at 100 Wilmot Line.**

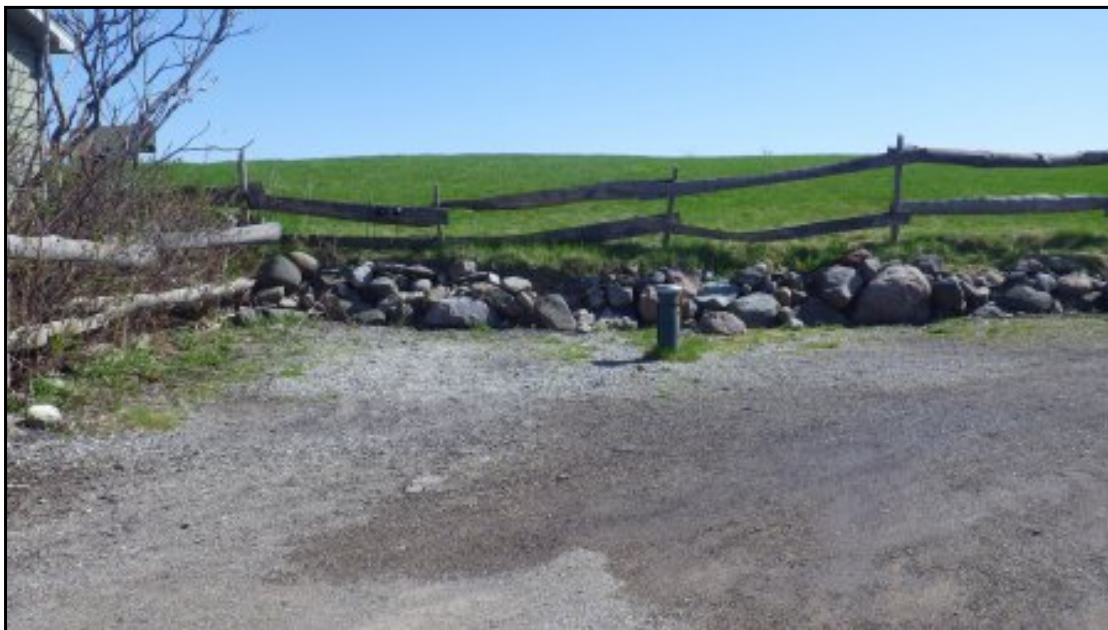
**Water supply well situated southeast of the Driving Range Shed at 100 Wilmot Line, facing east.**

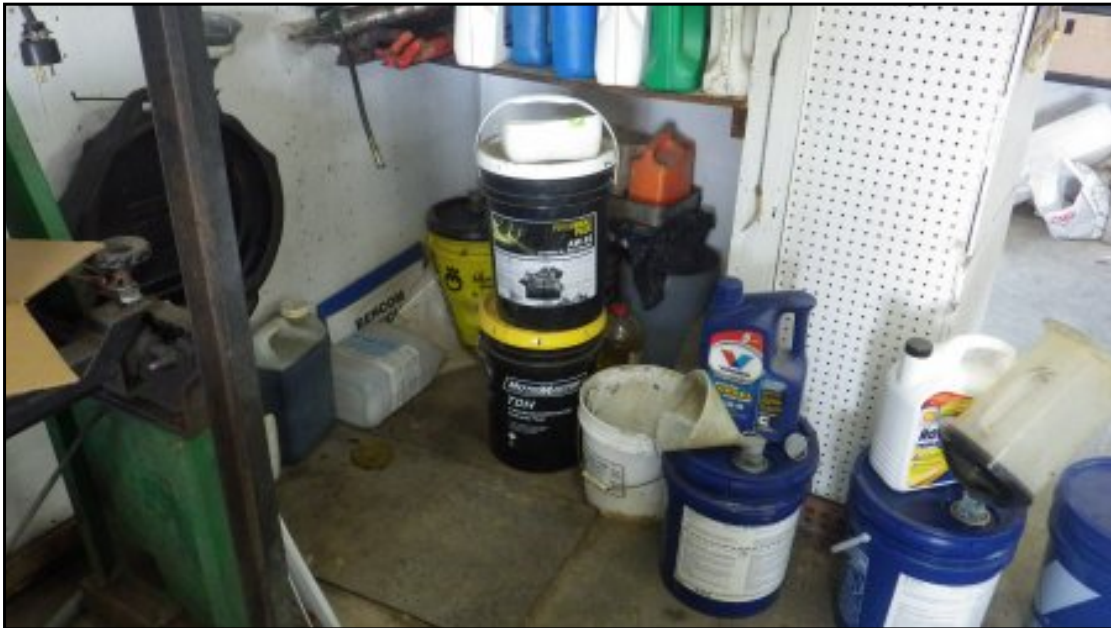
**Storage of motor oil, transmission fluid, engine oil, hydraulic fluid, anti-freeze, paints and varnishes in the Maintenance Building at 100 Wilmot Line.**

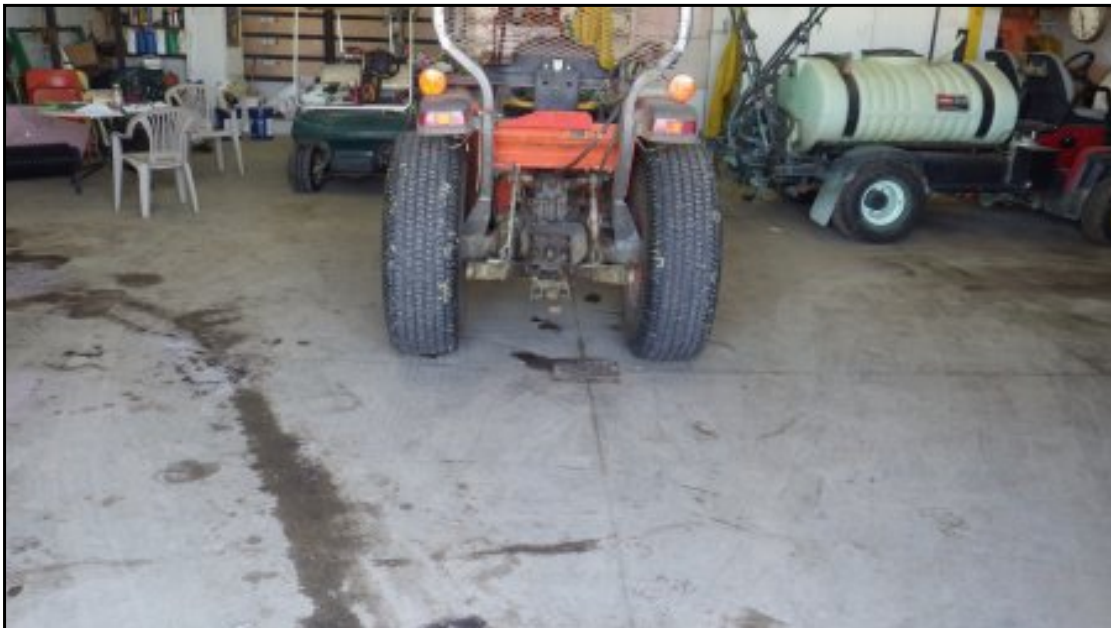
- A floor drain was situated in the central portion of the Maintenance Building, where observed maintenance and repairs of golf course equipment occurred. The observed associated staining in close proximity to the floor drain, which is reported to discharge to the west of the Maintenance Shed, represents a potential environmental concern to the Site.

The observed associated staining in close proximity to the floor drain, which is reported to discharge to the west of the Maintenance Shed, represents a potential environmental concern to the Site.

**Observed staining near the drain in the Maintenance Building at 100 Wilmot Line.**

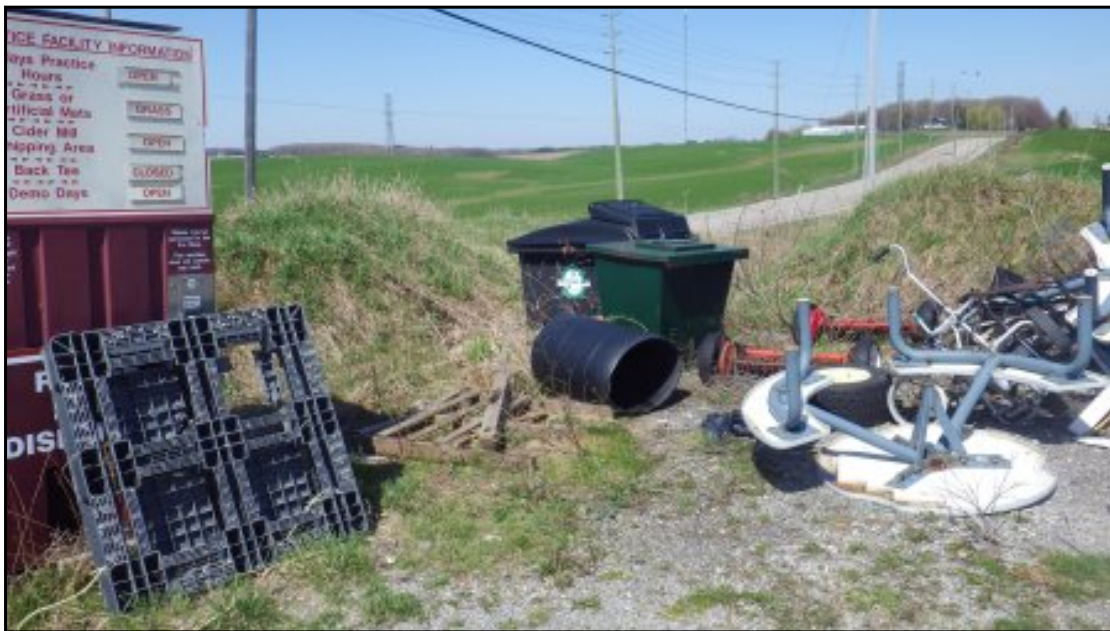
**Storage containers for used motor oil and used kitchen oil at 100 Wilmot Line, facing northwest.**

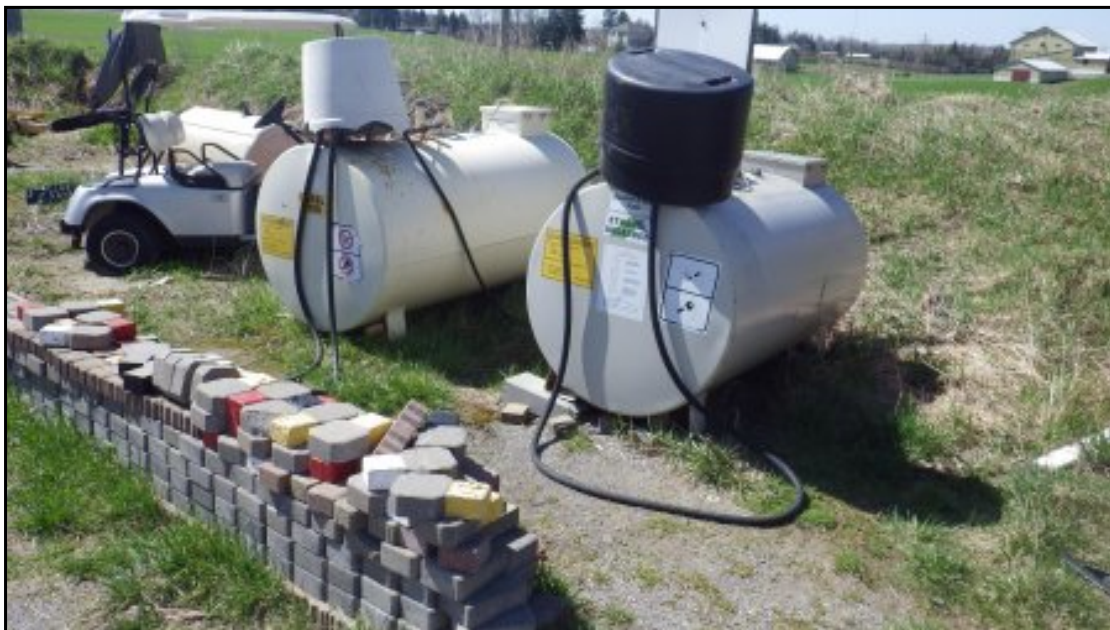
- Two fueling ASTs were present at 100 Wilmot Line with no secondary containment and a historical diesel spill was associated with the ASTs.
- The storage of used oil containers within the Maintenance Shed at 100 Wilmot Line with no secondary containment and associated staining.
- The presence of a floor drain, situated within the Maintenance Building at 100 Wilmot Line, with no associated oil water separator.
- The unknown quality of imported fill material at 980 Erb Street West.
-

One single-walled steel AST containing diesel was observed outside the south of the Maintenance Shed at 100 Wilmot Line. The AST had a manufacturing date of 2008 and a capacity of 1,360 litres (L). One single-walled steel AST containing gasoline was observed outside the south of the Maintenance Shed at 100 Wilmot Line. The AST had a manufacturing date of 2001 and a capacity of 1,360 L.

**Gasoline and diesel ASTs with no secondary containment at 100 Wilmot Line situated west of the Maintenance Building, facing west.**

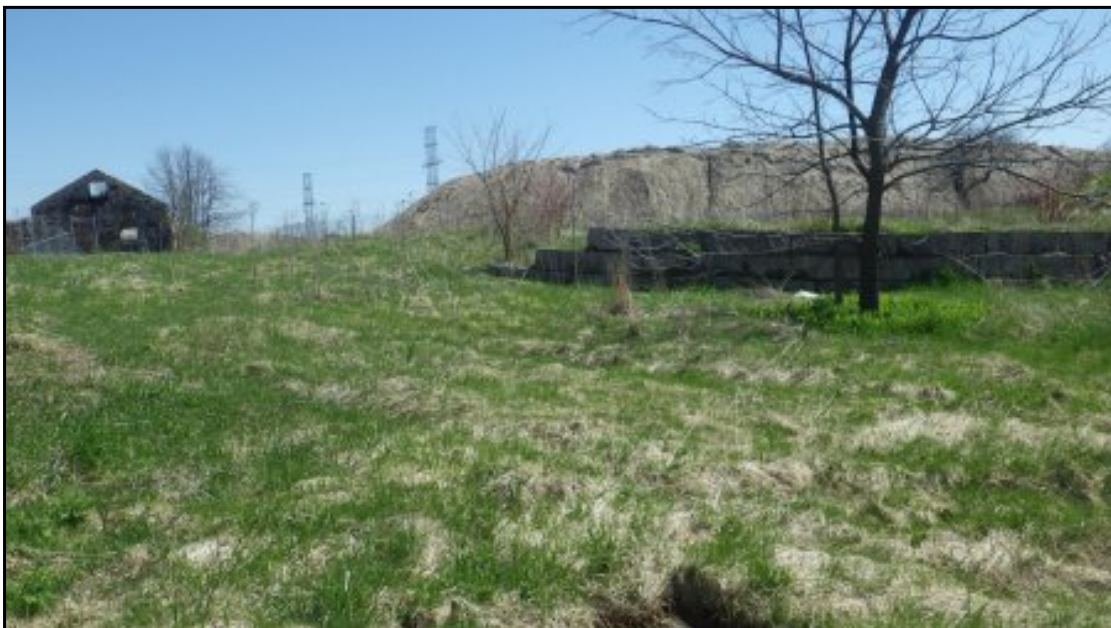
A stormwater management pond was observed on the eastern portion of 100 Wilmot Line. Associated stockpiled soil was observed south and east of 928 Erb Street West related to the development of the stormwater management pond.

**Former Hergott Lands at 928 Erb Street West and stockpiled soil, facing east.**

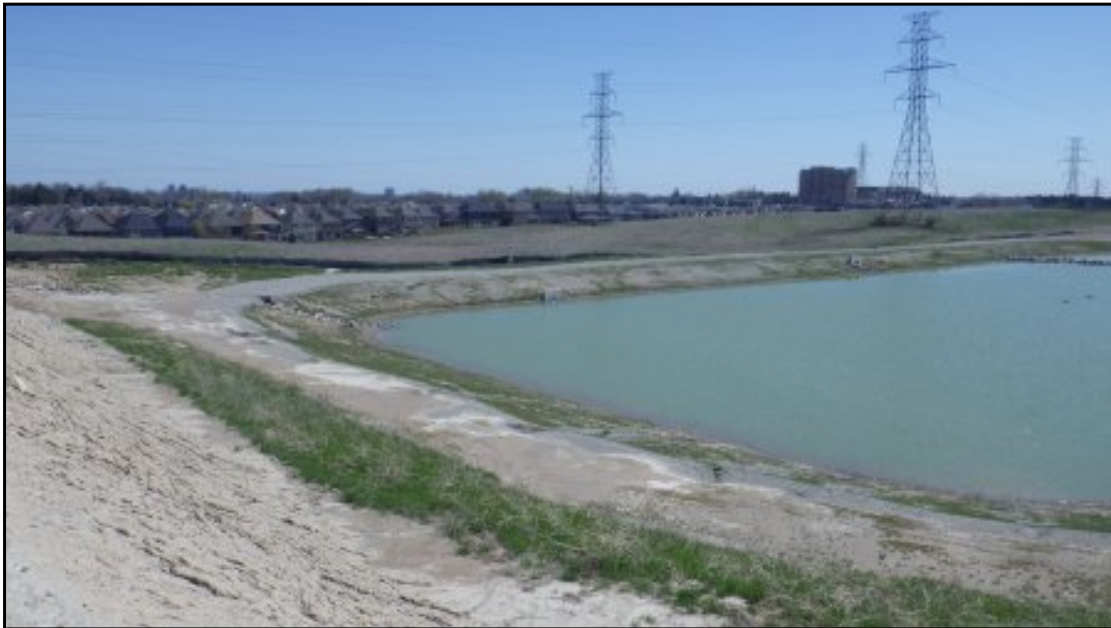
**Stormwater management pond situated on the eastern edge of 100 Wilmot Line, facing east.**

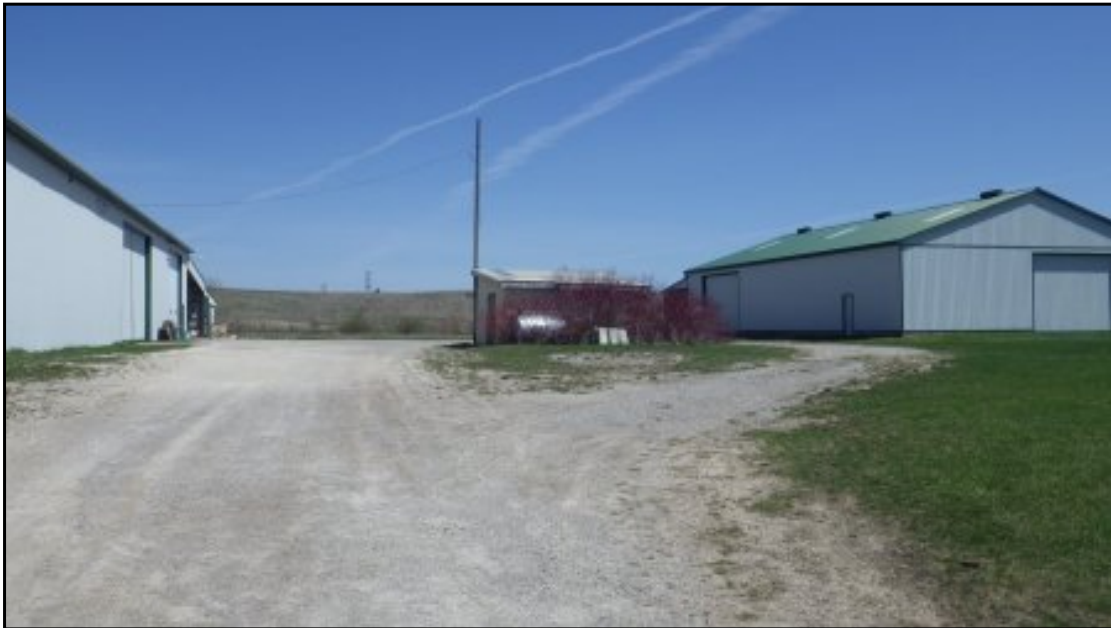
**Observed ASTs at 50 Wilmot Line, facing east.**

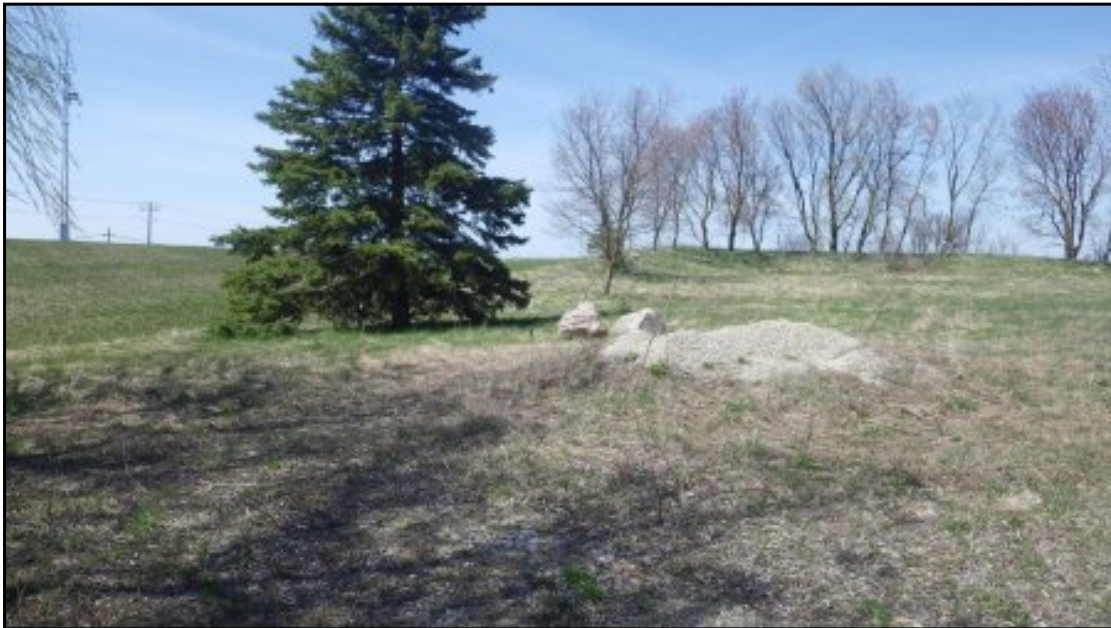
- Two stockpiles, approximately 20 cubic metres, consisting of gravel, concrete and asphalt were observed on the property at 980 Erb Street West. In addition, this property, formerly contained a residential house and therefore it is likely that quantities of fill materials were brought to the property related to backfilling operations. The presence of unknown quality of imported fill at 980 Erb Street West represents an environmental concern to the Site.

The property at 980 Erb Street generally appears to be at grade with the adjacent properties to the north, east, south and west. Two stockpiles, approximately 20 cubic meters, consisting of gravel, concrete and asphalt were observed on the property. In addition, based on the historical review of the property, a former residential house had been situated on the property. Therefore, it is likely that quantities of fill materials were brought onto the property related to backfilling operations.

**Observed stockpiled soil potentially related to backfilling operations at 980 Erb Street West, facing north.**

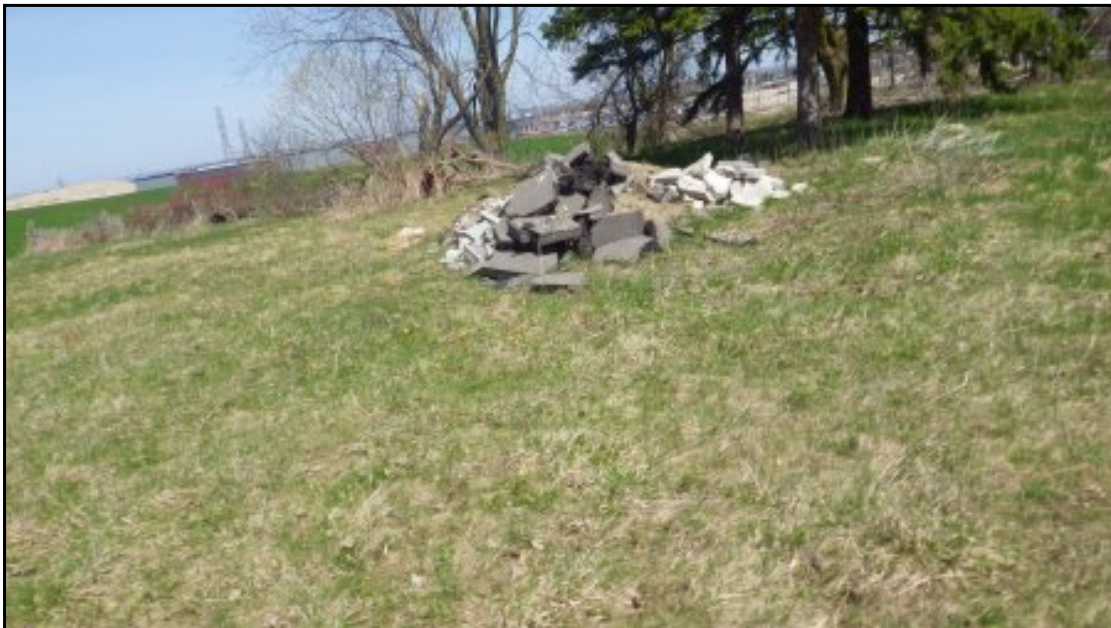
**Observed stockpiled fill material at 980 Erb Street West, facing northeast.**
