# **Response to the Region of Waterloo Hallman Pit Hydrogeology**

**Jackson Harvest Farms Ltd.**

**July 14 2020**

**REF. No. 1728**

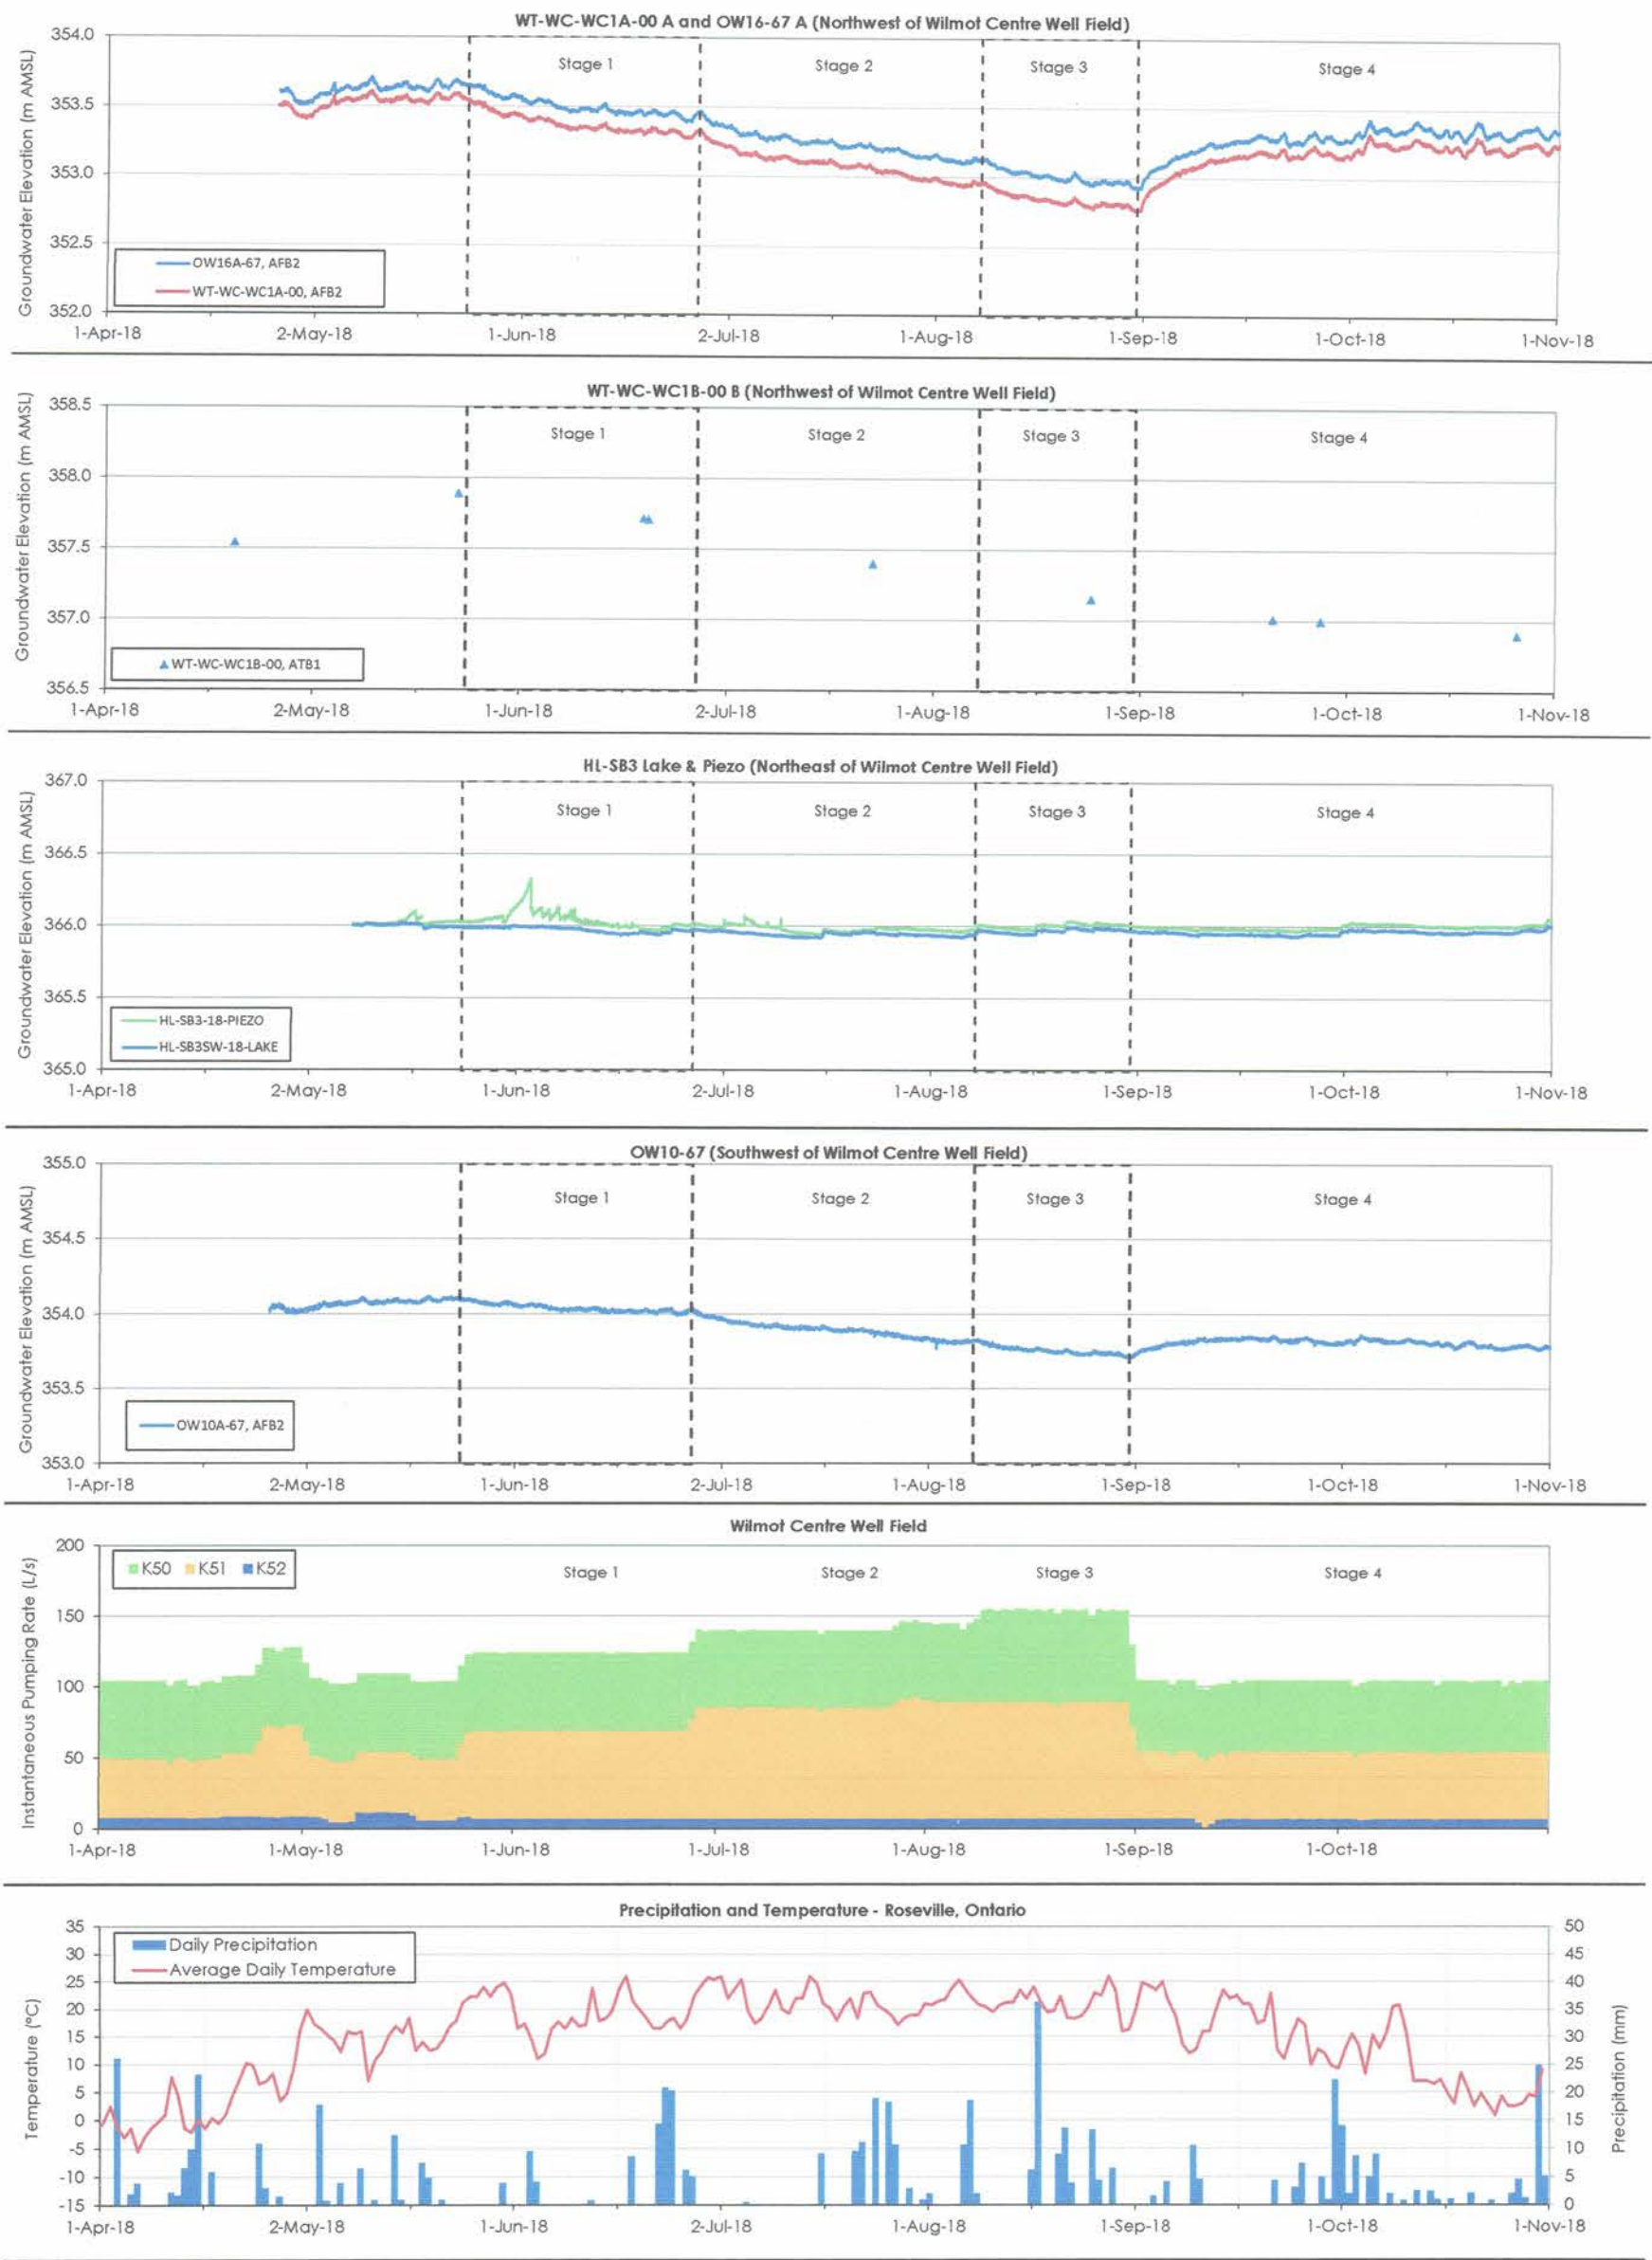
Notes:  
Water level and pumping rate shown as provided by the Region of Waterloo. Pumping rates shown are instantaneous values reported as averaged daily.

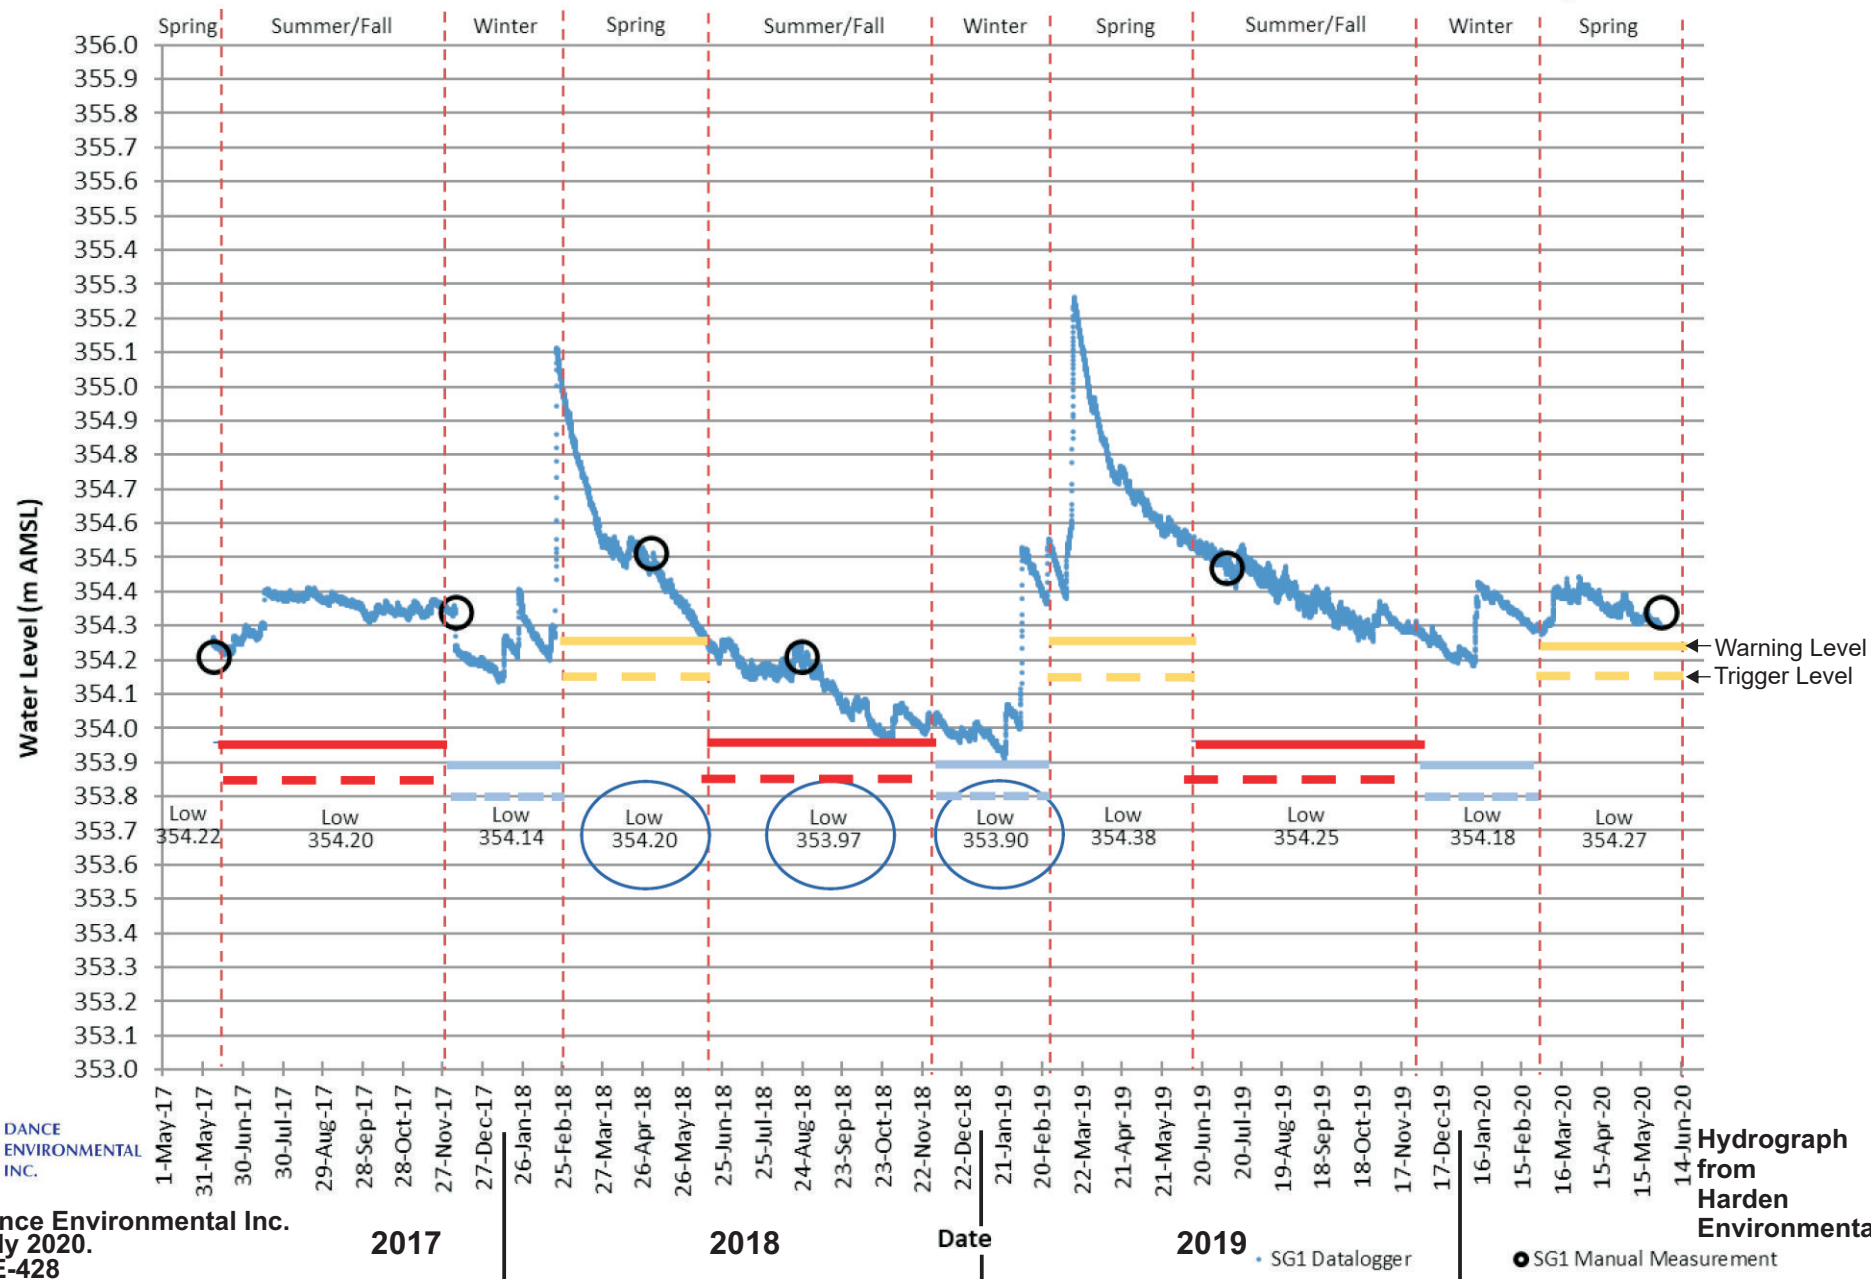
# FIGURE 1. SG1 Pond Hydrograph & Proposed Water Level Triggers.

Winter: Dec 1 - Mar 1  
 Spring: Mar 2 - Jun 15  
 Summer/Fall: Jun 16 - Nov 30
