**Westheights Pond and Park.  
Restoration and Management Plan  
SUMMARY REPORT  
May 2025.**

DE-478  
May 13, 2025.

# Westheights Pond and Park: Restoration and Management Plan.

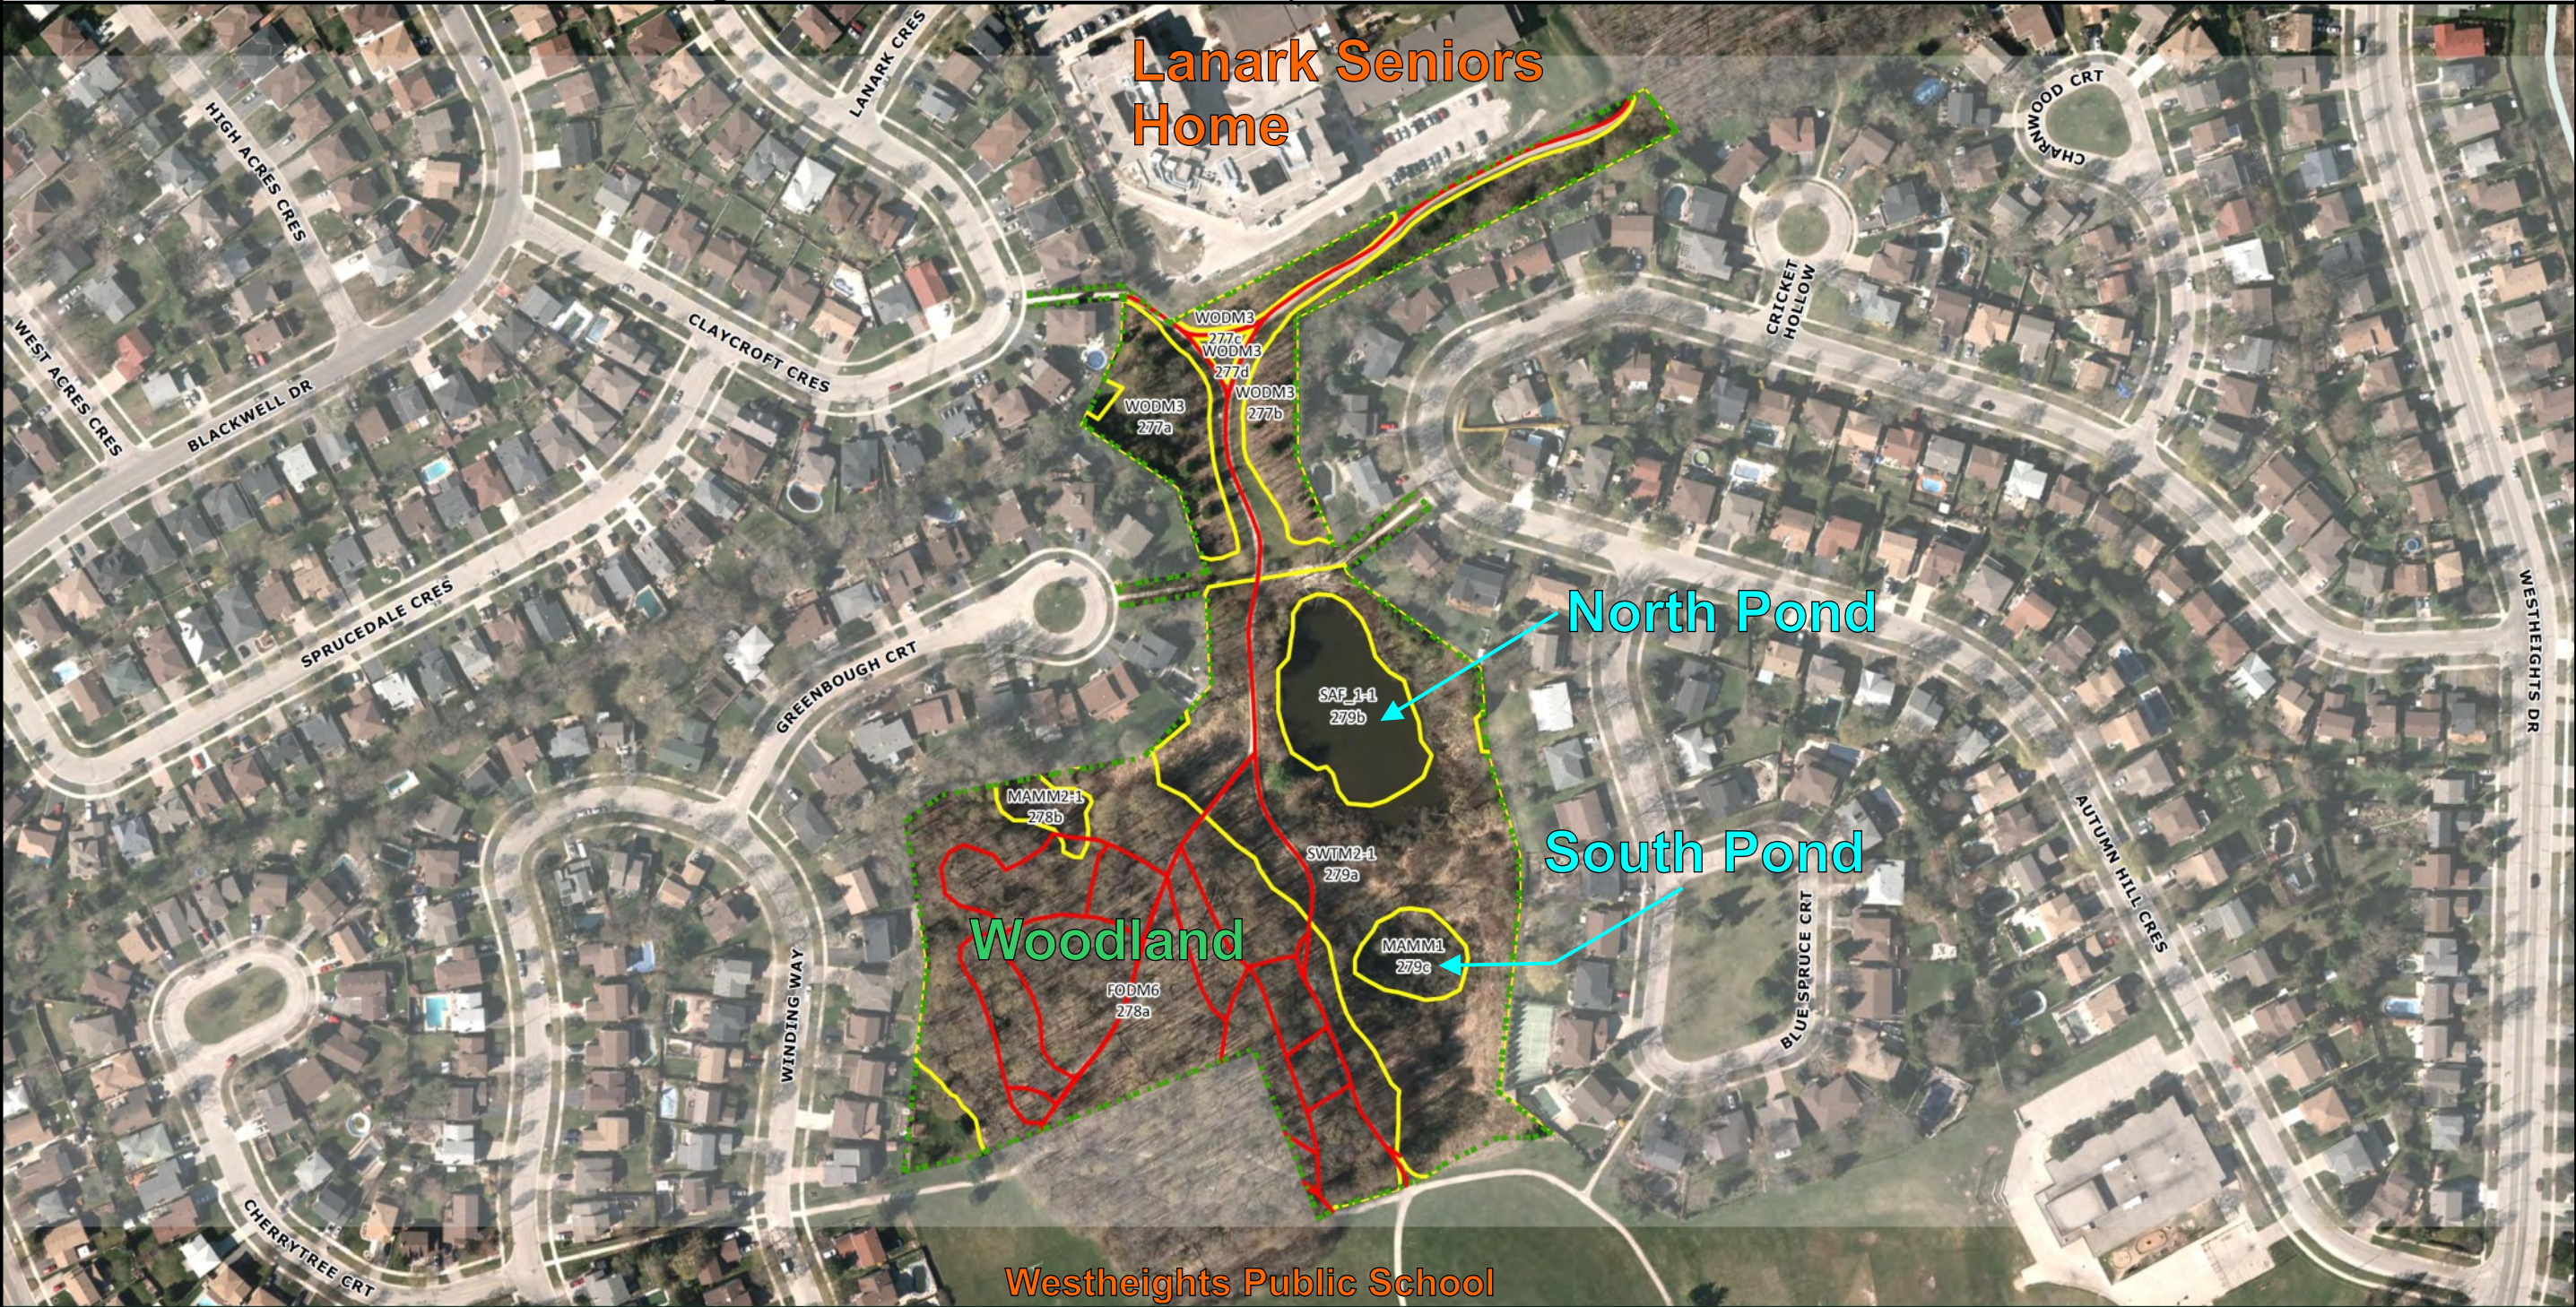
# Figure 1. Westheights Park Natural Area

Westheights Park is a 4 hectare park located north of Westheights Drive; west of Autumn Hill Crescent, and east of Winding Way, see Figure 1.

Westheights Park contains two ponds, a larger northern pond (0.7 ha± in area) and a smaller southern pond which is surrounded by dense tree growth. An upland deciduous forest on rolling topography is another key feature of the park.

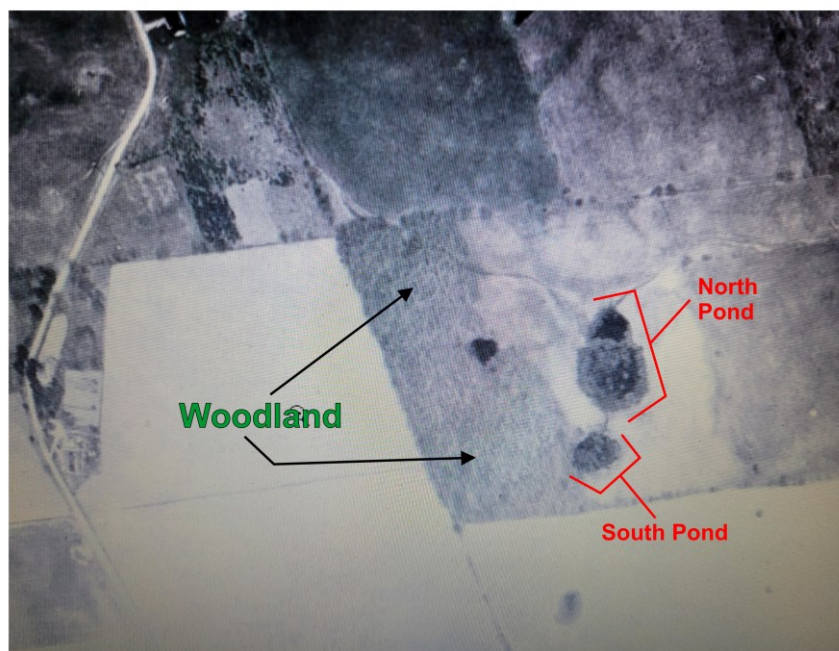
**Figure 3. 1971 Aerial Photograph of Westheights Pond**

The Westheights subdivision was constructed during the mid-late 70s, as the air photo from 1971 shows no development near Westheights Pond, see Figure 3.

Water flowing from the South Pond into the North Pond does not reduce the water quality in North Pond, but helps to maintain water depths in North Pond. The modern day drainage connections from South Pond to North Pond appear to be similar to those documented by historical air photos, Figures 2 & 3.

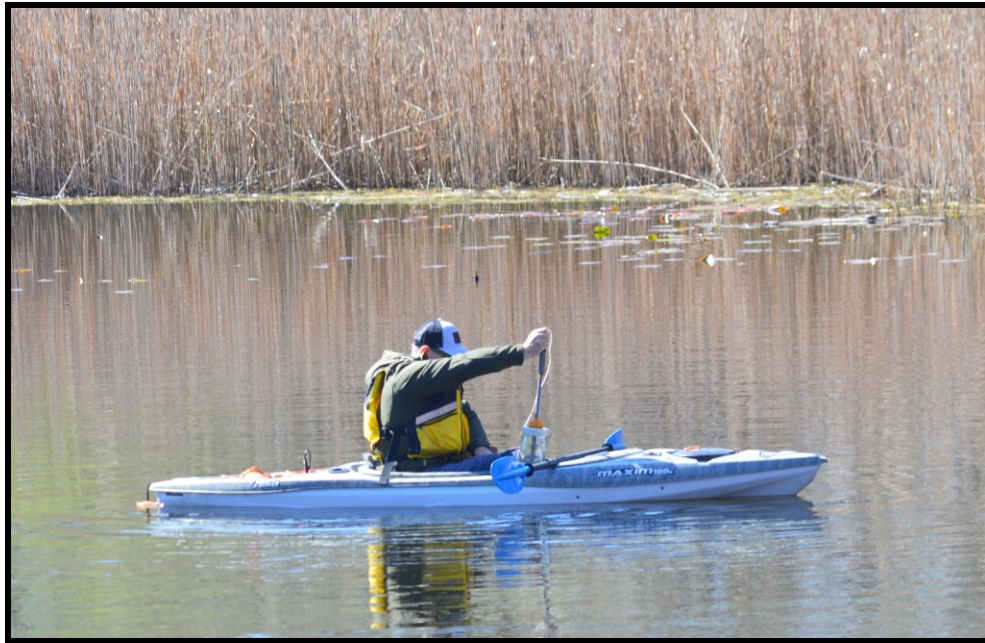
**Figure 5. Water Samples Being Collected in the North Pond.**

Water quality sampling occurred on 3 dates: July 10 and October 19, 2023, and April 25, 2024. Figure 5 shows water samples being collected from the North Pond using a kayak.

Table 1 lists the lab analysis results for water samples taken from the North Pond in 2023 and 2024. The results summarized in Table 1 are from a station located in the middle of North Pond where the deepest water was expected: water was collected from the top of the pond and from the bottom of the pond. A “north shore” station was located in shallow water out  $1 \text{ m} \pm$  from the armour stone north margin of North Pond.
