# Restoring Local Creeks: Voisin Creek and Borden Creek in Concordia Park

May 22, 2024, from 5:00 to 8:00 p.m.

# Project Background

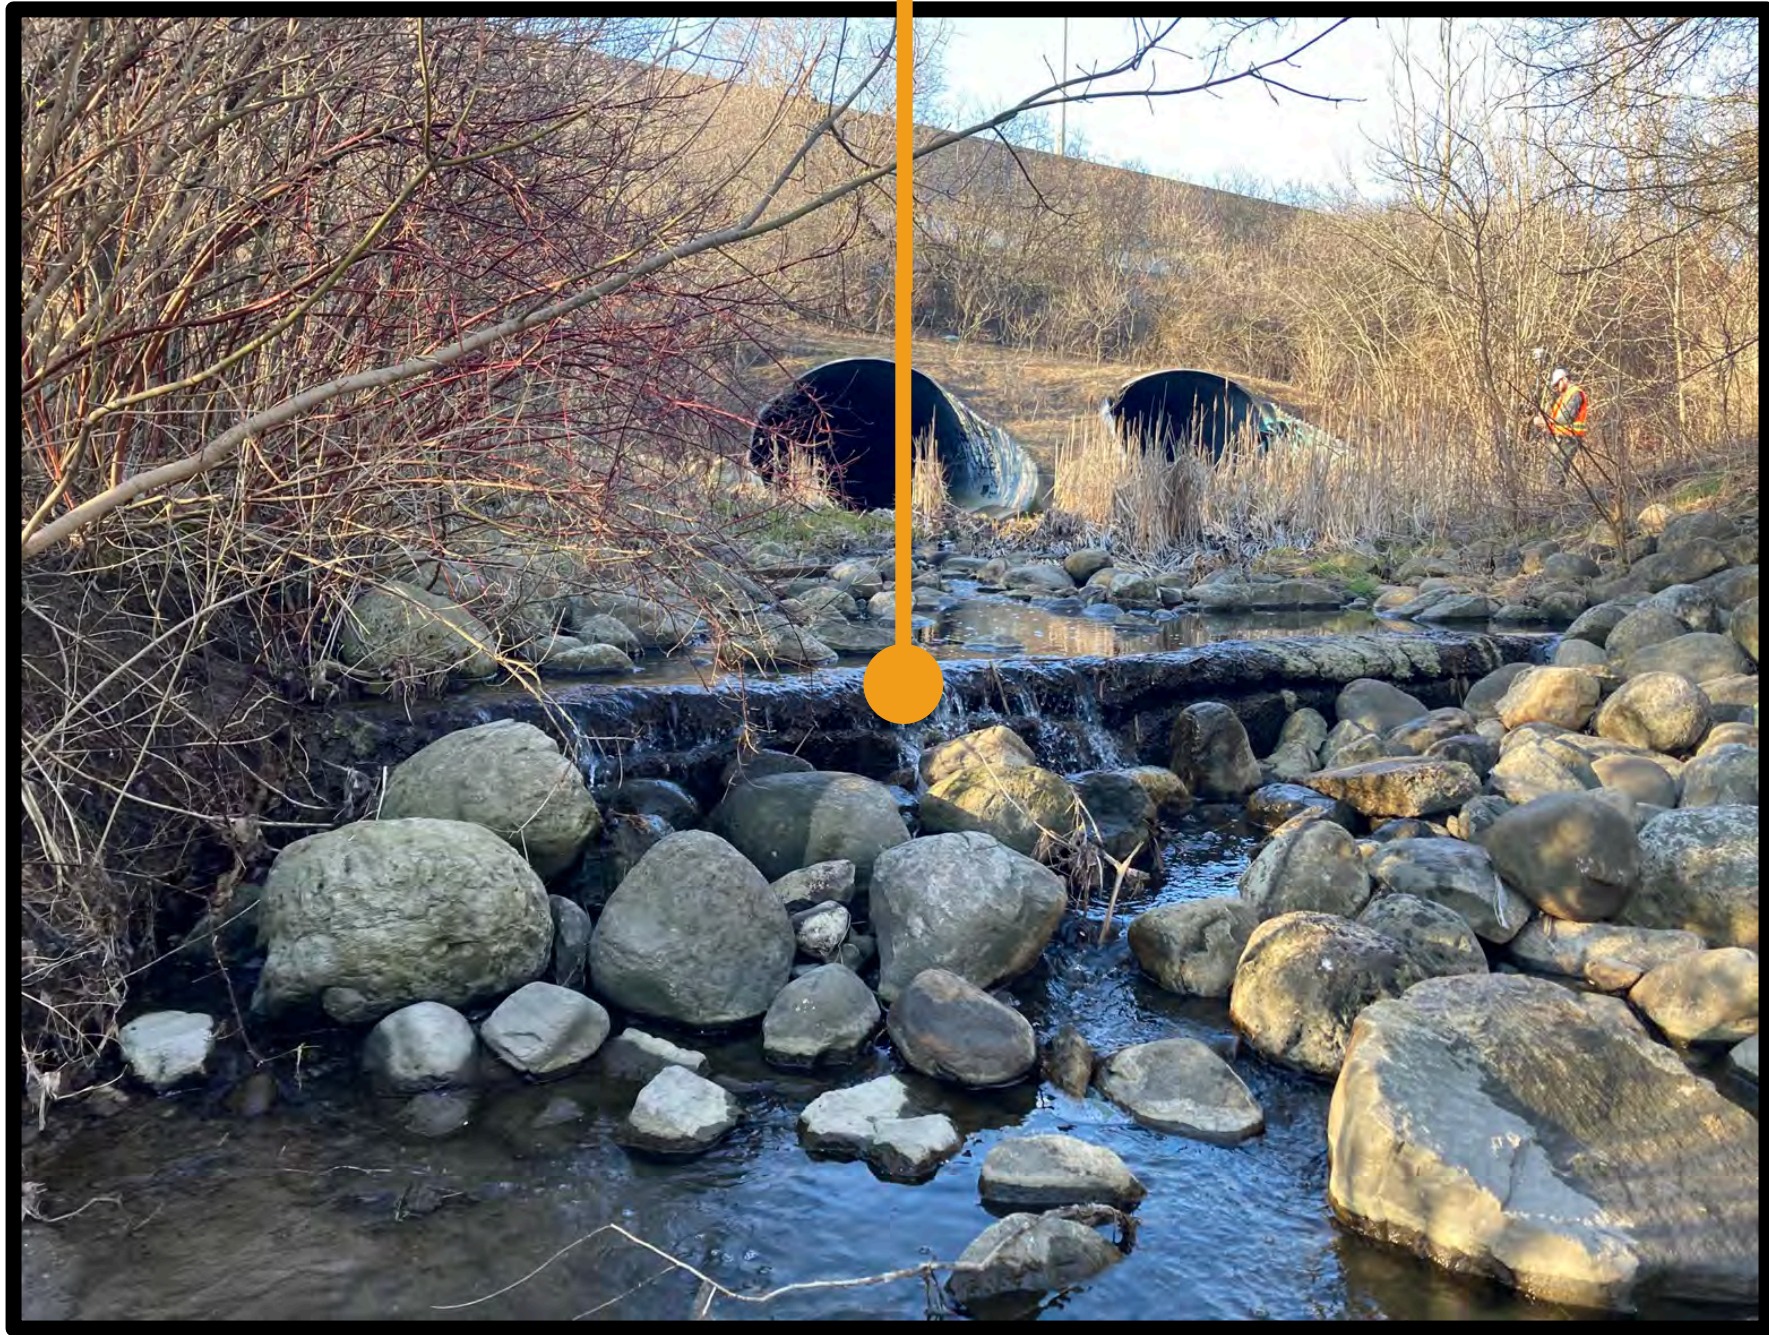
Exposed sanitary pipe (concrete-encased)

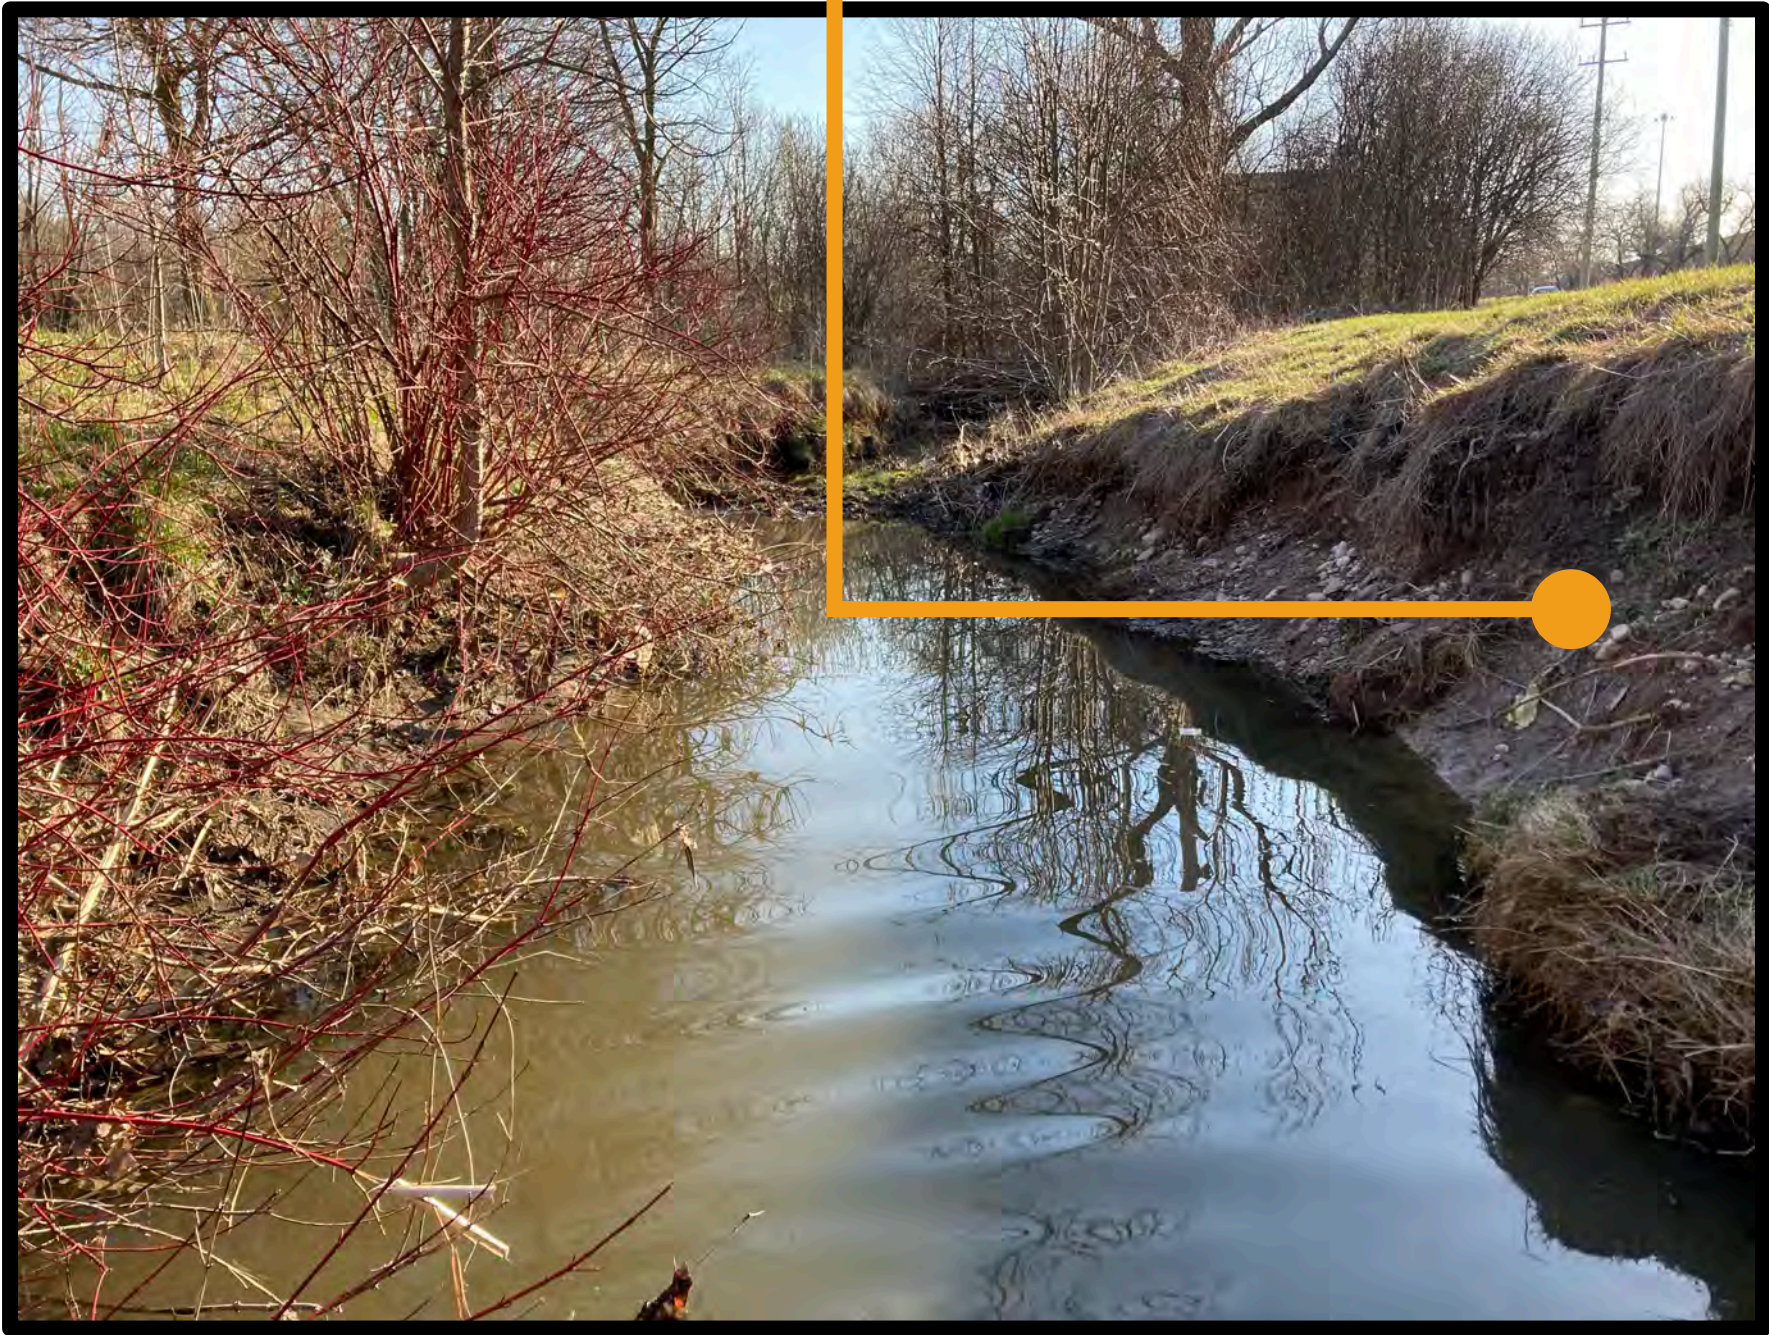
Eroding banks, exposed bare soil

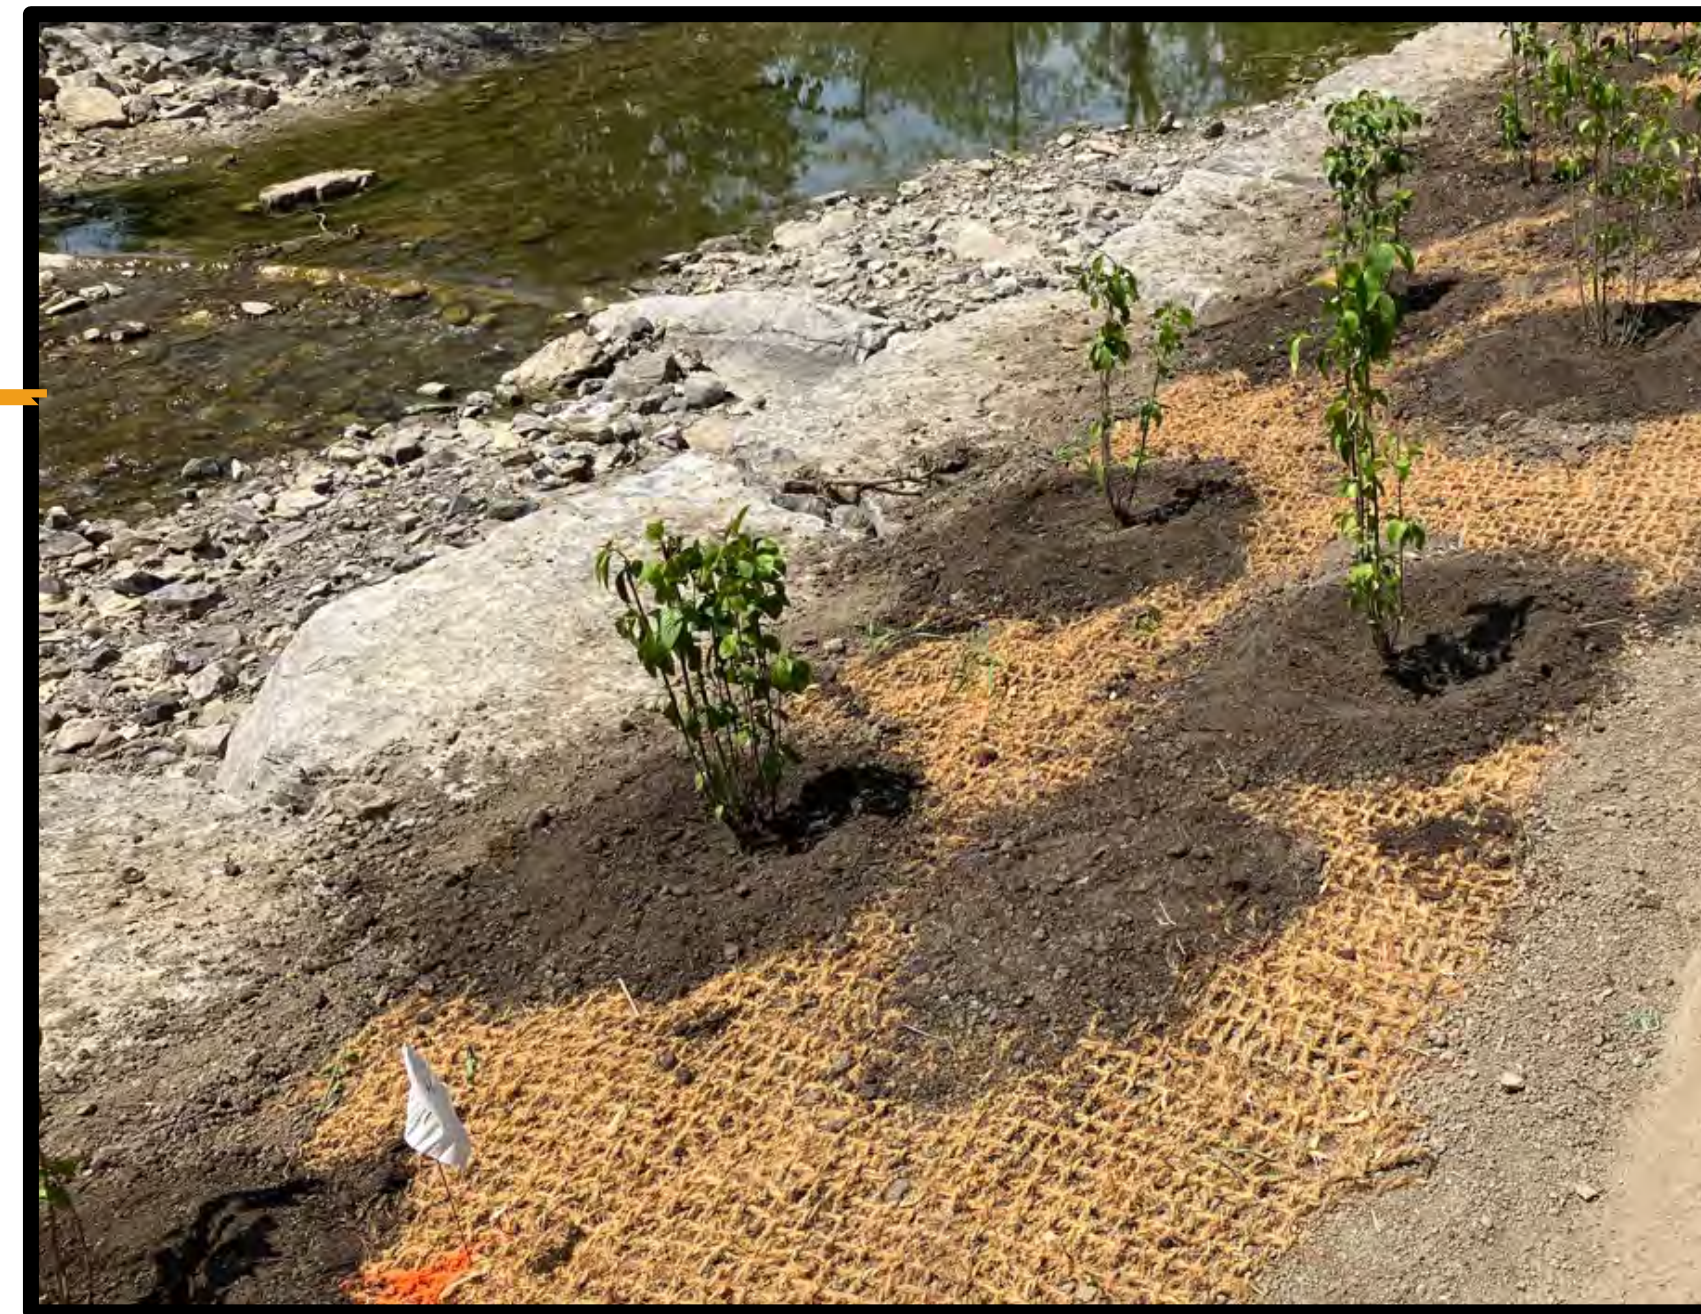
## Stabilize channel:

- Reshape bend
- Bioengineering on banks
- Make slope more gradual, allowing fish to travel upstream

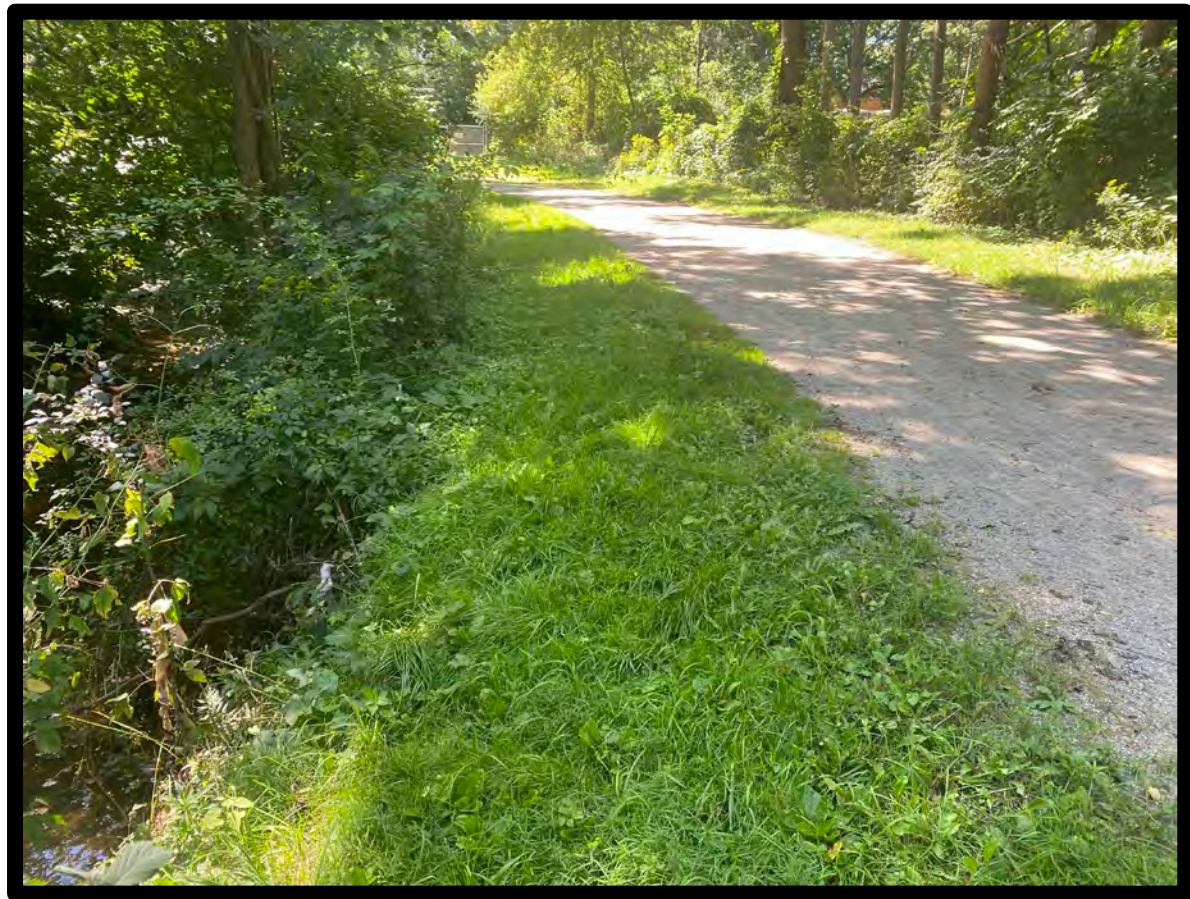
Erosion Near Trail

- Existing bank to be protected with boulders and planted with native shrub species
- Add a buried trough of stone to protect the trail in the future

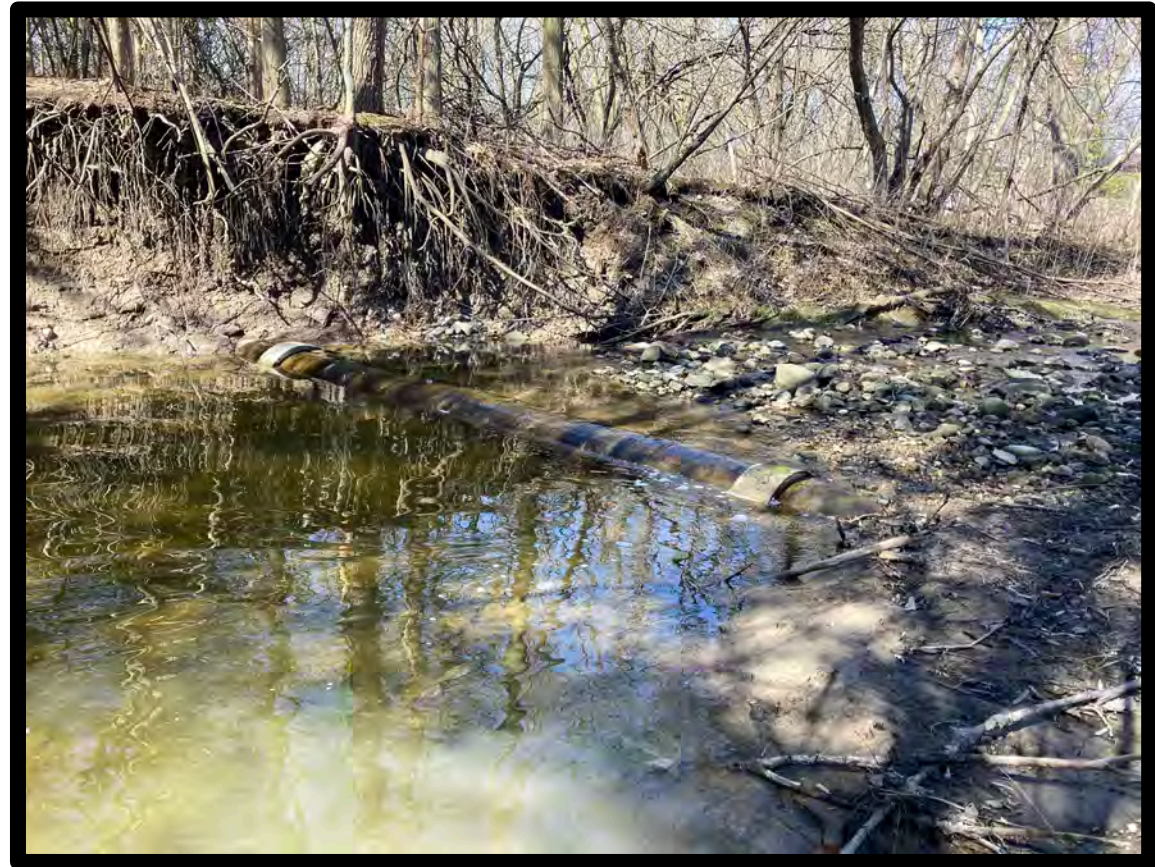
Exposed Watermain

| Design Element | Final Design Concept |
|---|---|
| Infrastructure Risks | Watermain to be decommissioned by Waterloo Region. Only exposed sections of watermain to be removed. Confirmed by regional staff that watermain does not need to be replaced/realigned. |

- Once decommissioned by the Region, the pipe will be capped and removed from the creek
- Repair channel bed and banks
- Incorporate native vegetation on banks and floodplain areas

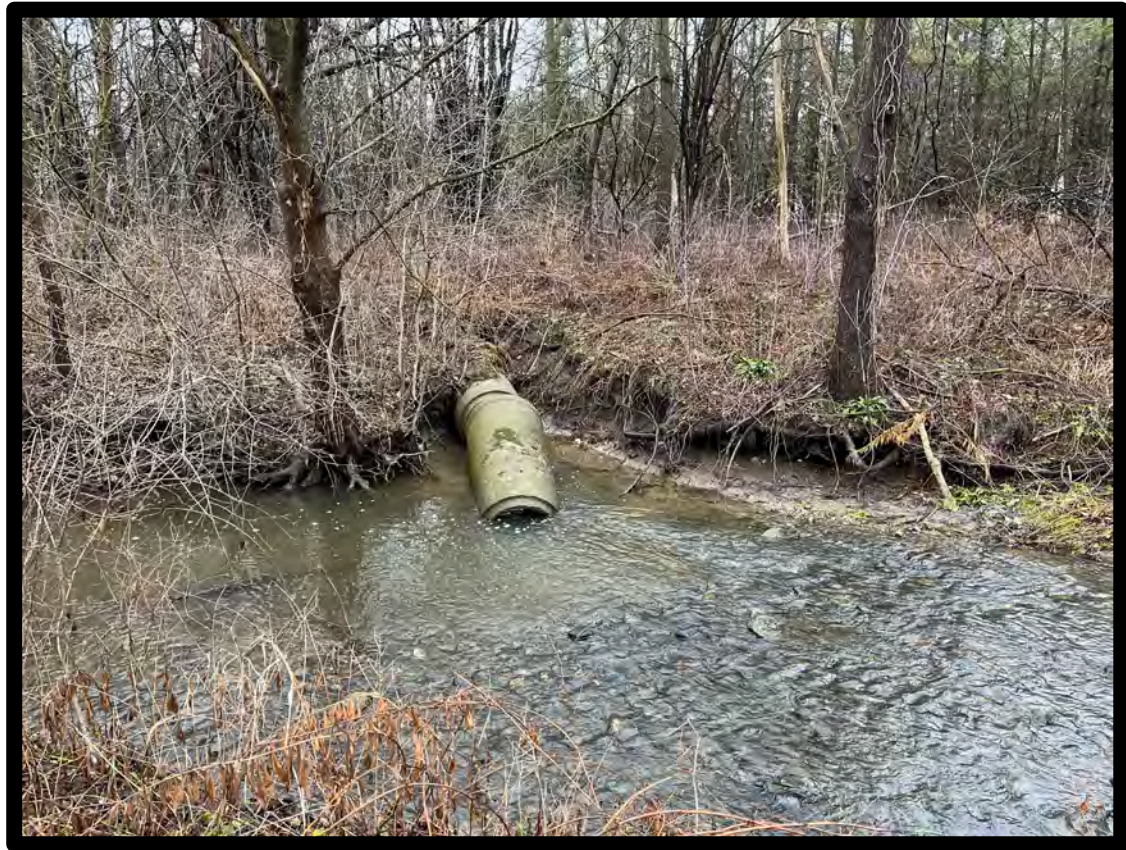
Failed Stormwater Outlet

- Remove broken concrete pipe
- Install poured concrete foundation
- Construct energy dissipation pool and apron out of river stone.

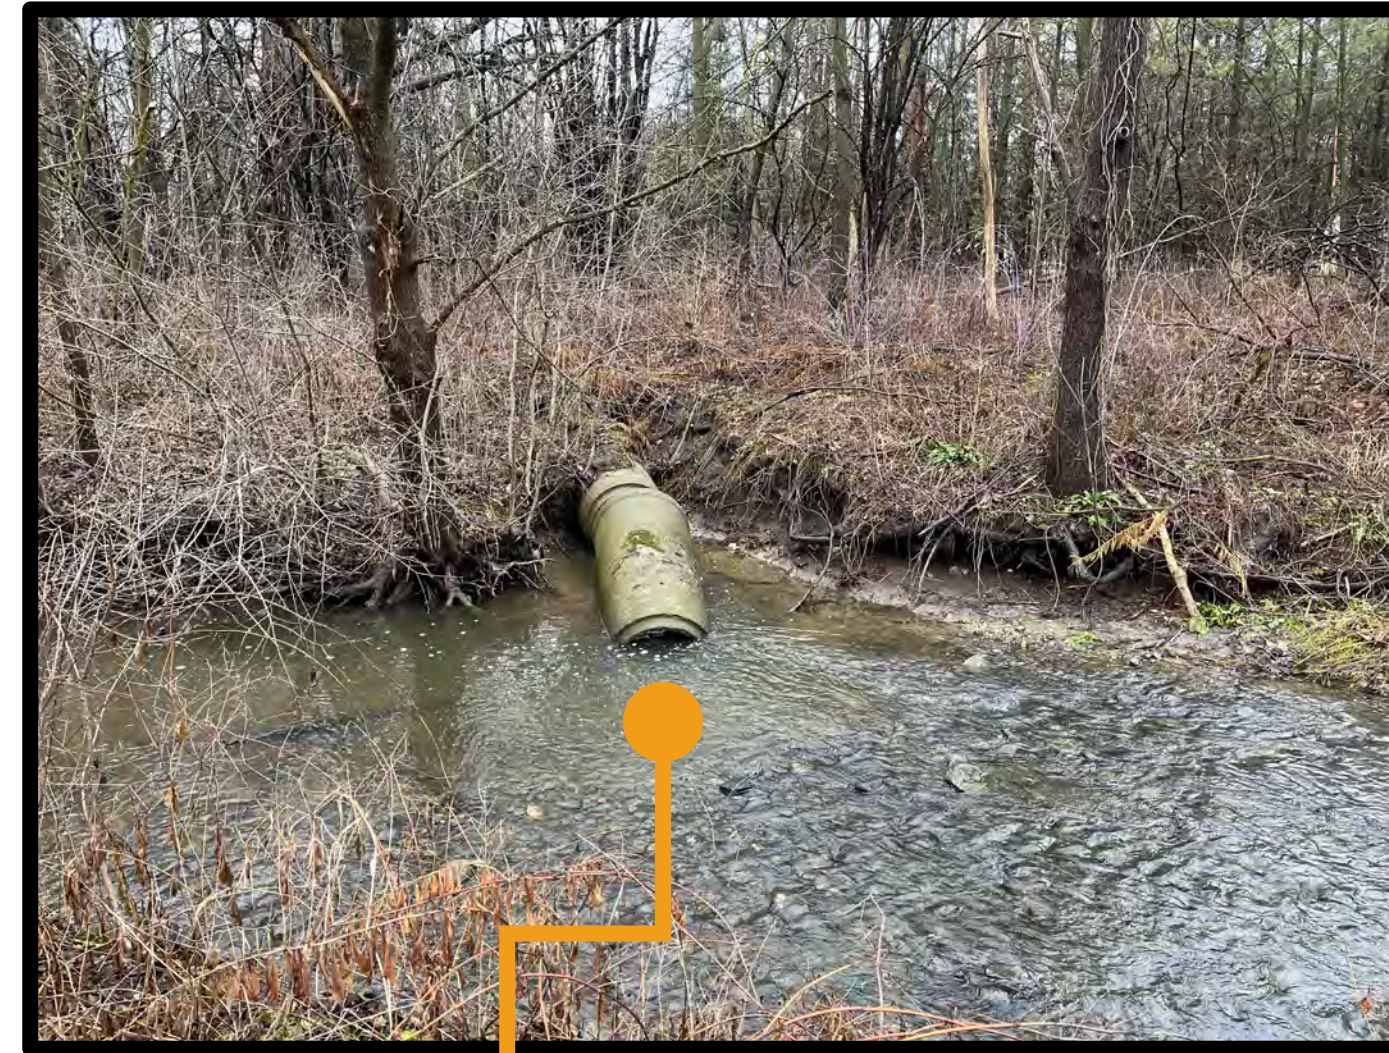
# Borden Creek at Concordia Park: Addressing Erosion

## Repair failed storm outlet:

## Protect trail with vegetated stone:

## Remove and cap exposed watermain:

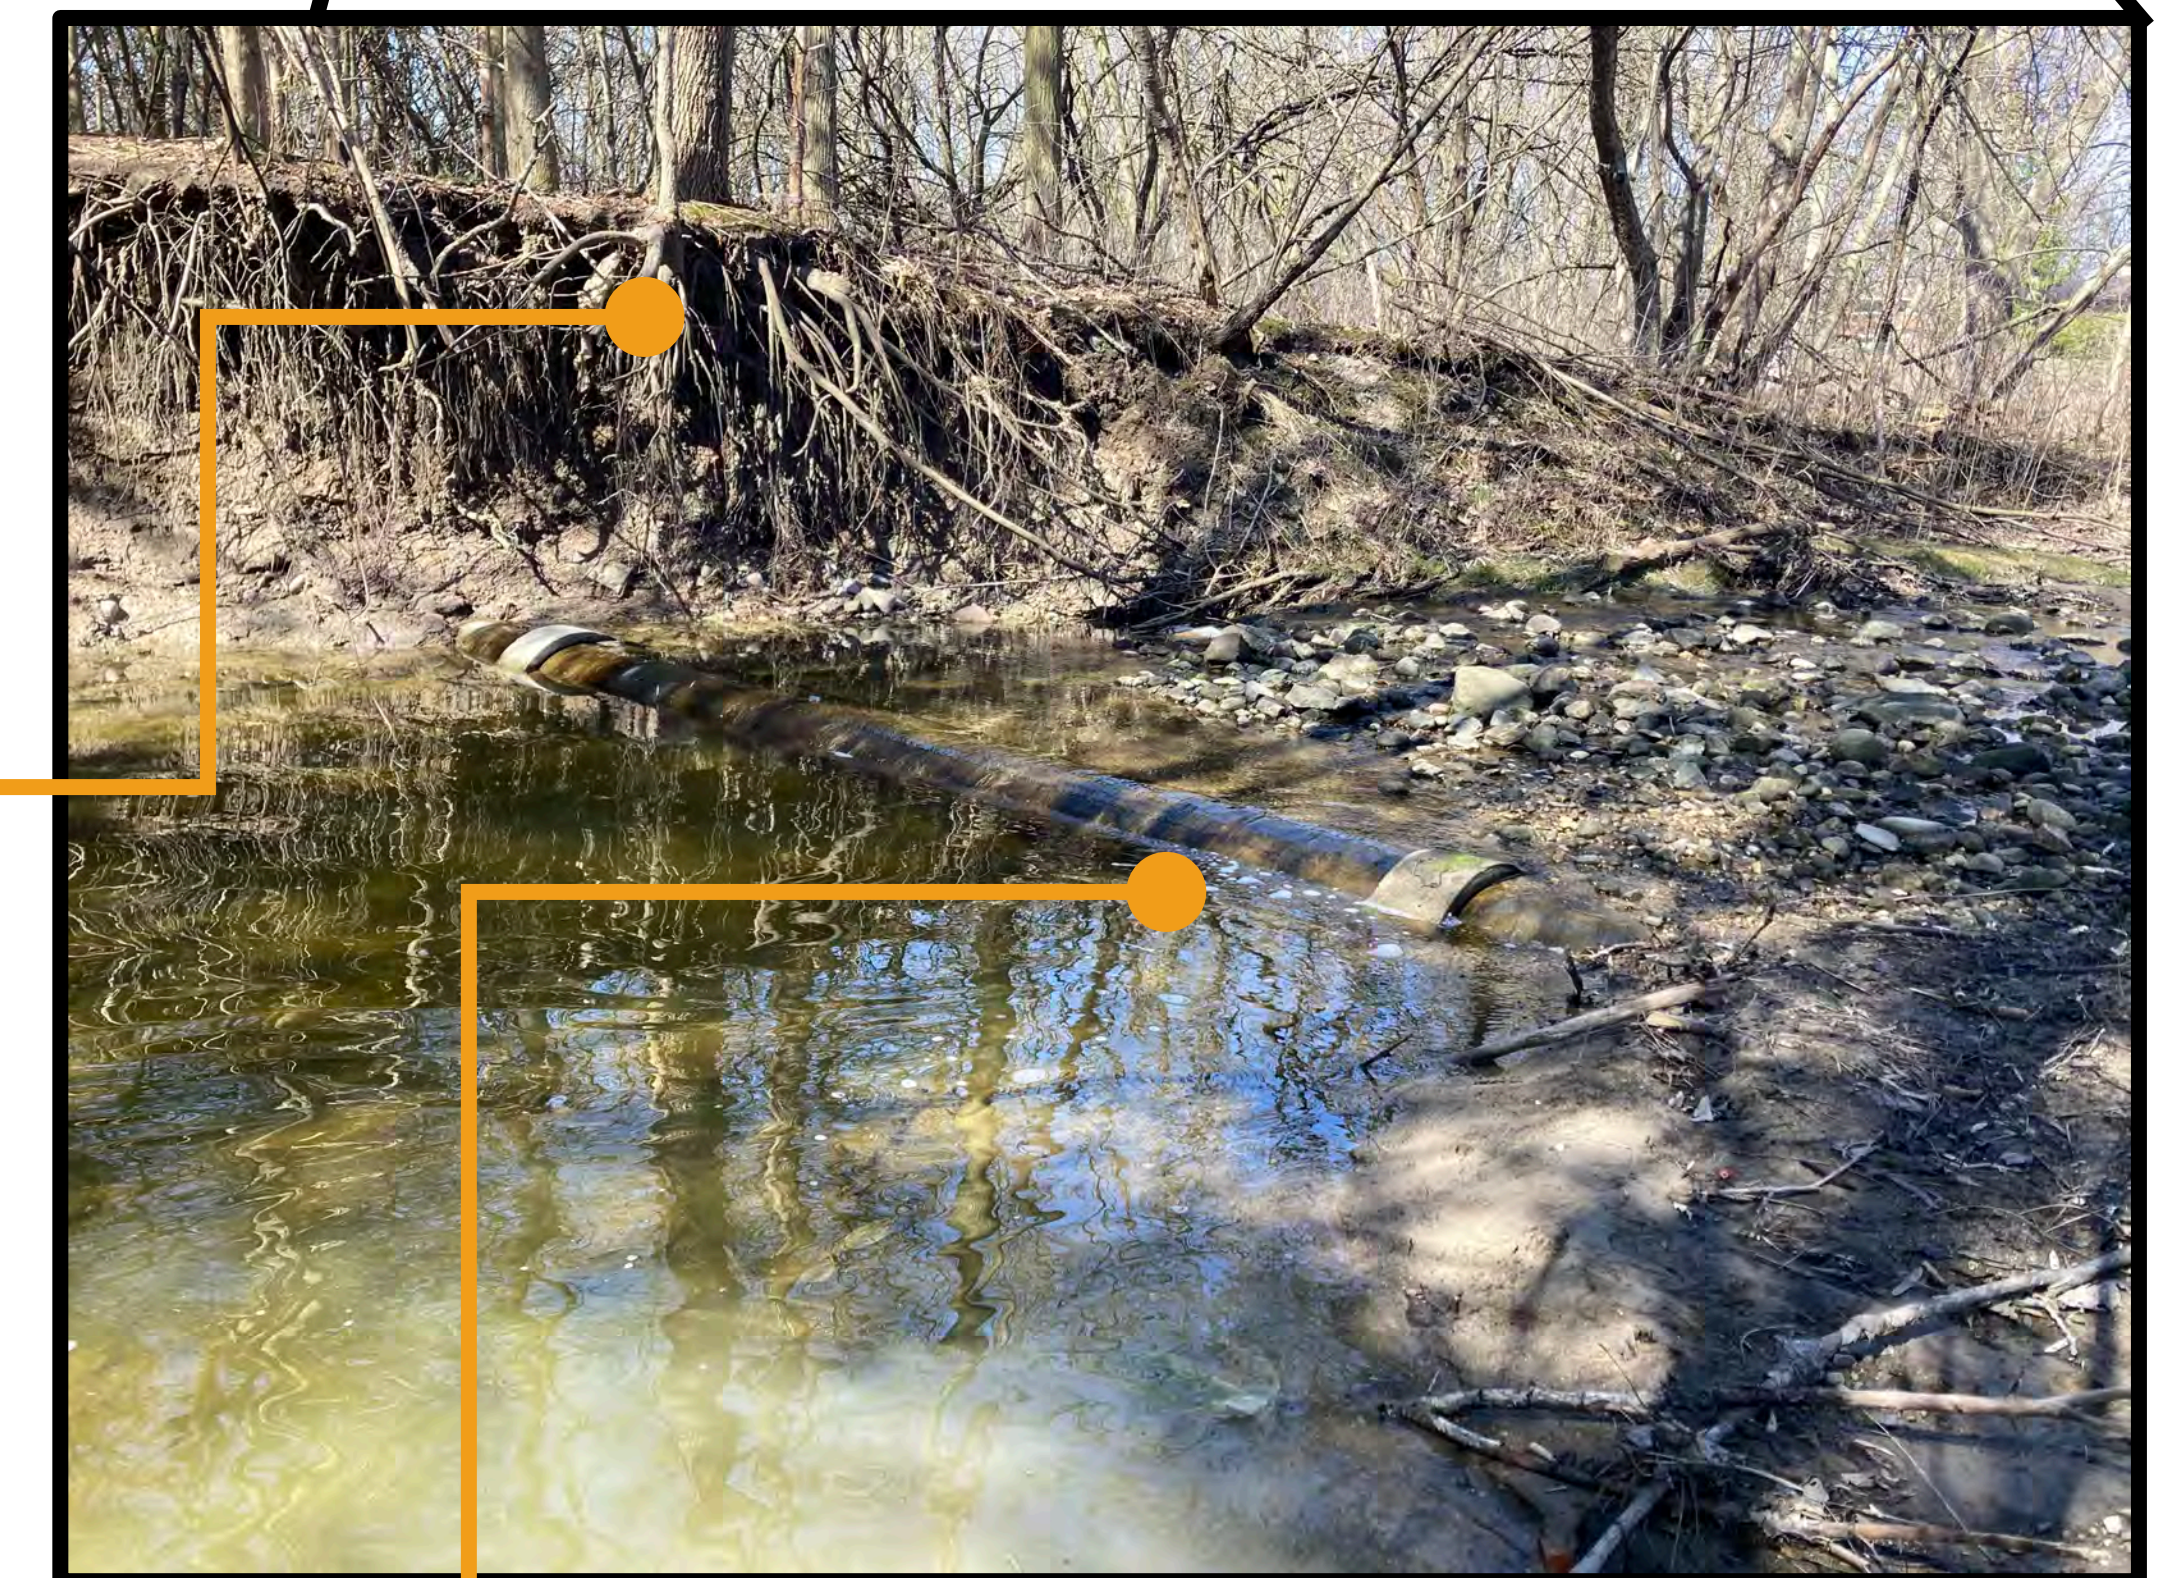
# Borden Creek at Concordia Park: Restoring Nature

- Borden Creek works within the park are only anticipated to impact small areas of natural habitat
  - Spot repair banks with coir matting and native seed
  - Plant native trees and shrubs where space permits
  - Potential for additional tree plantings within mowed lawn areas

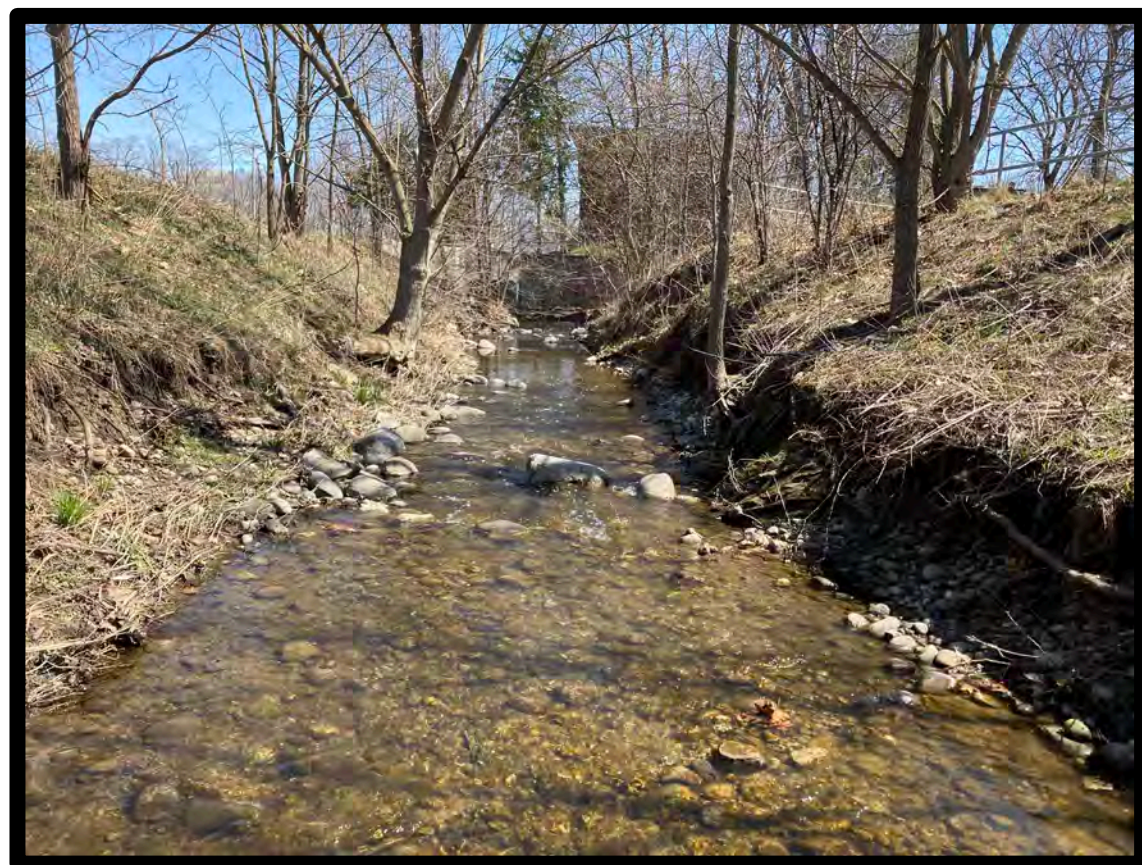
Bank Erosion

| Design Element | Final Design Concept |
|---|---|
| Natural Channel Design | Use natural channel design when possible. Add rock to protect banks near infrastructure. Create floodplain in Concordia Park to enhance local habitat. |

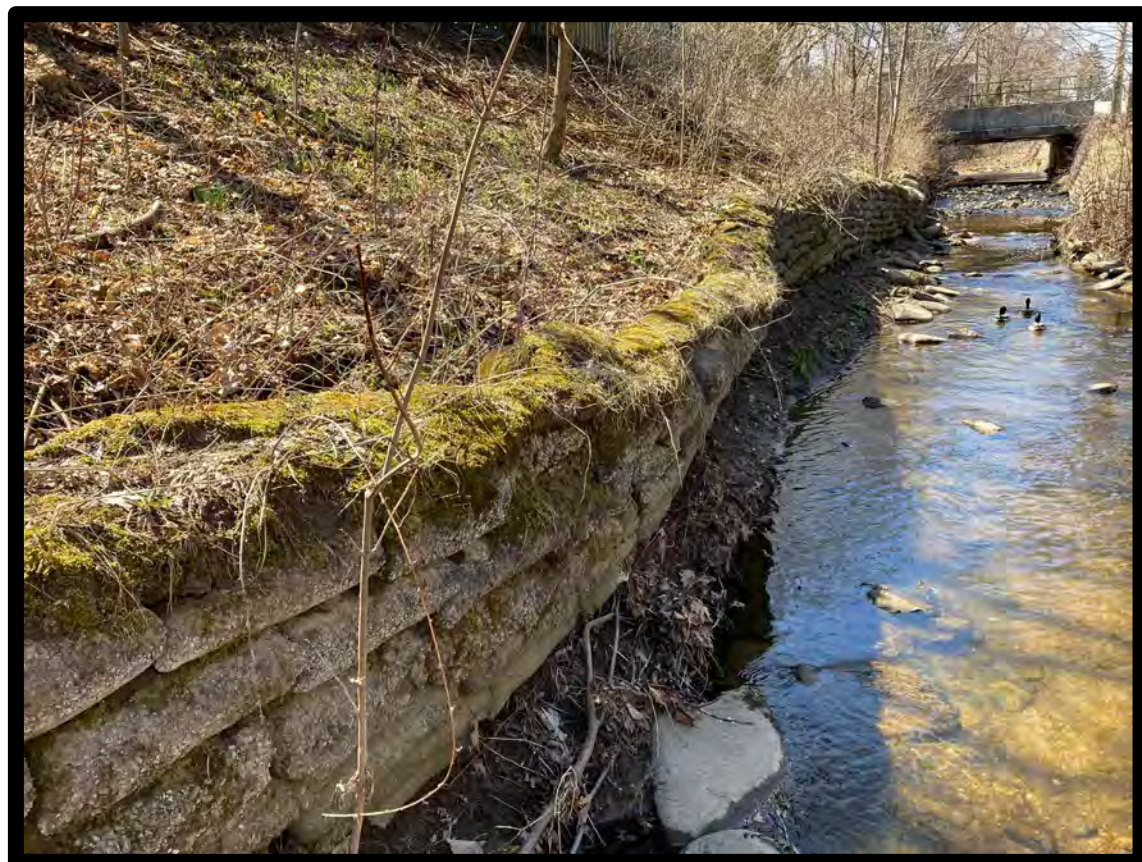
Slumping Retaining Wall

| Design Element | Final Design Concept |
|---|---|
| Infrastructure Protection | Remove existing “sack” concrete wall, replace with armourstone to protect Greenbrook Drive |

- Retaining wall to be replaced by armourstone and extended along the northern end to enhance protection of Greenbrook Drive.

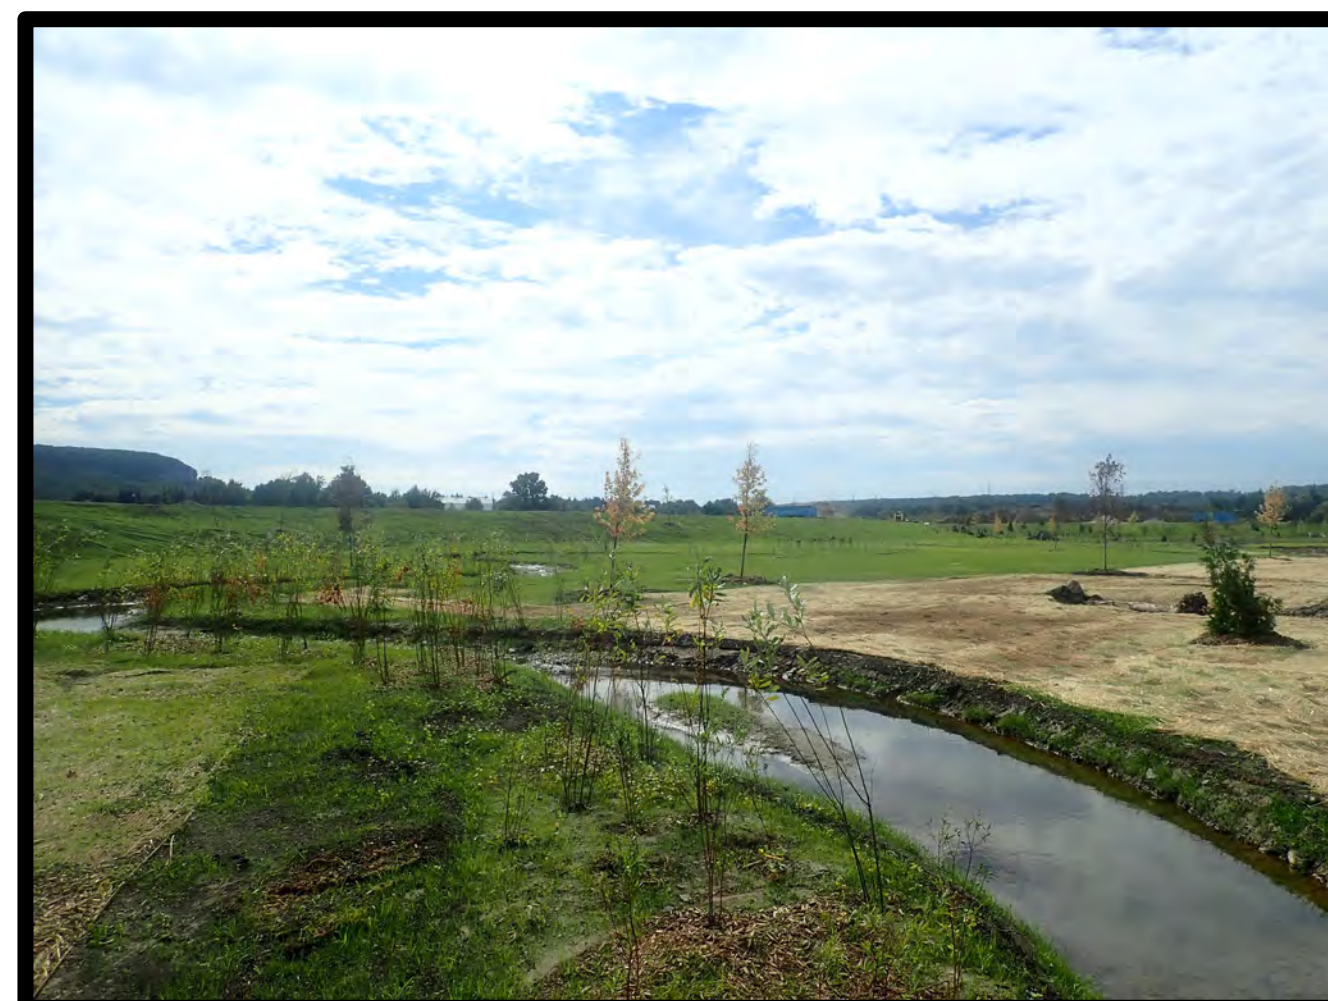
## Natural Channel Design:

- Create a natural profile.
- Widen existing floodplain and include native species.
- Reduce erosion, and improve water quality, aquatic habitat, and surface water temperature.

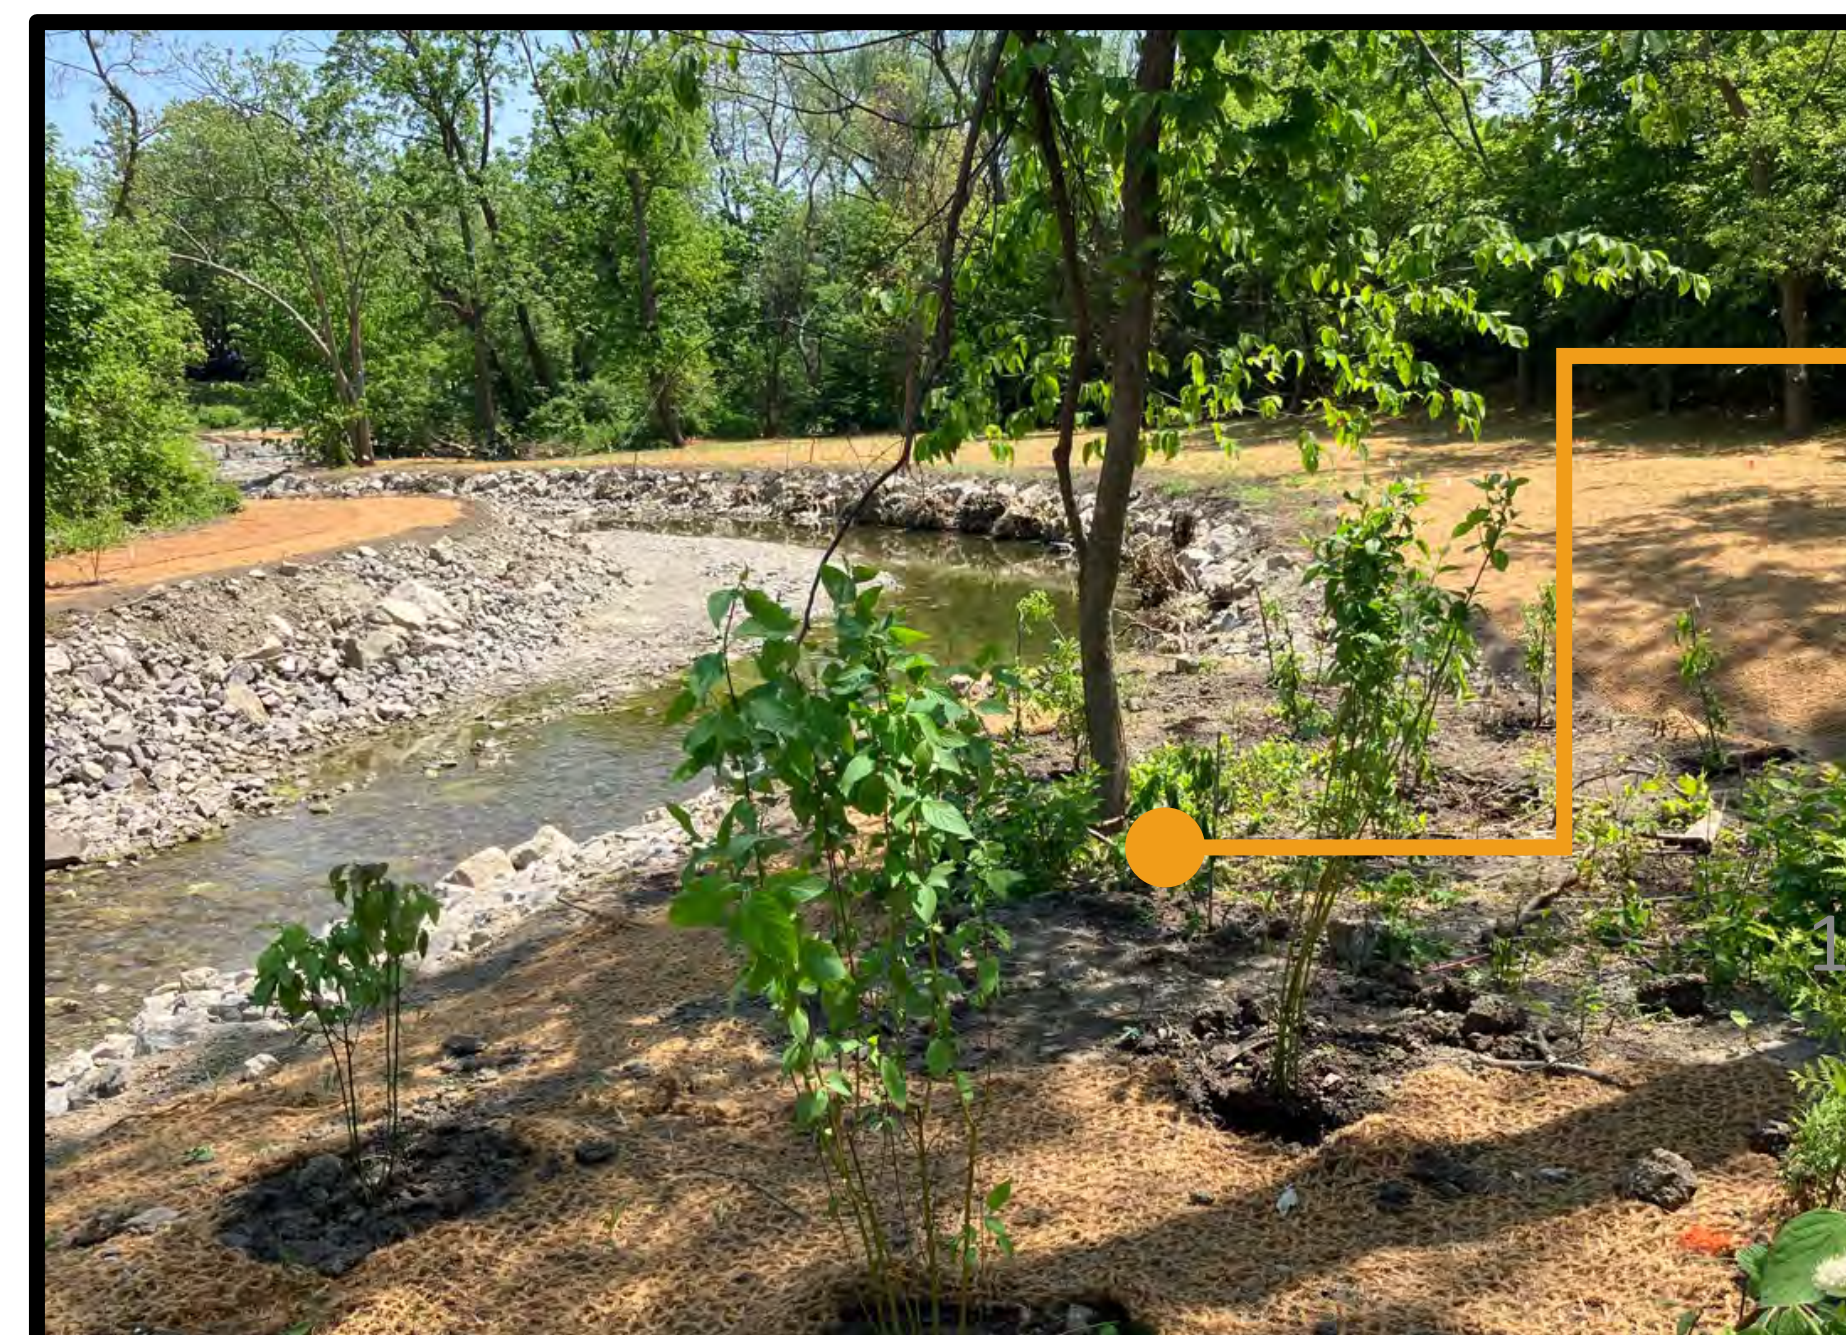
## Tree Removal and Plantings:

- Any tree required to be removed to complete the proposed work will be replaced in line with the City of Kitchener guidelines.
