# Restoring Local Creeks: Voisin Creek and Borden Creek in Concordia Park

May 22, 2024, from 5:00 to 8:00 p.m.

# Project Background

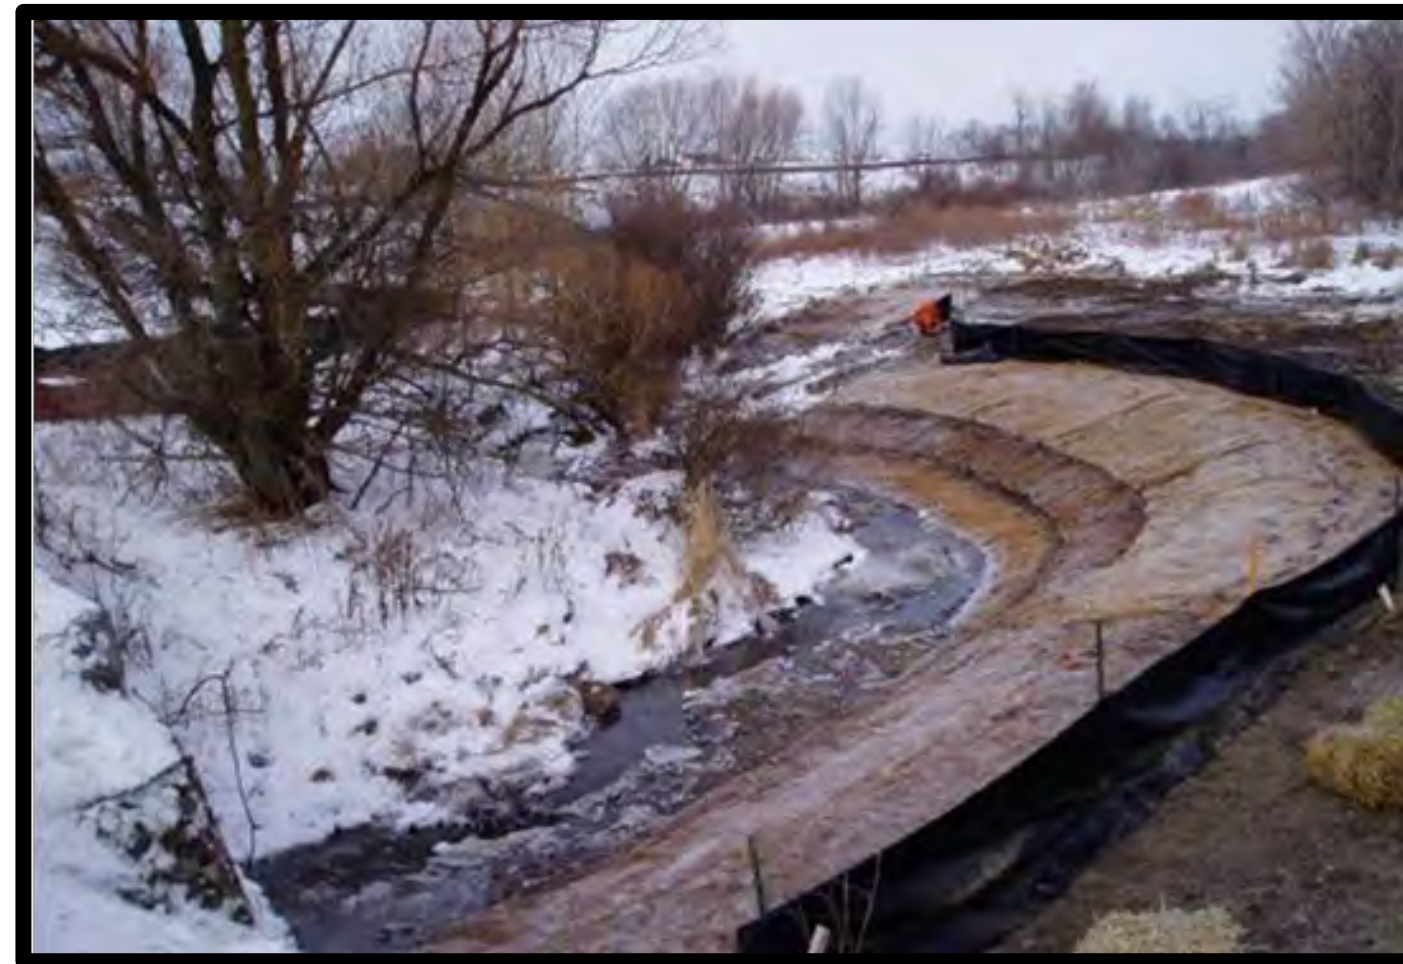
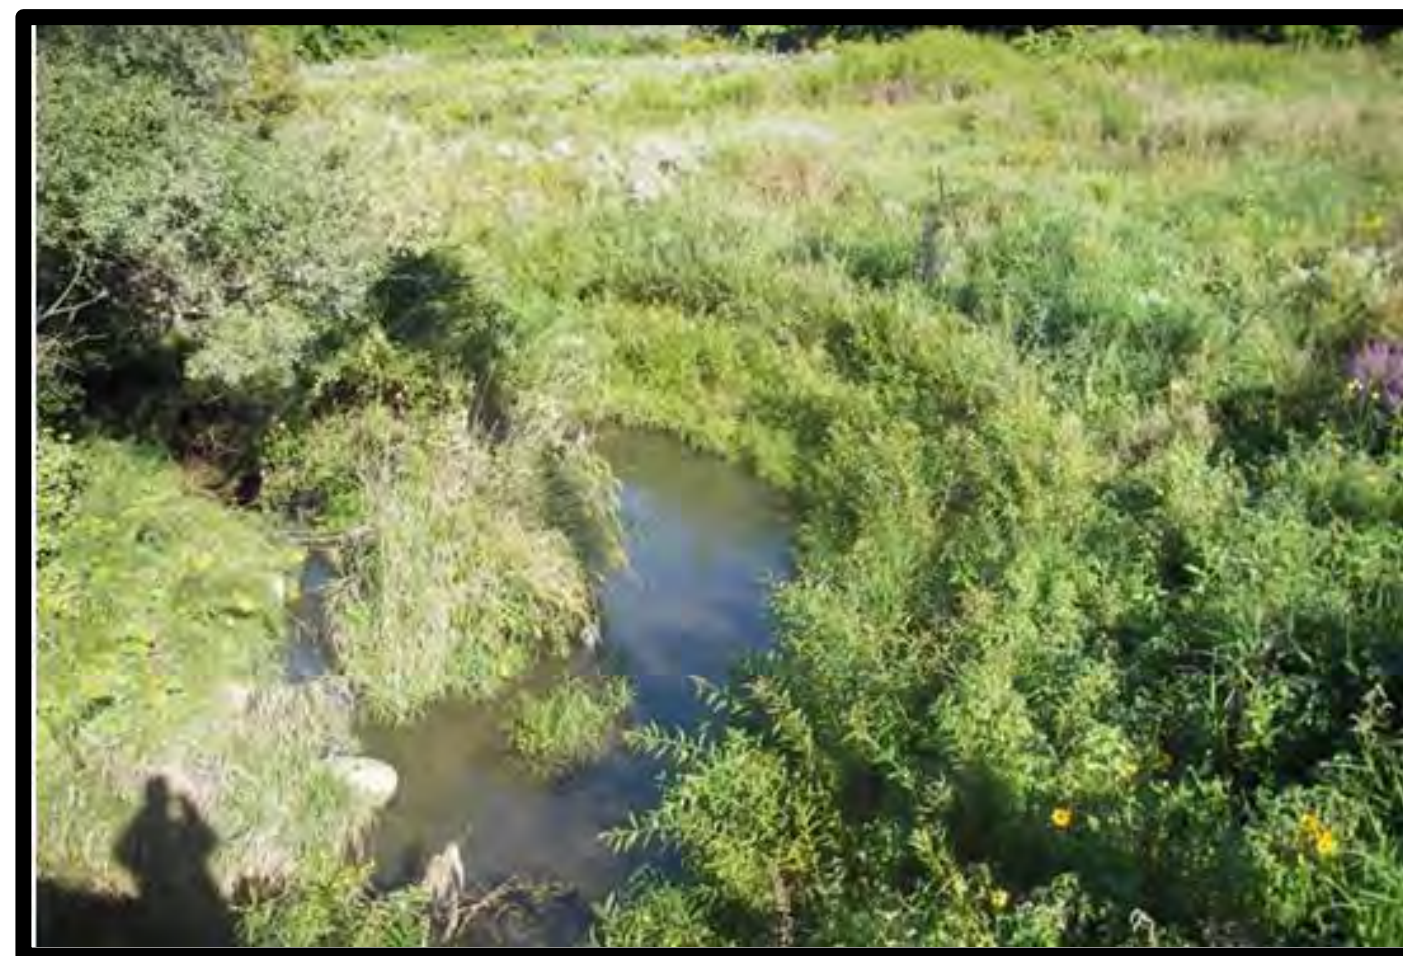
# Voisin Creek at Greenbrook Drive: Restoring Nature

## Riparian and Brush Layer Vegetation:

- Biodegradable coconut fiber matting (coir) used to stabilize slopes while vegetation grows
- Woody vegetation (trees and shrubs) planted in and around coir are allowed to root and mature
- Within 1 to 2 years, native species begin to grow and further stabilize the ground

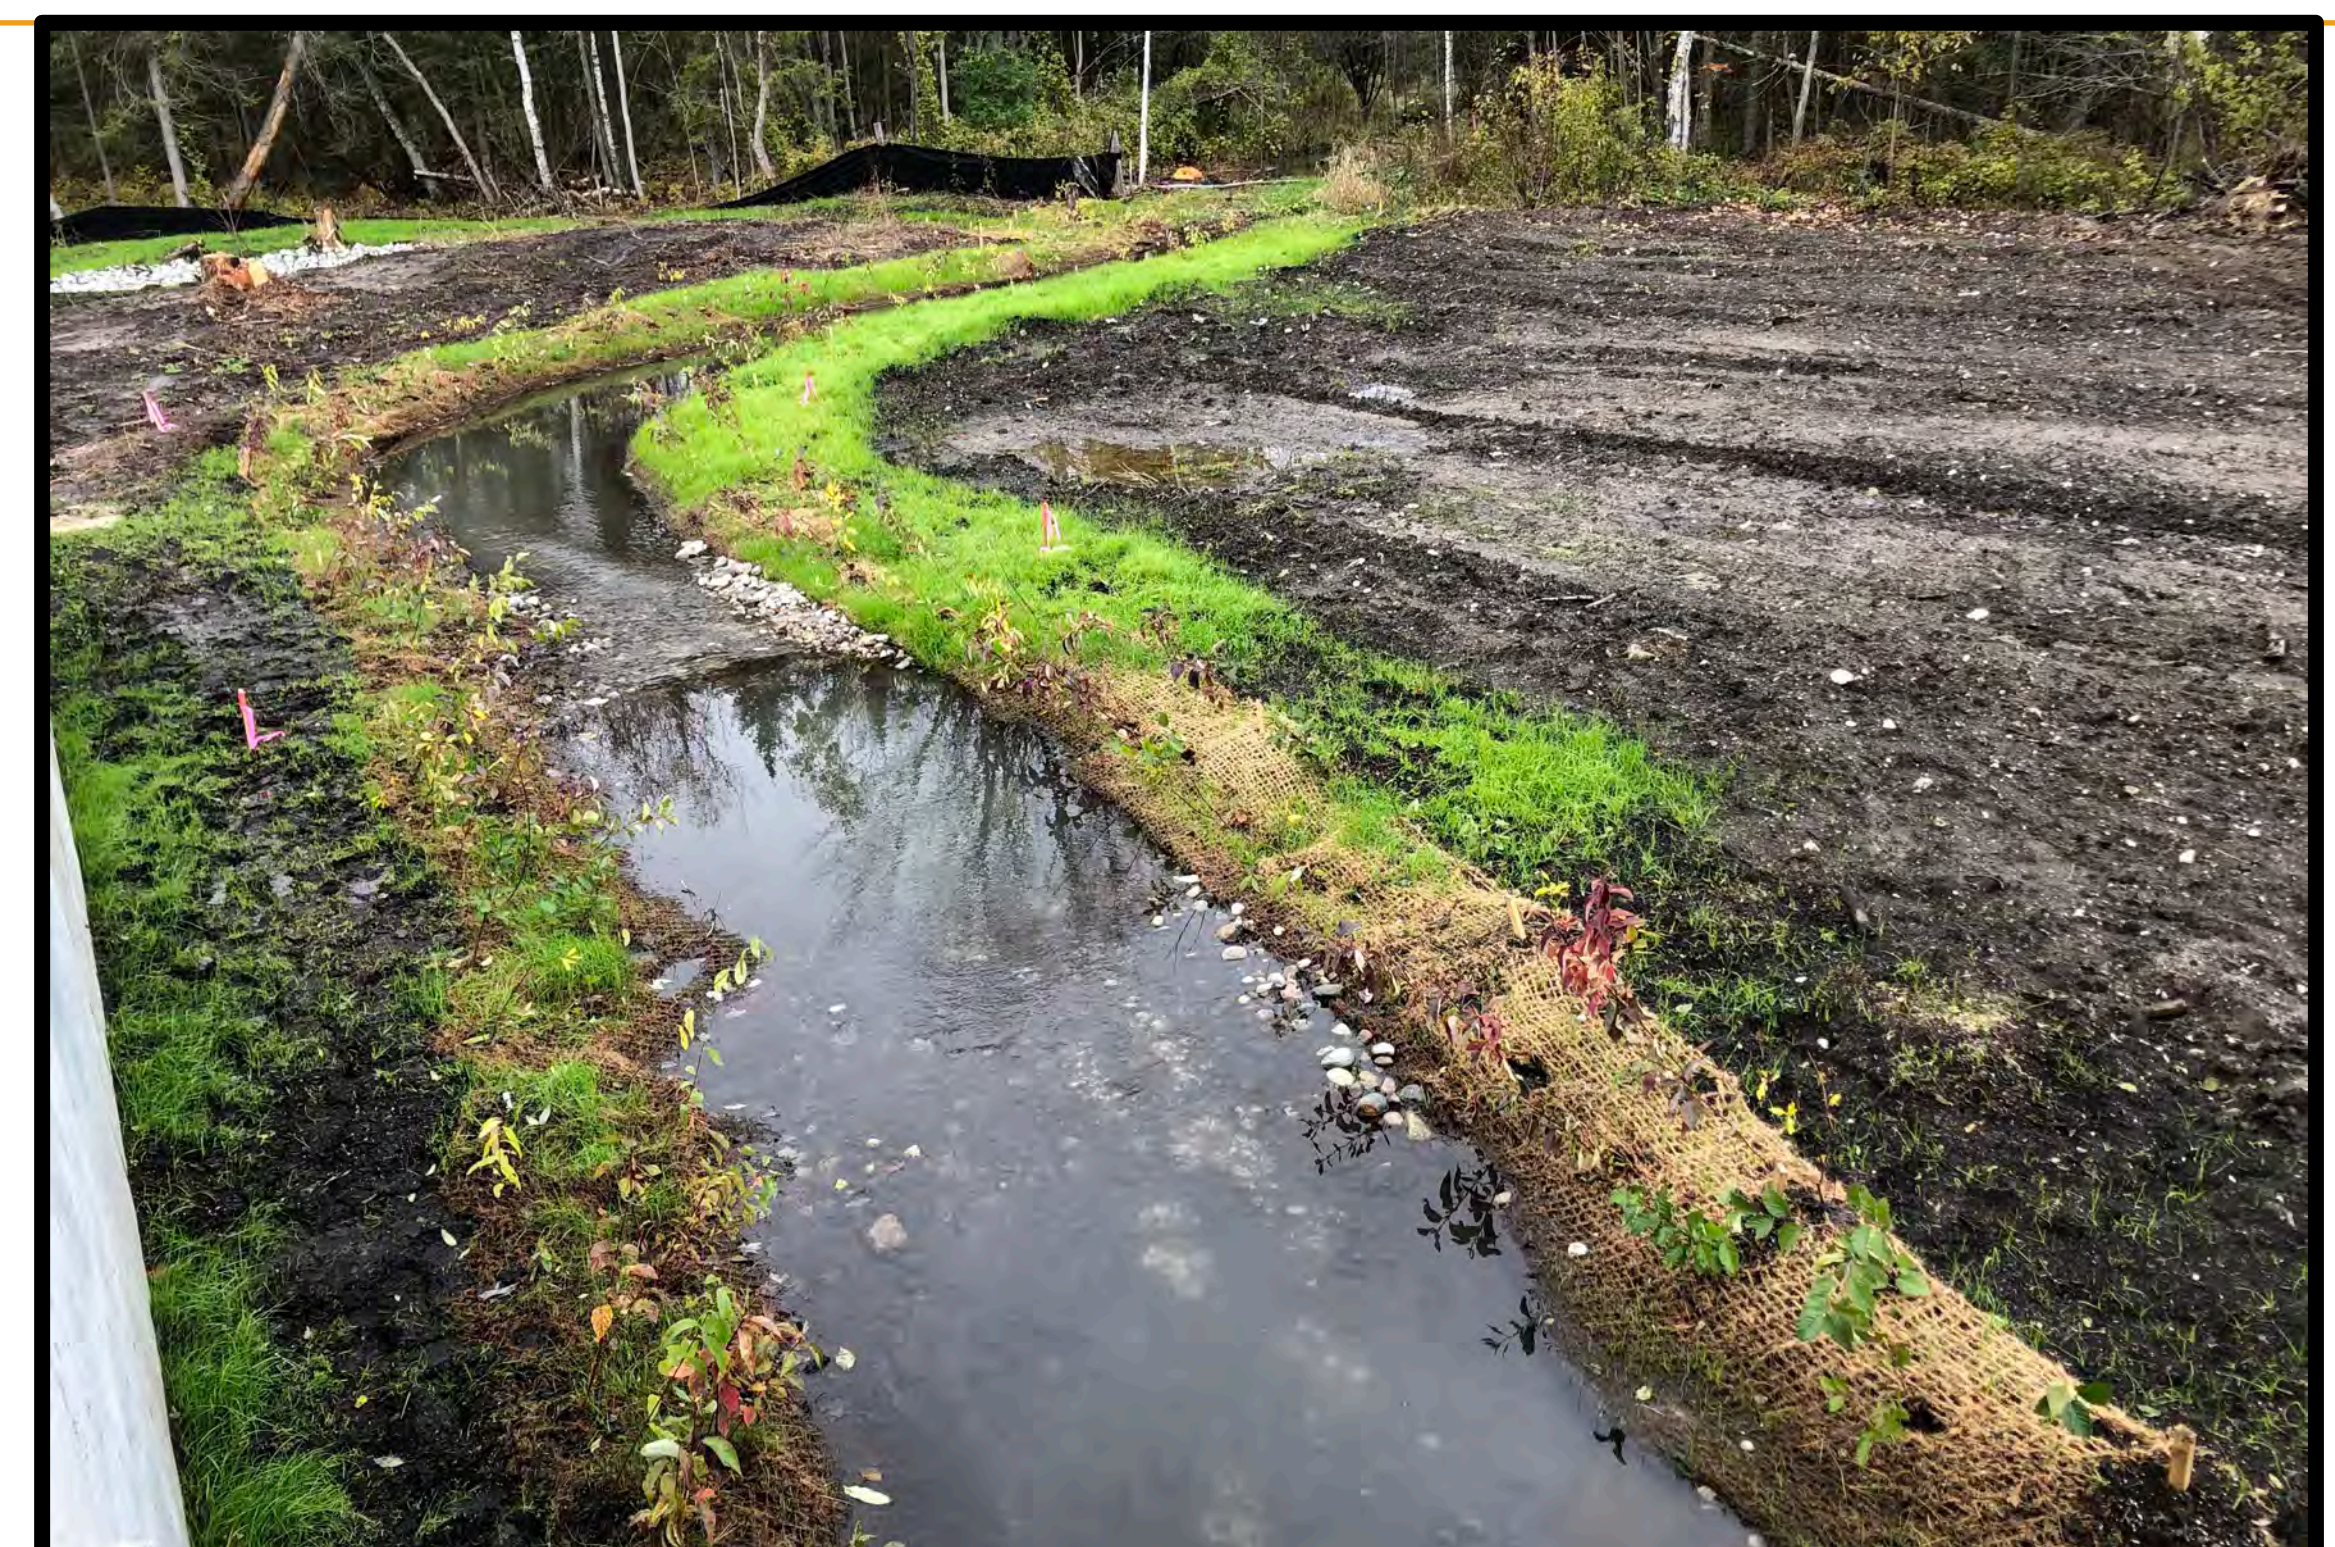
## Targeted Planting Plans

- Different species are used for lower, wetter areas near Voisin Creek (blue) and upper, drier areas further away from the water.
