# PHASE I ENVIRONMENTAL SITE ASSESSMENT 51, 55 AND 57 HAWKESVILLE ROAD, ST. JACOBS, ON

Prepared for: Polocorp Inc.

Prepared by: Premier Environmental Services Inc.

Premier Project Number: 623088.CE

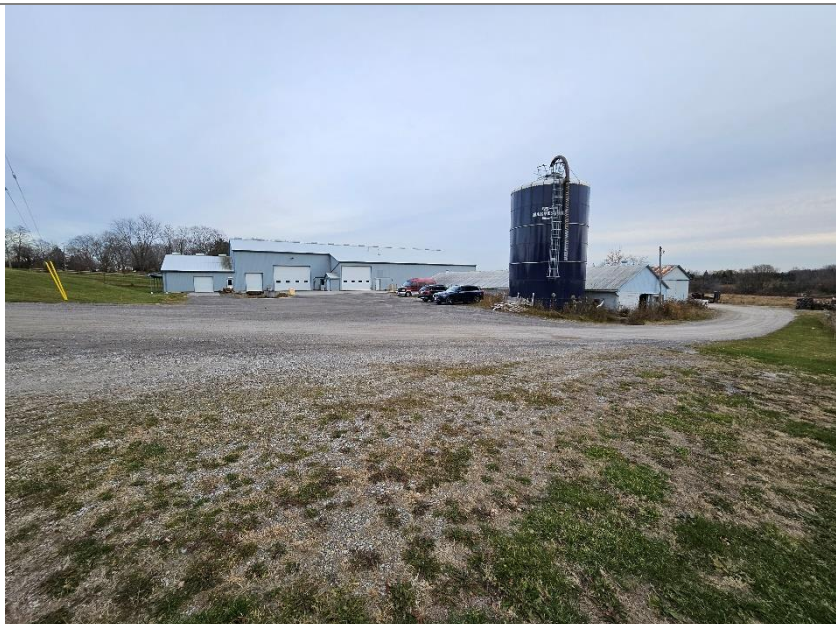
| <b>Description:</b><br><br>The on-Site buildings in the north-central portion of the property. | |

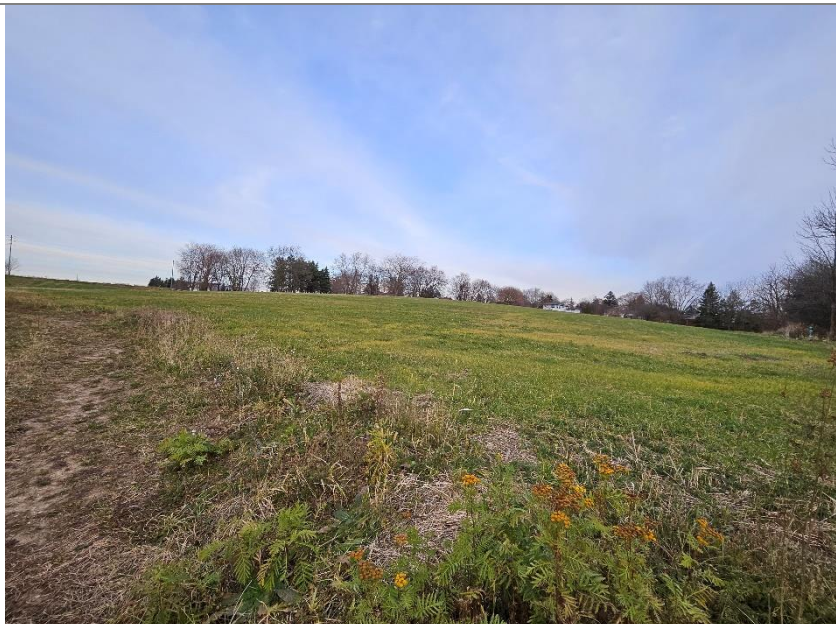
| 3 | 20-Nov-23 | |

| The central portion of the Site. Single-family detached dwellings are visible to the northeast and east. | | |

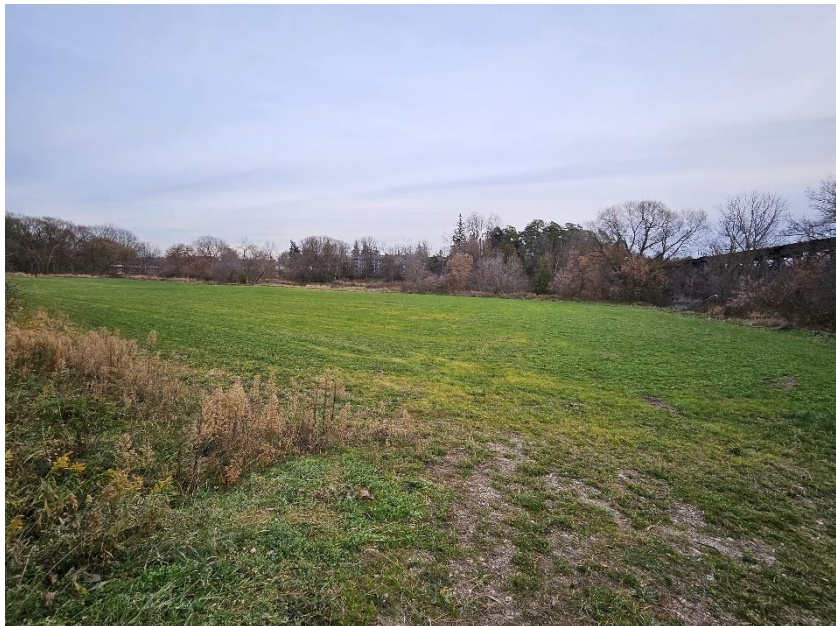
| <b>Photo No.</b><br>4 | <b>Date:</b><br>20-Nov-23 | |

| <b>Description:</b><br><br>The south portion of the Site located within a floodplain. | | |

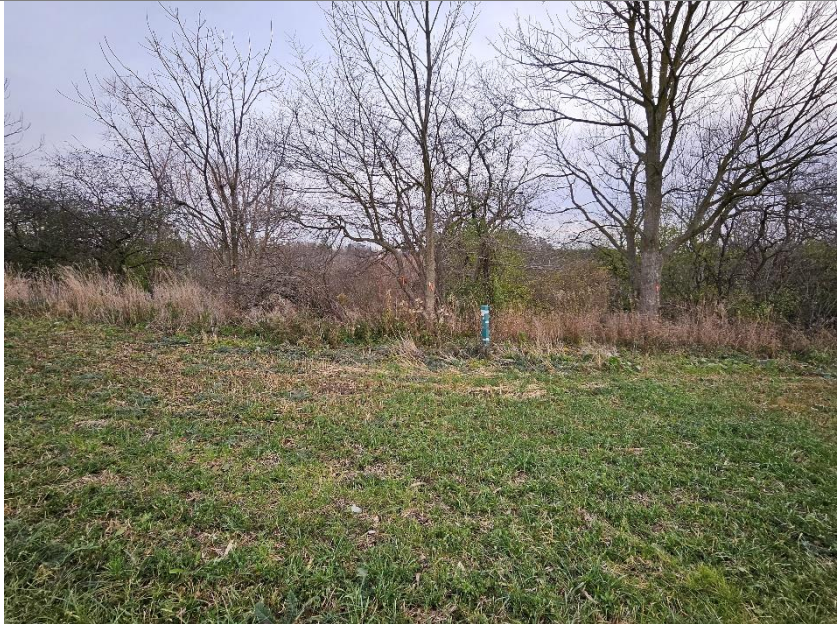
| Photo No. | Date: | |

| Photo No. | Date: | |
|---|---|---|
| Monitoring well located in the central portion of the Site. This well was reportedly installed as part of a hydrogeological study in 2021. | | |

One (1) monitoring well was observed in the central portion of the subject property. The presence of this well is not considered to represent a potential environmental concern as it was reportedly installed as part of a hydrogeological study in 2021.

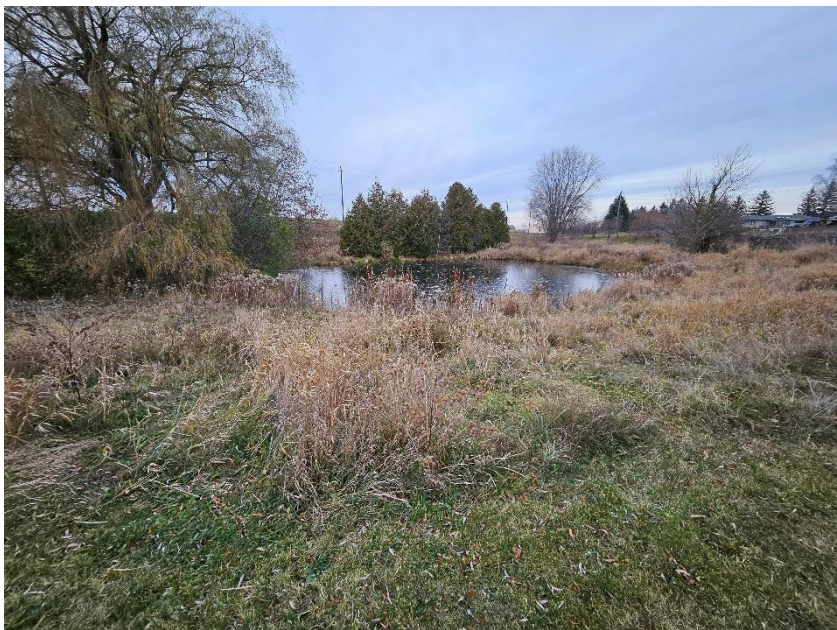
| Photo No. | Date: | |
|---|---|---|
| The pond located in the northwest portion of the Site. | | |

No lagoons or holding ponds were observed by Premier during the Site reconnaissance. A pond which was likely used for agricultural purposes is present in the northwest portion of the property.

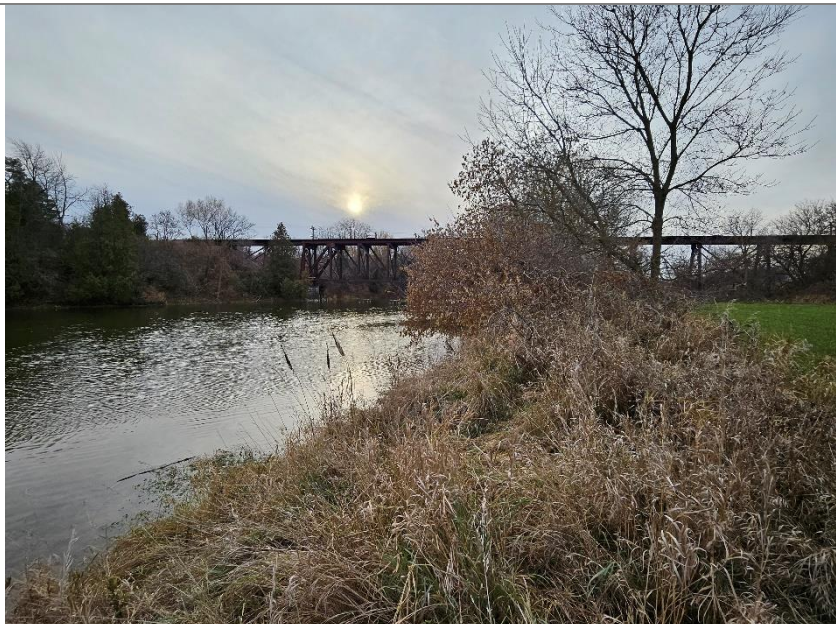
| <b>Description:</b><br><br>The south property boundary and Conestogo River. | |

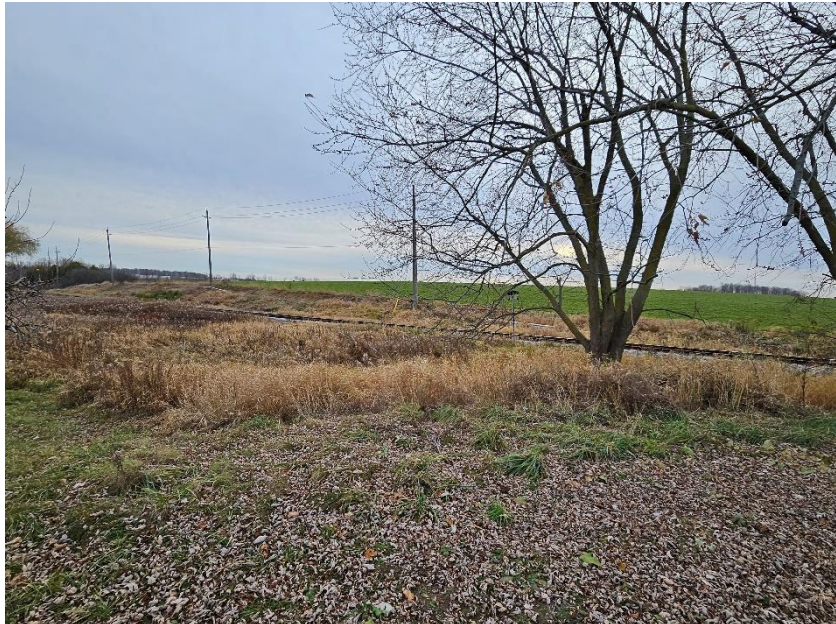
| <b>Photo No.</b><br>10 | <b>Date:</b><br>20-Nov-23 |

| <b>Description:</b><br><br>The rail line and agricultural property west of the Site. | |

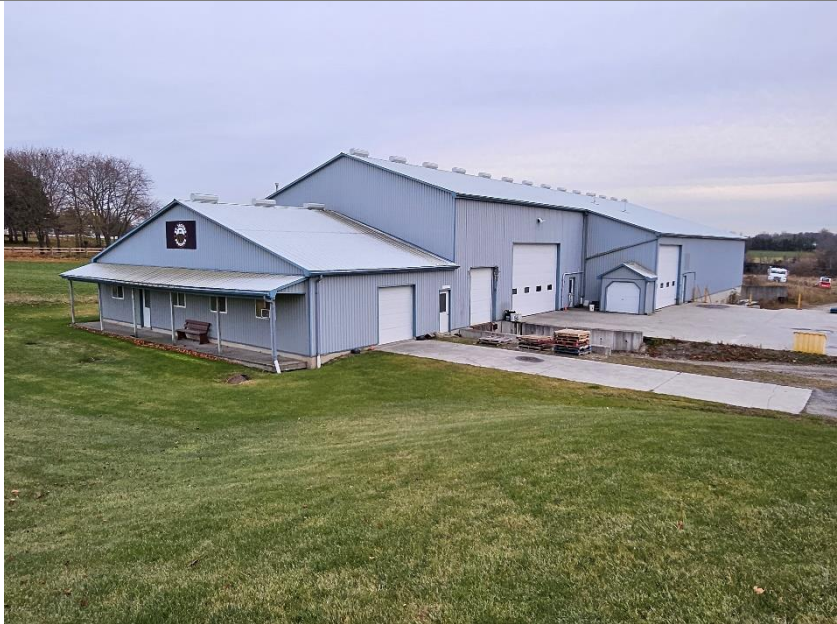
| Photo No. | Date: | |
|---|---|---|
| Storage Building A. | | |

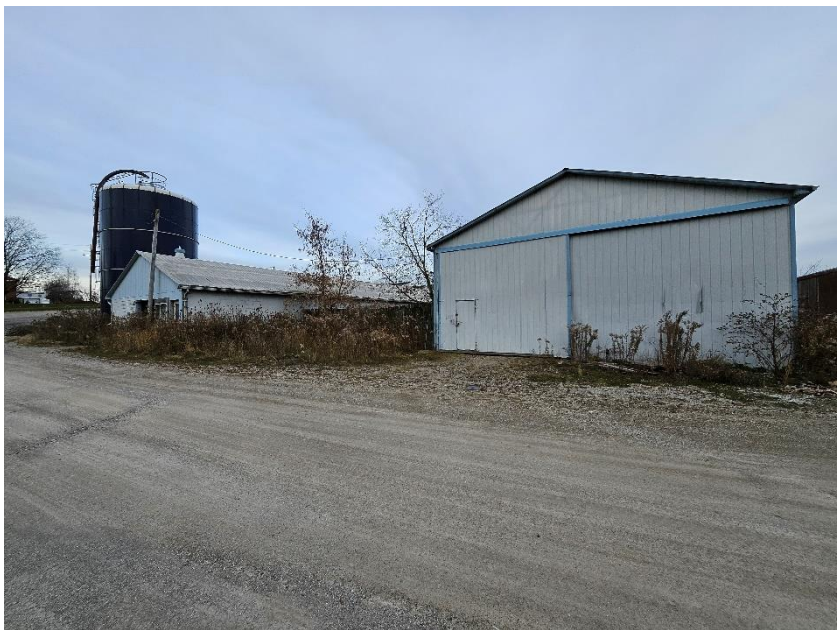
| Photo No. | Date: | |
|---|---|---|
| 12 | 20-Nov-23 | |

| Photo No. | Date: | |
|---|---|---|
| The silo, barn, and Storage Building B. | | |

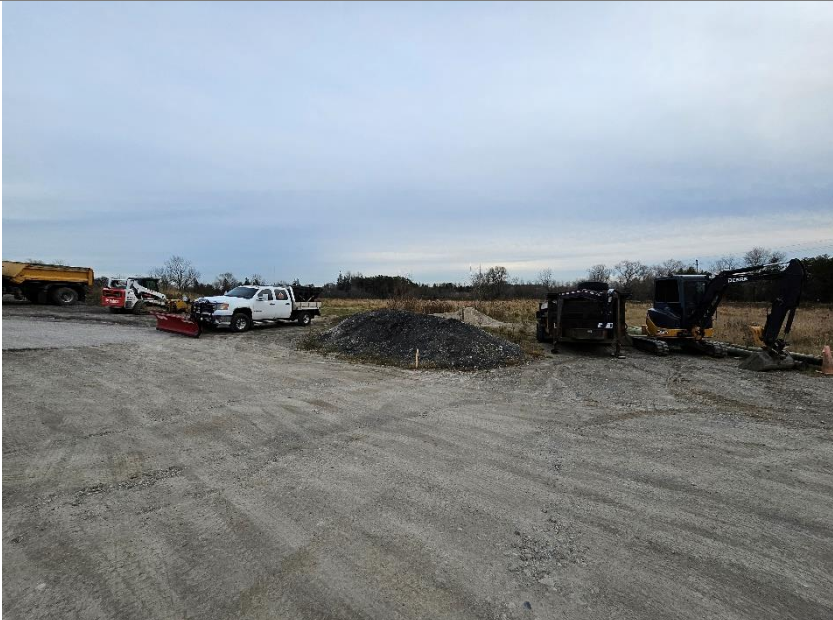
| <b>Description:</b><br><br>The asphalt and sand piles south of the on-Site buildings. | |

The exterior areas of the subject property are generally covered with cropland, grass, and mature trees. Piles of asphalt and sand were observed to the south of the on-Site buildings and are not considered significant since they are leftover from previous Site grading work. An pond is also located in the northwest portion of the property.

A sand pile was observed south of the on-Site buildings and is reportedly clean fill used to grade the driveway and parking areas. Fill materials have been used in the construction of the on-Site buildings, driveways, and parking areas but these are not considered significant.

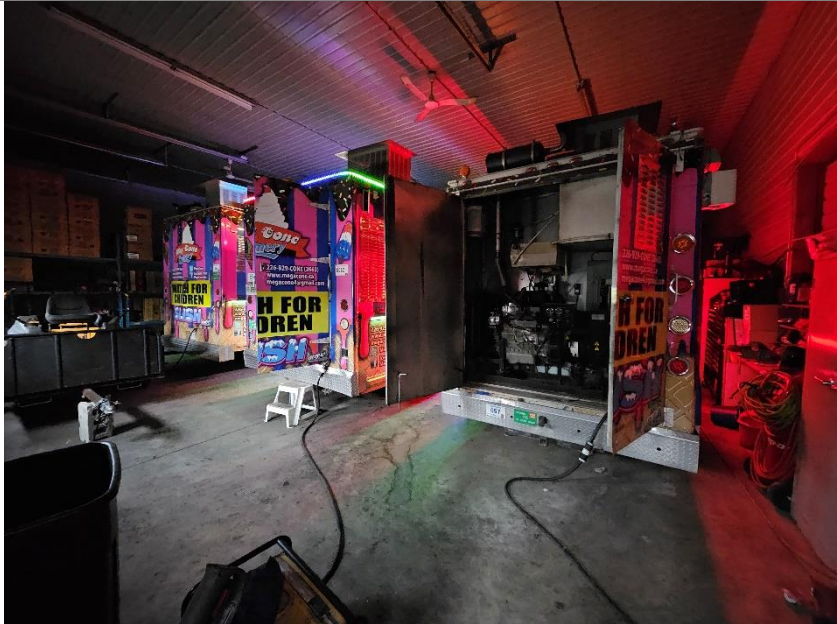
| Photo No. | Date: | |
|---|---|---|
| Vehicle bay in the Mega Cone Creamery unit. | | |

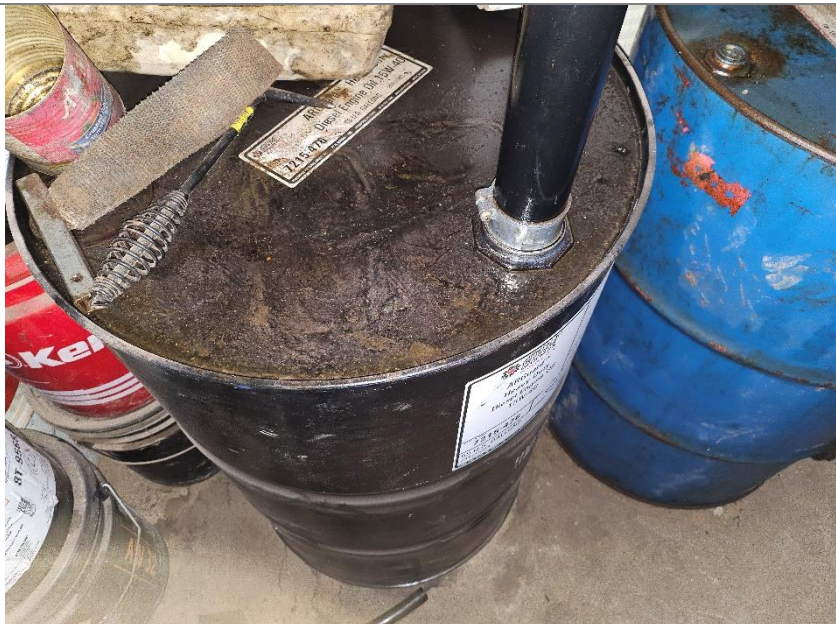
| <b>Description:</b><br>Oil drums in the TAS Trucking unit. | | |

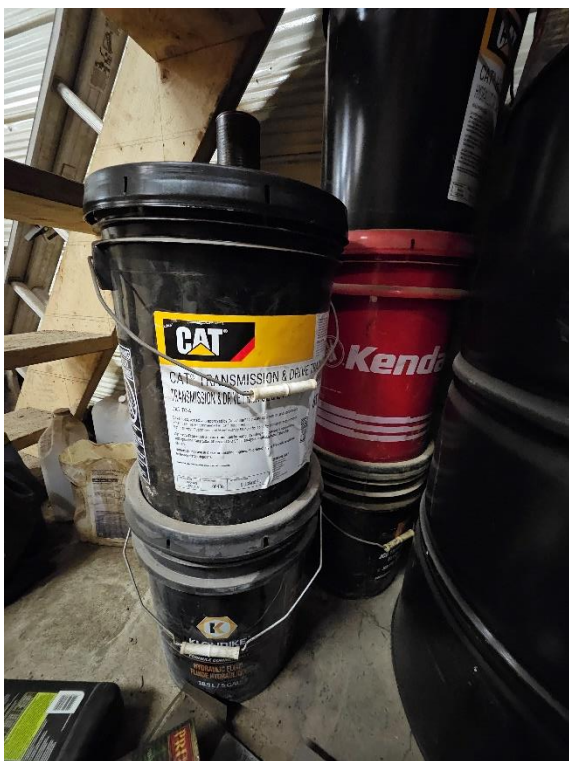
| <b>Description:</b><br>Pails containing oil and hydraulic fluid within the TAS Trucking unit. | |

All chemicals are stored in manufacturer-supplied containers. Minor staining was observed on the concrete floor adjacent the stored chemicals within the TAS Trucking unit. Since no cracks or drains were observed in the vicinity of the staining, it is not considered significant.

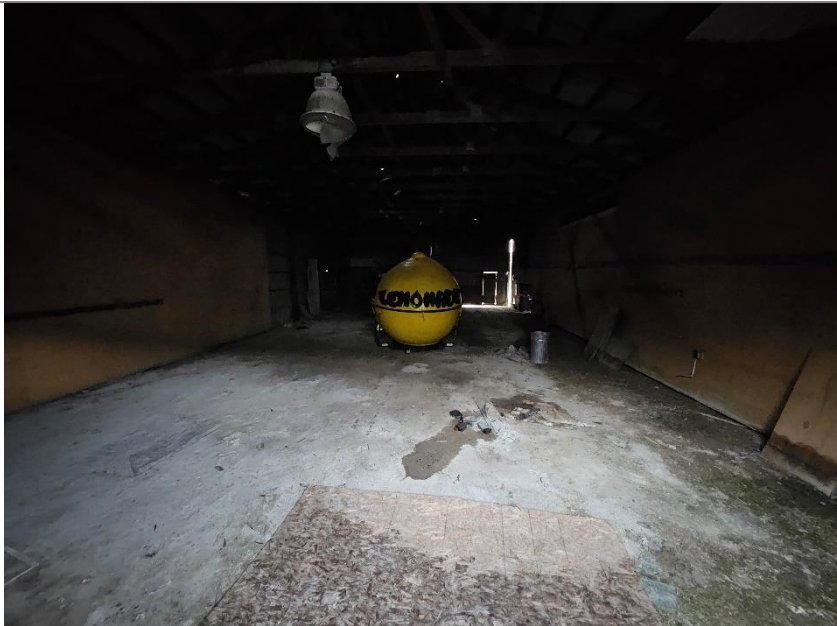
| Photo No. | Date: | |
|---|---|---|
| Interior of Storage Building B. | | |

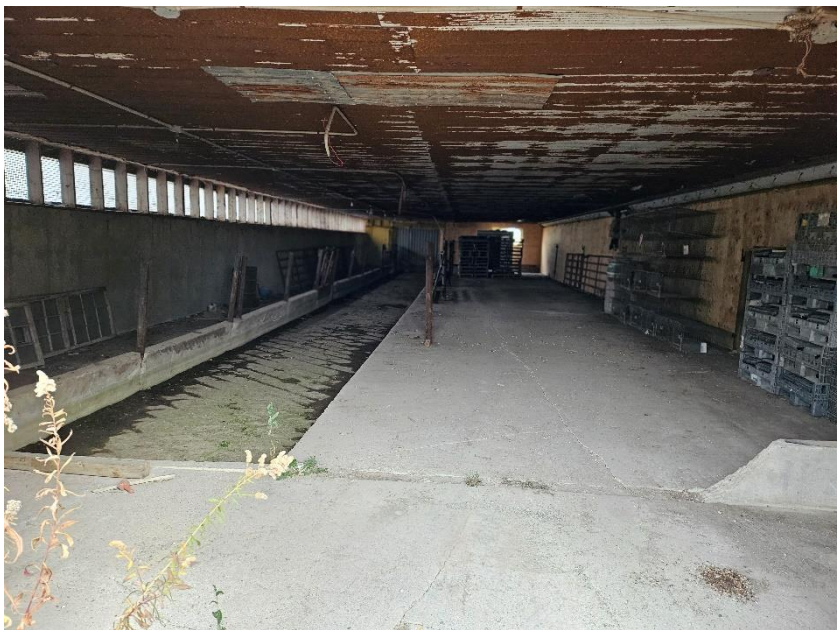
| Photo No. | Date: | |
|---|---|---|
| 20 | 20-Nov-23 | |

| Photo No. | Date: | |
|---|---|---|
| Interior of the barn. | | |
