West Montrose Covered Bridge

Preservation Plan

Submitted to The Regional Municipality of Waterloo
by IBI Group

April 2014

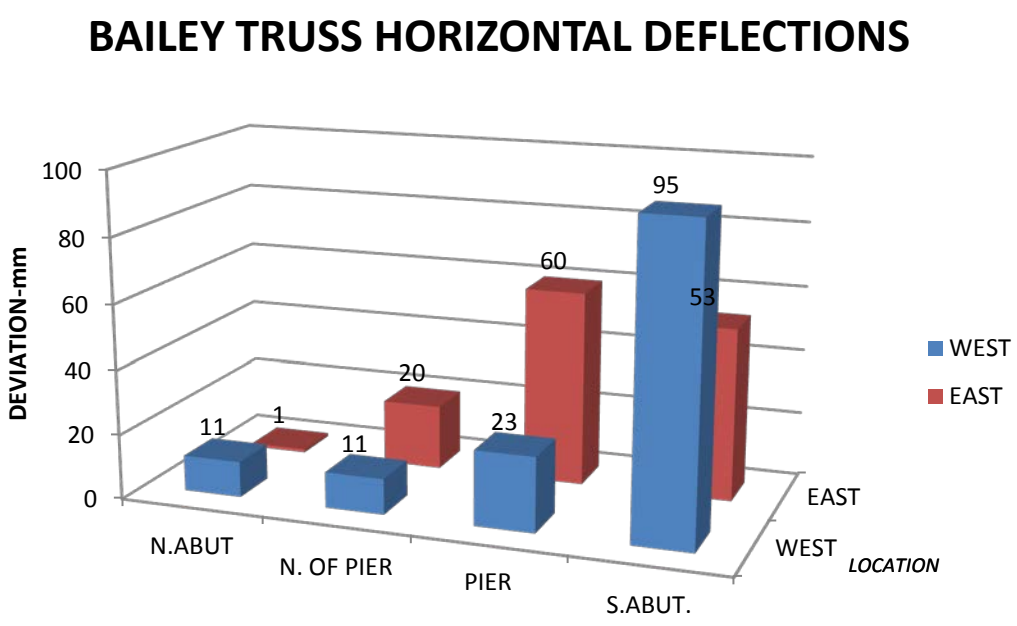
Figure 1 Horizontal Deflection of Bailey Truss's Top Chord

In addition any horizontal deflection of Bailey truss top chord with respect to the bottom chord (i.e. out of plumb of the truss) was measured at these locations. The results varied from a low value of 1 mm to a high 60 mm (Fig.1). Almost all showed the top chord movement to be in the easterly direction.

- Bailey trusses are generally in good condition; however, high out of plane deviation toward east especially (up to 95 mm for South west top chord as mentioned earlier) affects the general stability of truss and should be addressed in next maintenance work.

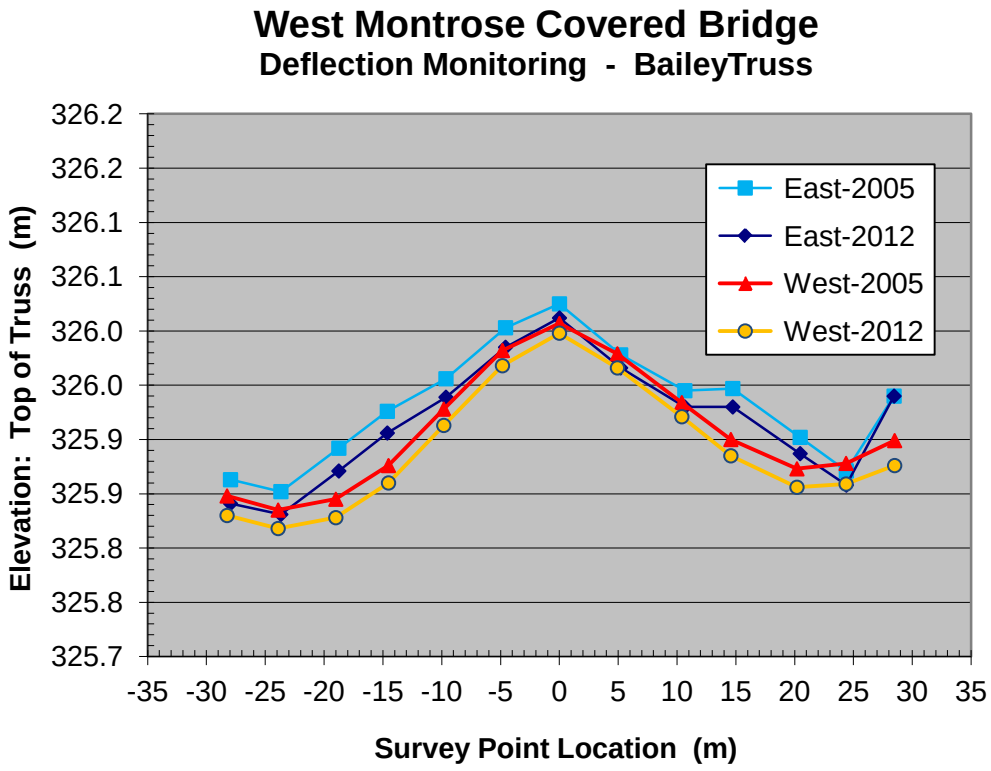
Figure 2 West and East Bailey Trusses Deflection in 2005 and 2012

A survey to measure vertical deflection of the Bailey truss along the spans was carried out in October 2012 and compared to a similar survey carried out in 2005. Deflection measurements indicate increased vertical deflection of the Bailey trusses in both the West and East trusses of less than 20 mm (Fig.2). This increase in vertical deflection is attributed to the transfer of additional load to the Bailey system from the timber truss systems (and minor measurement tolerance issues).

The vertical deflection curve of the West Bailey truss is uniform and considered reasonable. However discontinuities were noted in the deflection curve of the east Bailey truss. Therefore the east bailey was exposed at the apparent discontinuity and inspected for any pin/weld failure. No significant problems were detected in the Bailey truss assembly.

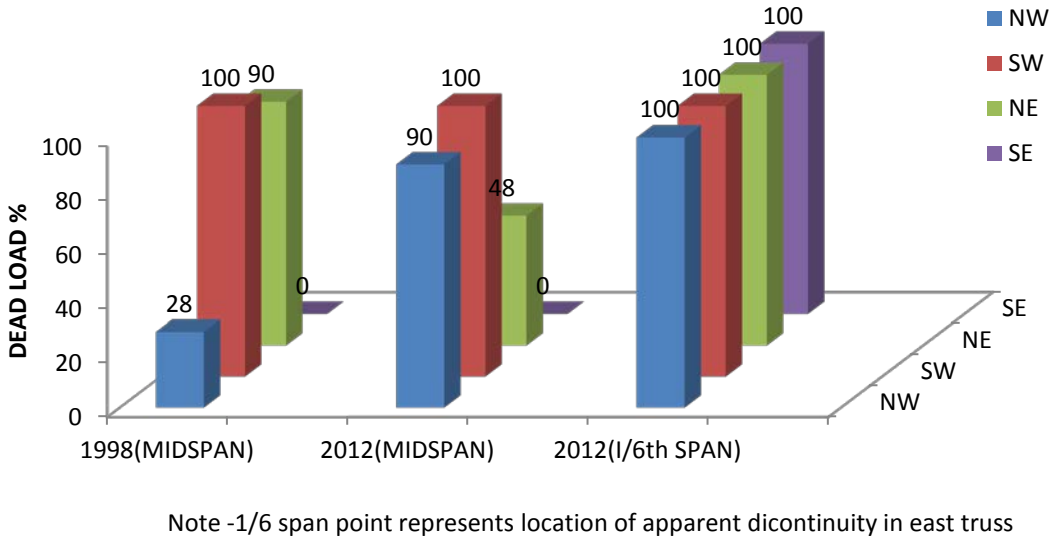
Figure. 3 Bailey Truss Dead Load Carrying Percentages 1998 and 2012

Based upon the theoretical deflection curves for the Bailey Trusses compared to observed vertical deflections it is concluded that the west Bailey Truss system is now carrying the total dead load of the structure with little contribution from the original west timber truss systems. The east load distribution is less distinct due to apparent anomalies in the deflection curves. Deflections should be monitored on a regular basis until the anomalies have been rationalised. The current observations were also compared with the assessments carried out in 1998. It is noted that overall deflections have increased, which is indicative of a load shedding from the timber trusses to the Bailey systems

This is shown diagrammatically in Figure 3.

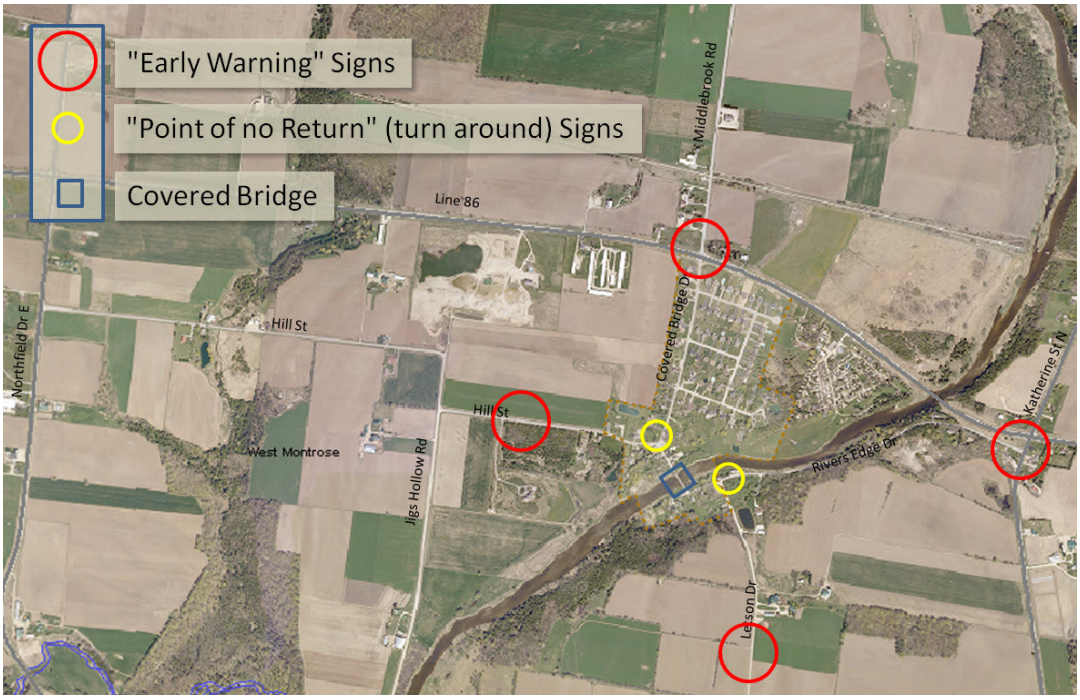
5.9 Signage and Operational Issues

The bridge operates as a single lane facility without significant incidents being noted. Traffic is self-managing with vehicles yielding to other vehicles and pedestrians. However there are operational constraints associated with the bridge including load restriction, vehicle restriction, and height restriction.

Although signage receives compliance by the majority of users as evidenced by reported observations, violations in all categories occur either by intent or ignorance.

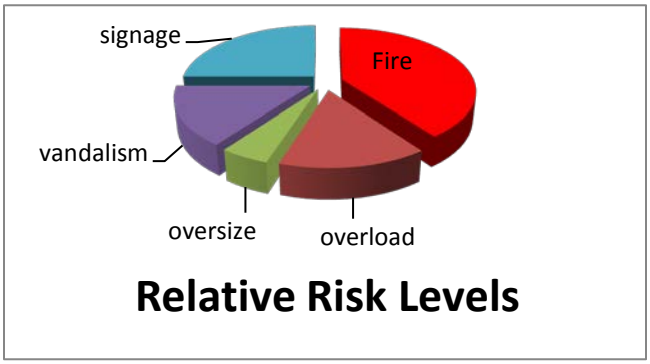
Currently fire is considered the highest risk with the highest potential for consequential loss followed by signage deficiencies, overloading, vandalism and finally oversize vehicles. The relative levels of risk and consequential loss are shown schematically above.
