# **Slope Stability Report**

## **Proposed Residential Development**

51-55 Hawkesville Road, St. Jacobs

January 23, 2025  
Project No. 2403070

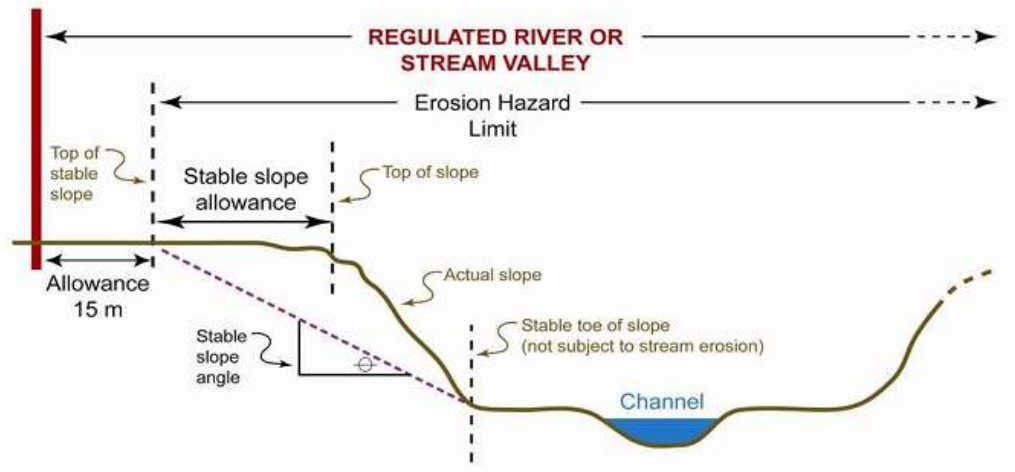
**Figure A – Riverine Erosion Hazard Schematic.** The 15 m Allowance is used to define the Regulated Area but GRCA Policy 8.2.8 permits a minimum 6 m allowance from the Erosion Hazard Limit for new multi-lot developments. (GRCA 2015)
