#### TREE PROTECTION FENCING

LESTER SUNVIEW  
DEVELOPMENT INC.

Table 1 - Existing Tree Inventory  
Sunview Street, City of Waterloo, Ontario  
Project #: 133419  
Data observed on August 12, 2022.

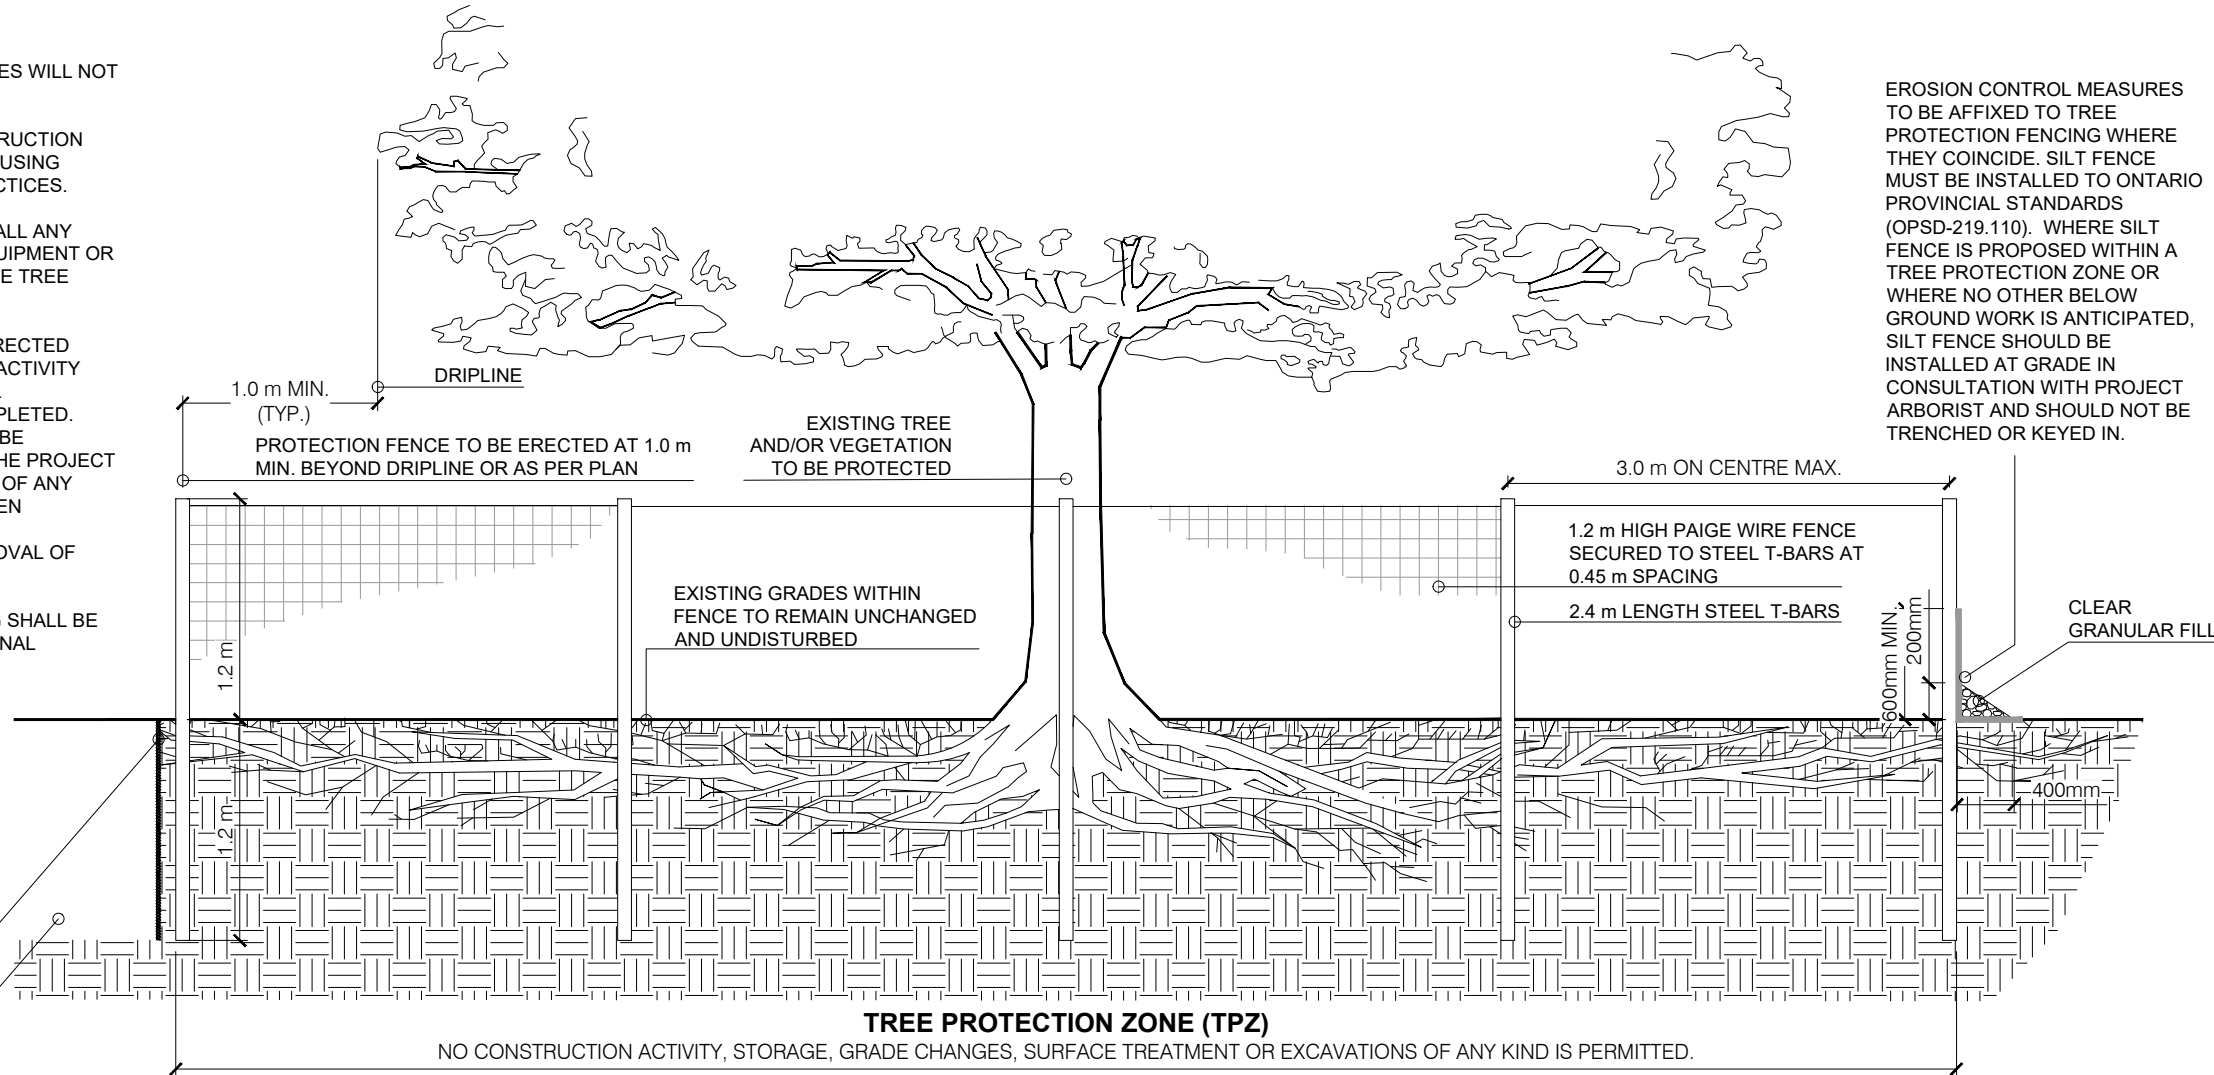
EROSION CONTROL MEASURES TO BE AFFIXED TO TREE PROTECTION FENCING WHERE THEY COINCIDE. SILT FENCE MUST BE INSTALLED TO ONTARIO PROVINCIAL STANDARDS (OPSD-219.110). WHERE SILT FENCE IS PROPOSED WITHIN A TREE PROTECTION ZONE OR WHERE NO OTHER BELOW GROUND WORK IS ANTICIPATED, SILT FENCE SHOULD BE INSTALLED AT GRADE IN CONSULTATION WITH PROJECT ARBORIST AND SHOULD NOT BE TRENCHED OR KEYED IN.
